**Star
Home
Inspection Services**

Home Inspection Report

613 SE James CT, MO 64063

Inspection Date: 10/21/2008

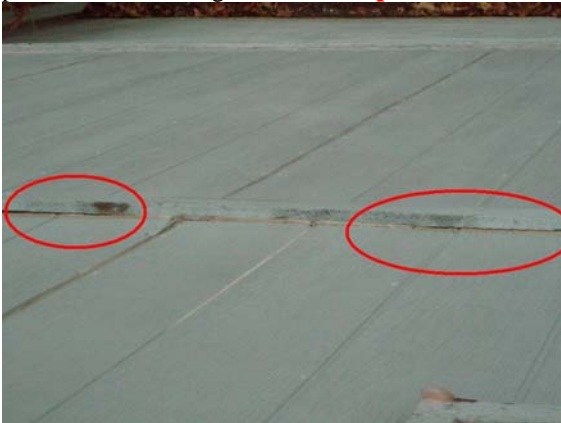
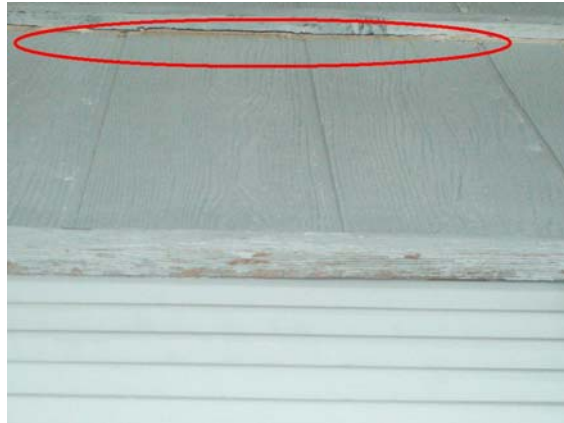
Exterior Walls

- **Repair:** The paint on the trim around the gable vents trim is peeling. These areas should be painted and caulked to prevent water damage and rot. **Repaired**
