**Star  
Home  
Inspection Services**

*Home Inspection Report*

**10 W 80th Terr, Kansas City, MO 64114**

**Report Number: 03062009-1A**

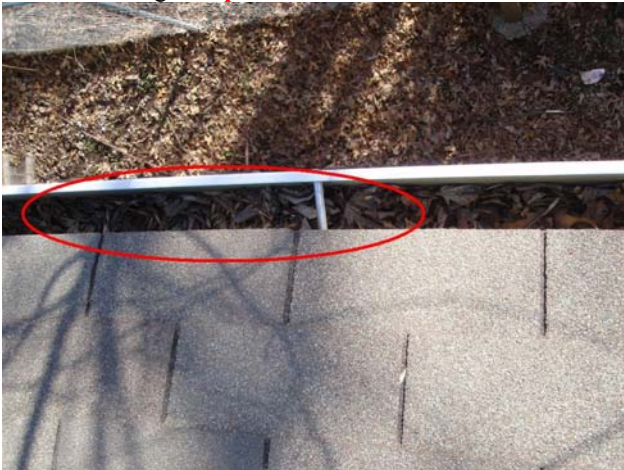
- **Repair:** The gutters require cleaning to avoid spilling roof runoff around the building – a potential source of water entry or water damage. **Repaired**

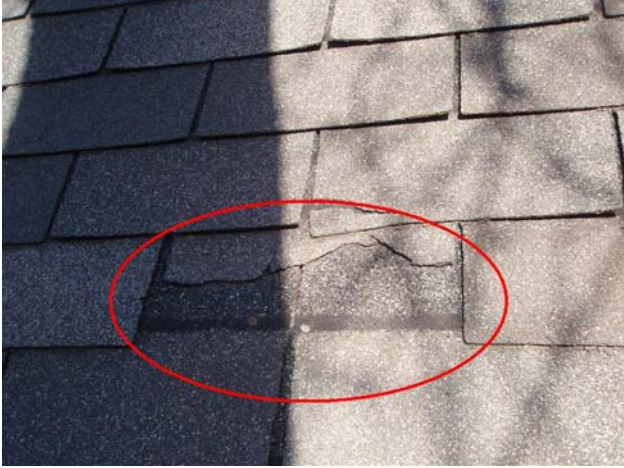
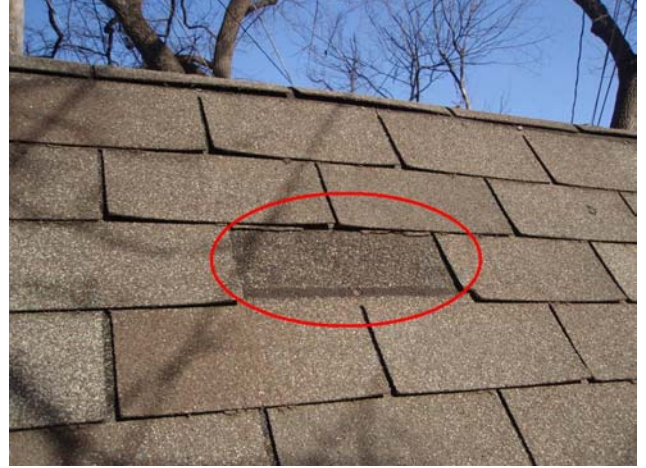
- **Repair:** Minor repairs to the outbuilding roofing are needed. Damaged or missing roofing material should be repaired. All roof penetrations should be examined and sealed as necessary.

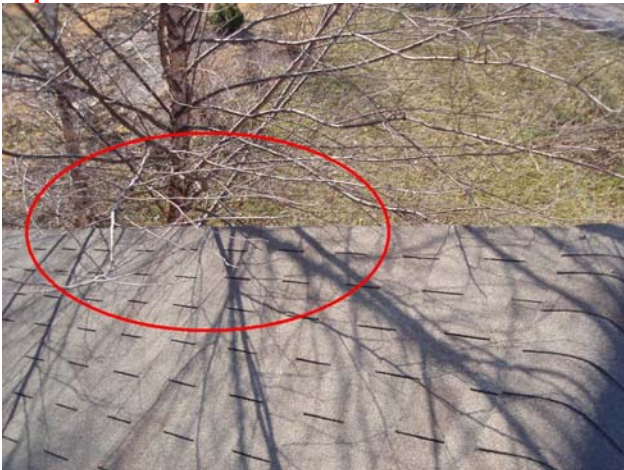
- **Repair:** Tree branches should be trimmed away from the house to avoid damage to the building (example at front).

**Repaired**

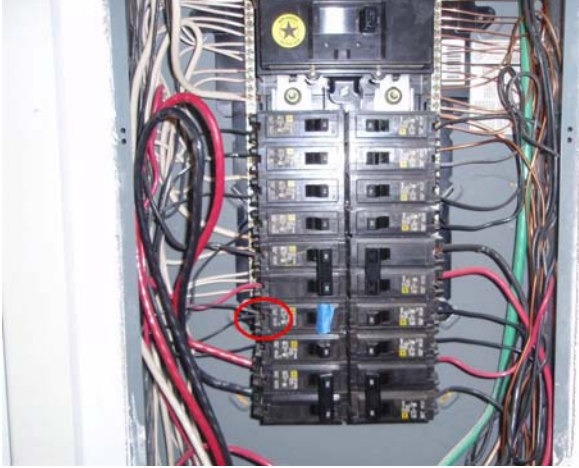
- **Repair:** Circuits within the main distribution panel that are doubled up (referred to as “double taps”) should be separated (marked with blue tape). Each circuit should be served by a separate fuse or breaker. **Repaired**

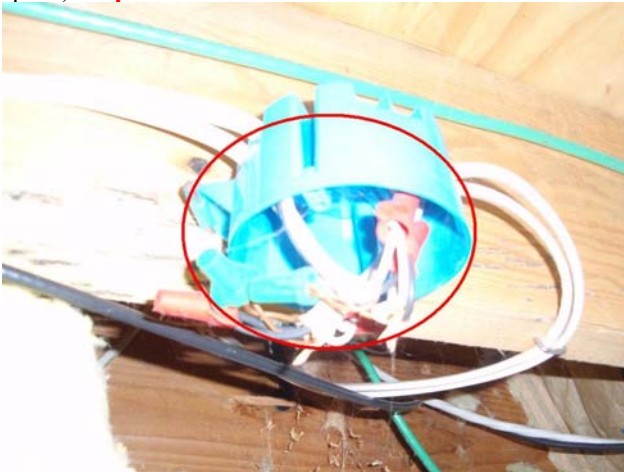
- **Repair:** All junction boxes should be fitted with cover plates, in order to protect the wire connections (example in crawl space). **Repaired**
