**Star
Home
Inspection Services**

Home Inspection Report

1003 N Dickinson Rd, Independence, MO 64050

Inspection Date: 06/25/2009

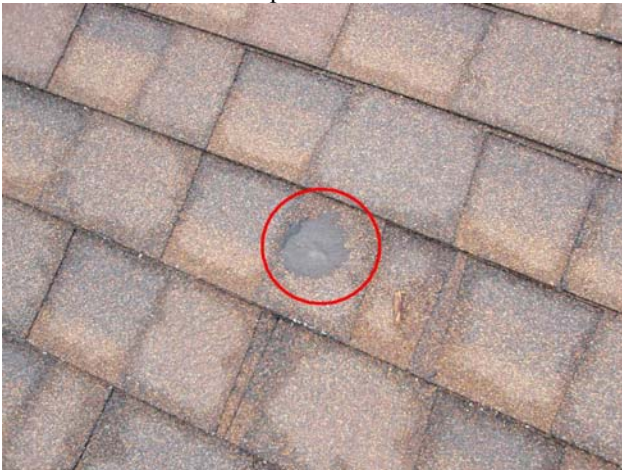
- **Repair:** The gutters require cleaning to avoid spilling roof runoff around the building – a potential source of water entry or water damage.
- **Monitor:** Prior minor repair to the roof was noted.

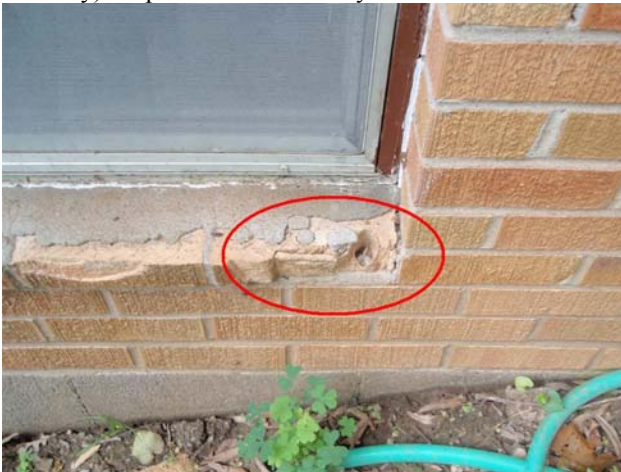
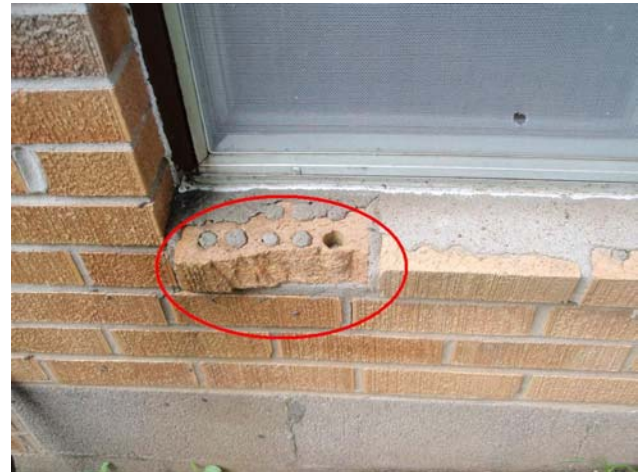
- **Monitor:** The masonry exterior window sill at the north side at shows evidence of spalling (surface deterioration of the masonry). Repair is not necessary at this time but this condition should be monitored.

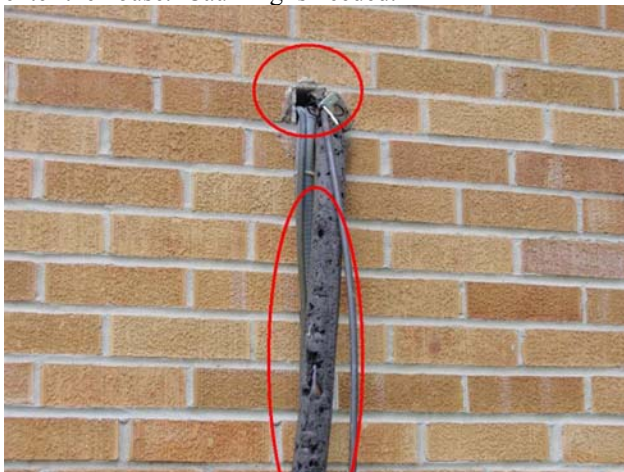
- **Repair:** Any openings in the exterior siding should be sealed. An example is where the air conditioner refrigerant lines enter the house. Caulking is needed.

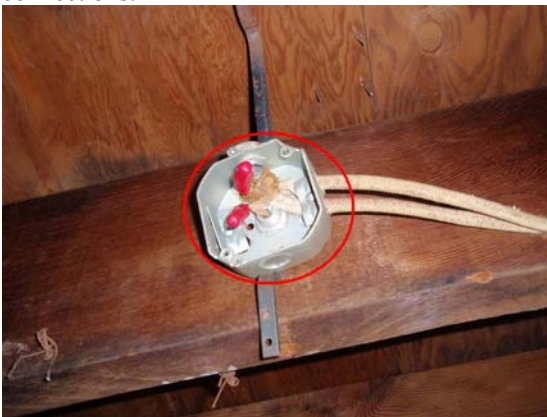
- **Repair:** The junction box at the basement ceiling should be fitted with a cover plate in order to protect the wire connections.

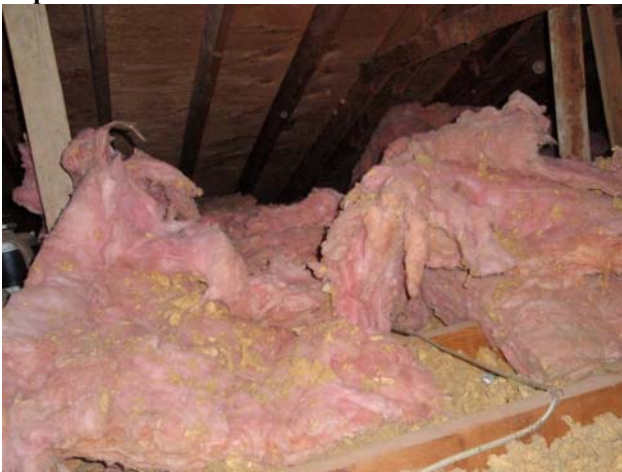
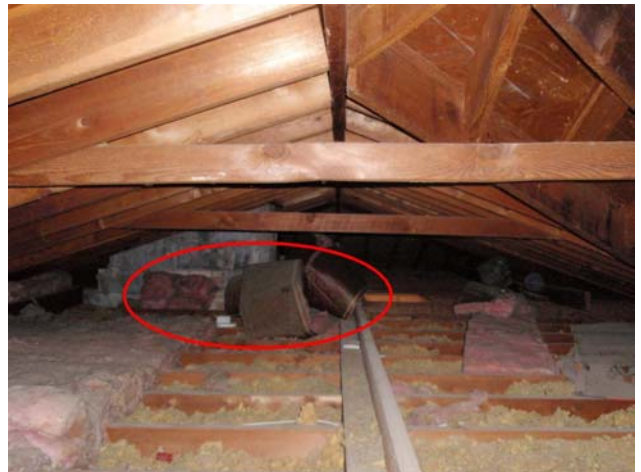
- **Repair:** Insulation should be evened out.

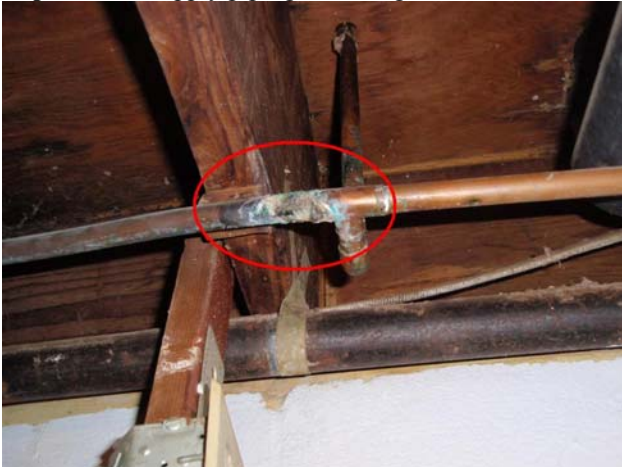
- **Repair:** The supply piping is leaking at the southwest corner of the basement ceiling.
