Star Home Inspection Services

Home Inspection Report

101 E Lawrence St, Kearney, MO 64060

Inspection Date: 10/28/2008

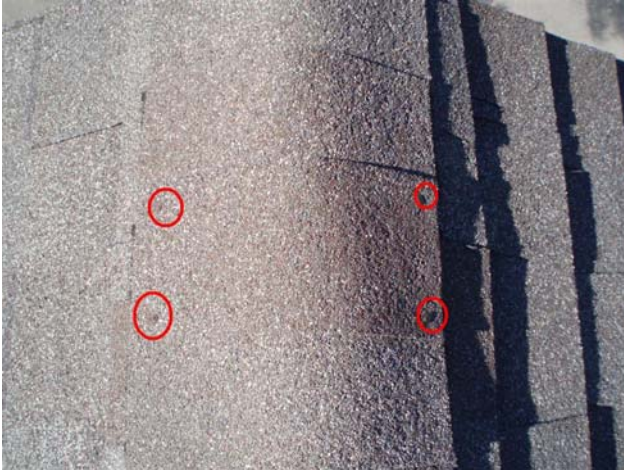
- **Repair:** Nail heads are exposed at the flashing. They should be sealed to reduce risk of leaks. **Repaired**
