**Star
Home
Inspection Services**

Home Inspection Report

10200 Noland Rd Lenexa, KS 66215

Report Number: 01202010-1A

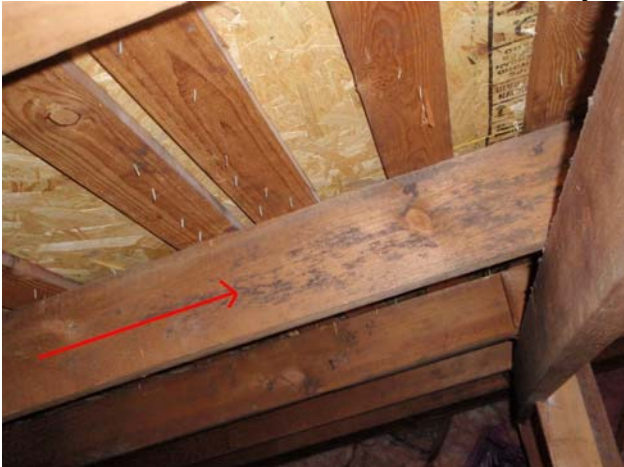
- **Monitor:** Construction mold was visible on some roof rafters. This is mold that grows on the lumber while lying in the weather during construction as evidenced by the strap marks. Most homes have some level of this mold and it goes dormant once removed from the elements and normally does not present any problems.

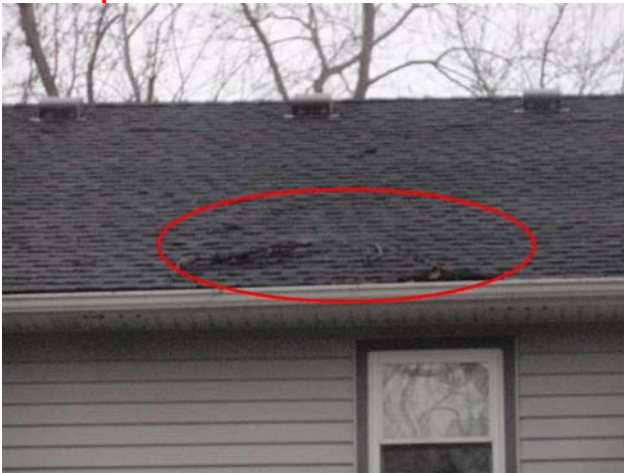
- **Improve:** Debris should be removed from the roofing to reduce risk of leaks and early roof wear. **Will repair when weather permits safe access**

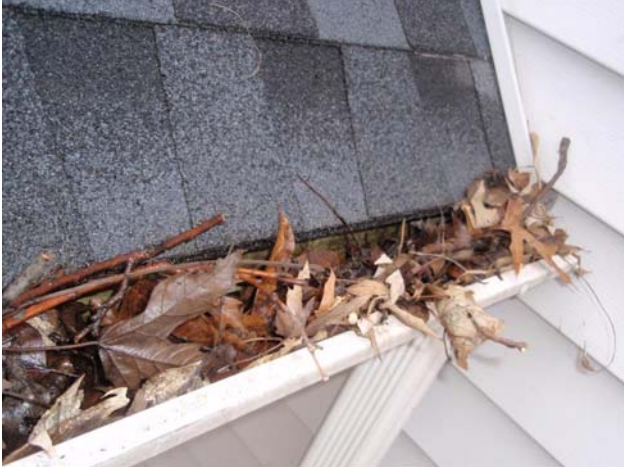
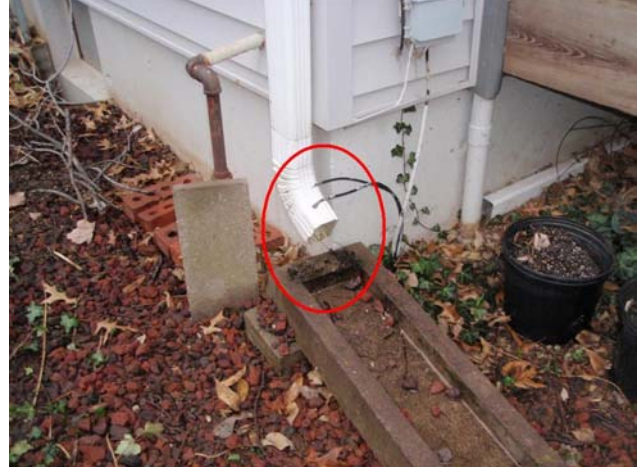
- **Repair:** The gutters require cleaning to avoid spilling roof runoff around the building – a potential source of water entry or water damage. **Will repair when weather permits safe access**
- **Repair:** The downspout(s) should discharge water at least five (5) feet from the house (i.e. northwest corner). Storm water should be encouraged to flow away from the building at the point of discharge. **Repaired**

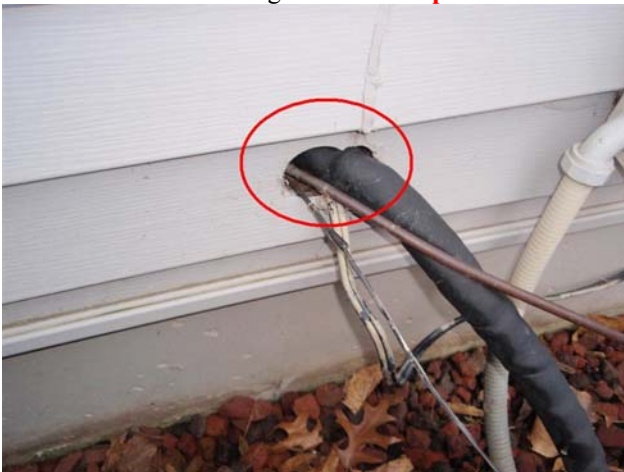
- **Repair:** Any openings in the exterior siding should be sealed. An example is where the air conditioner refrigerant lines enter the house. Caulking is needed. **Repaired**

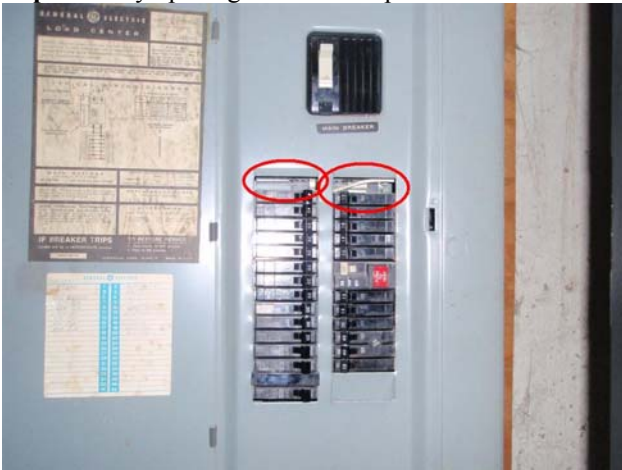
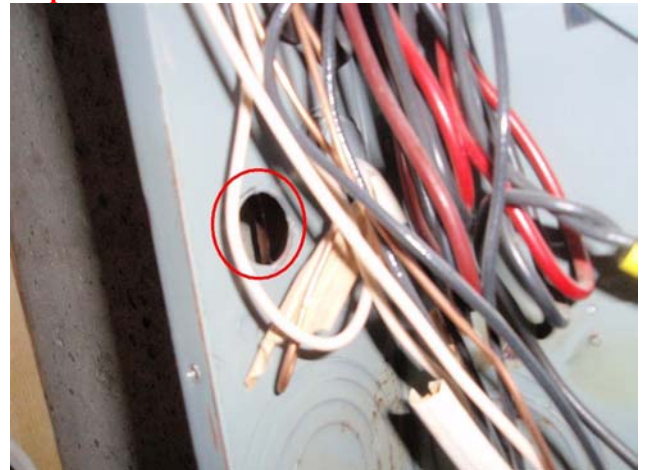
- **Repair:** Any openings in the main panel should be covered. **Repaired**

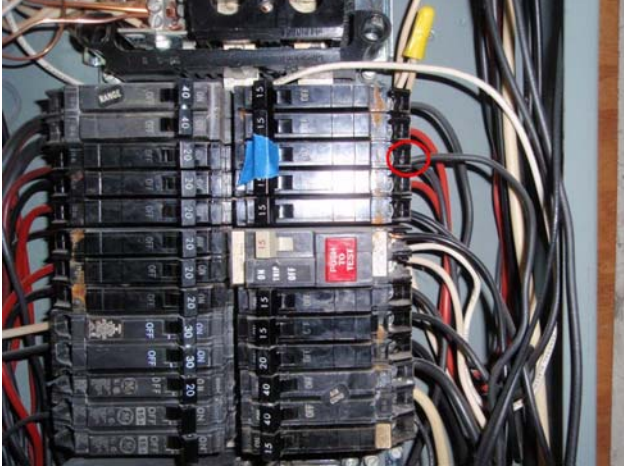
- **Repair:** Circuits within the main distribution panel that are doubled up (referred to as “double taps”) marked with “blue tape” should be separated. Each circuit should be served by a separate fuse or breaker. **Repaired (installed additional breaker)**

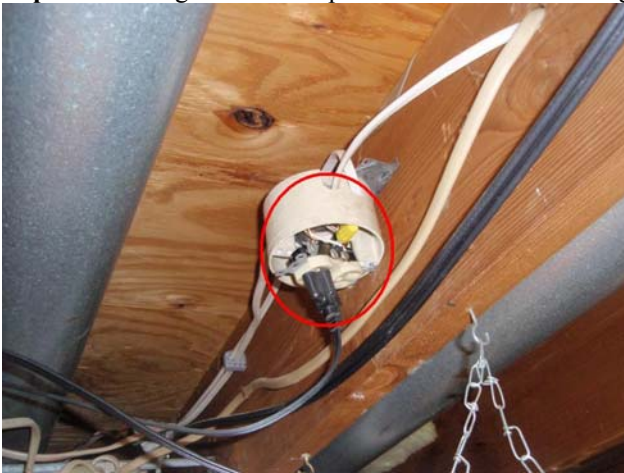
- **Repair:** Missing outlet cover plate at the basement ceiling should be replaced to avoid a shock hazard. **Repaired**

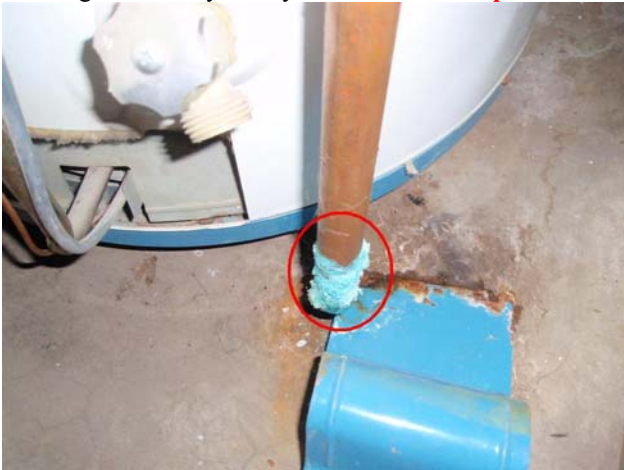
- **Monitor:** Water heaters have a typical life expectancy of 7 to 12 years. The existing unit is approaching or has exceeded this age range. One cannot predict with certainty when replacement will become necessary.
- **Repair:** The Temperature and Pressure Relief (TPR) Valve serving the water heater is leaking slightly. Minor repairs or cleaning can usually rectify this condition. **Repaired**

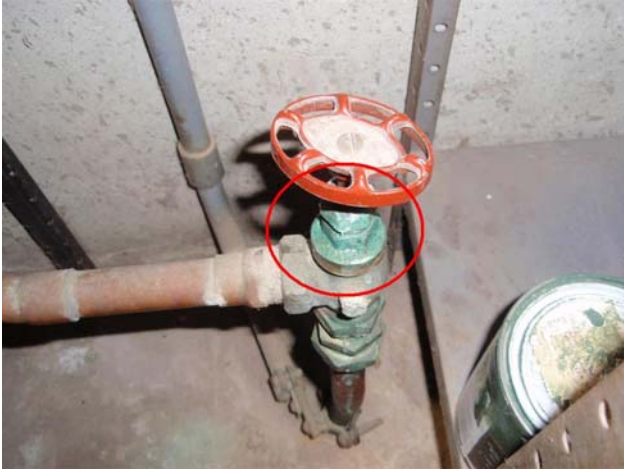
- **Repair:** The supply piping is leaking at the main shutoff handle. **Repaired (tightened packing nut)**

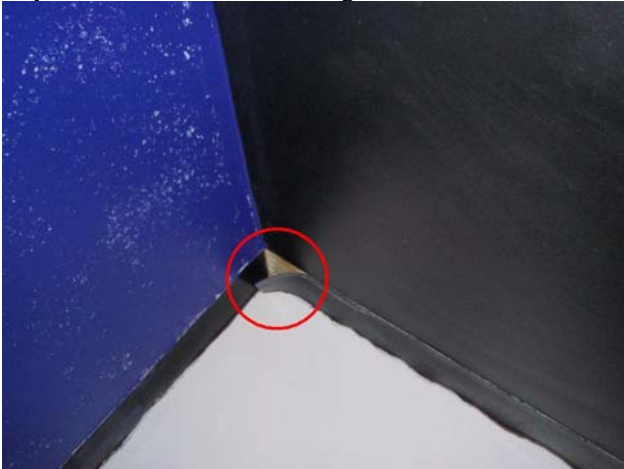
- **Monitor:** The vinyl flooring in the master bath was observed to have minor surface wear.
- **Repair:** The baseboard molding in the basement is loose. **Repaired**
