Star Home Inspection Services

Home Inspection Report

10211 W 98th Terr, Overland Park, KS 66212

Inspection Date: 07/13/2009

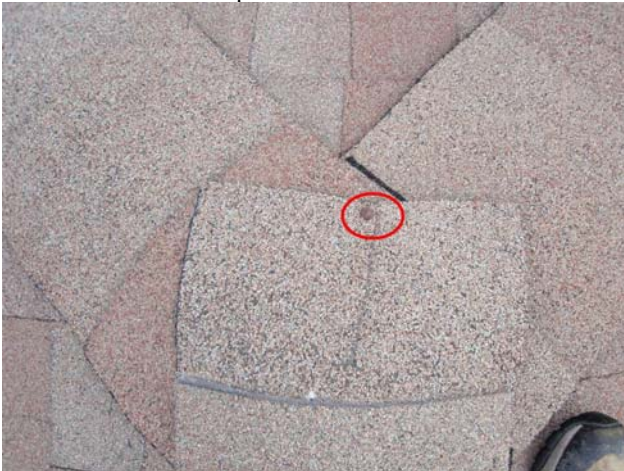
- **Repair:** Exposed nail heads were observed in the roofing shingles and/or ridge caps. All exposed nail heads should be caulked to reduce the potential of leaks.

- **Monitor:** The roofing is in fair condition. We did not see evidence of active leaks nor need for immediate major repair.
- It is recommended that the present layers of roofing materials be removed prior to re-roofing. This adds cost of demolition and debris removal to the re-roof cost.

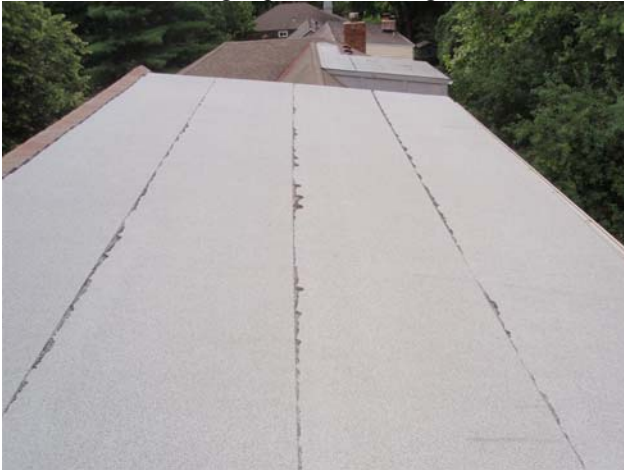
- **Note:** Rolled roofing is prone to leaking and requires close monitoring and higher than normal maintenance.

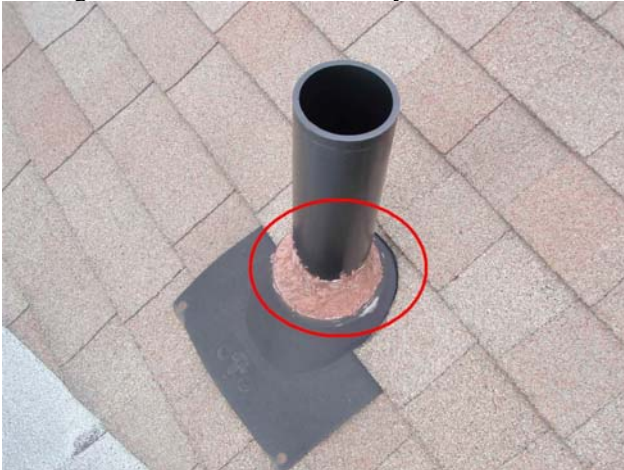
- **Monitor:** The plumbing vent flashing boot has been caulked, leaked in the past and may be vulnerable to leaks. These flashings should be monitored closely.

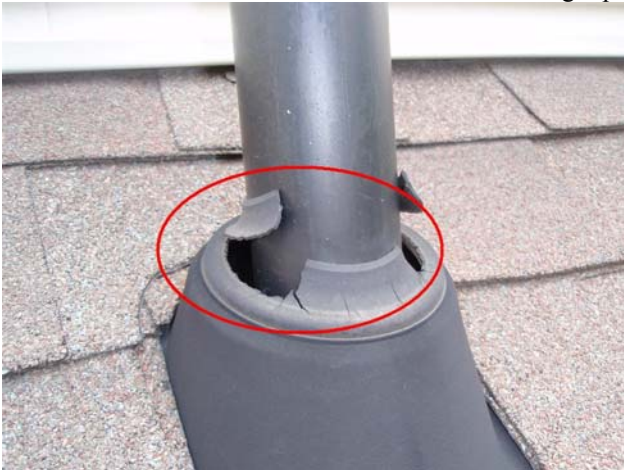
- **Monitor, Repair:** The plumbing vent flashing boot at the back roof is split making it vulnerable to leaks. It's recommended that the boot be caulked or the flashing replaced.

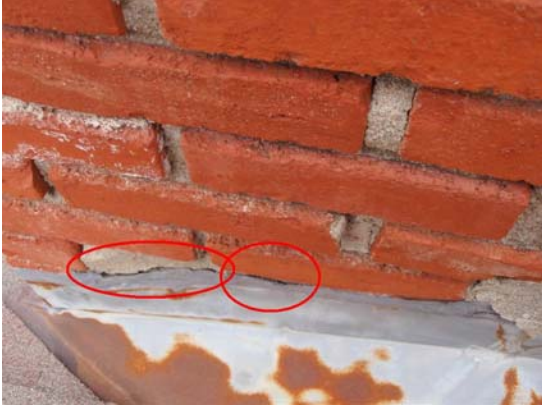
- **Repair:** The chimney flashing should be caulked to avoid leaks.

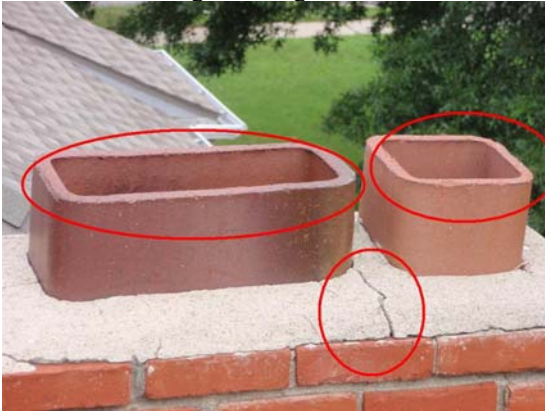
- **Monitor, Repair:** The cap of the masonry chimney is cracked. These cracks should be sealed or caulked before winter to prevent damage from freezing water.
- **Repair:** A rain cap and vermin screen should be installed on the masonry chimney and the chimney flue should be checked for damage. Damaged flues can be unsafe.

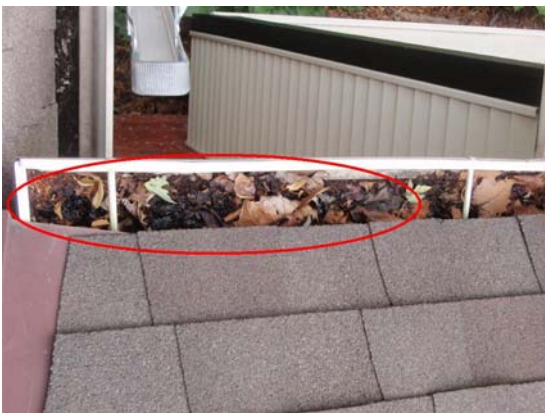
- **Repair:** The front short section of gutter require cleaning to avoid spilling roof runoff around the building – a potential source of water entry or water damage.

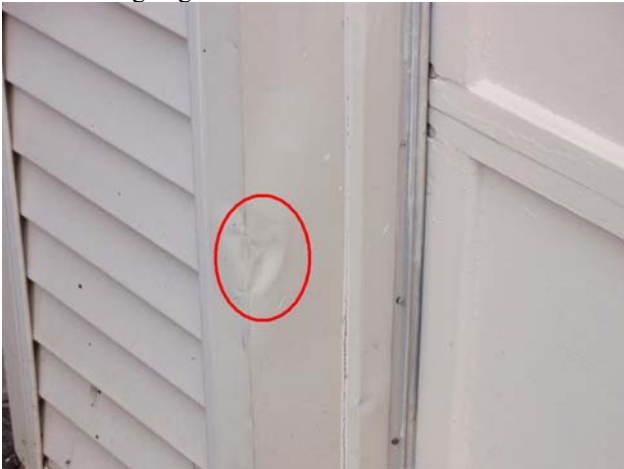
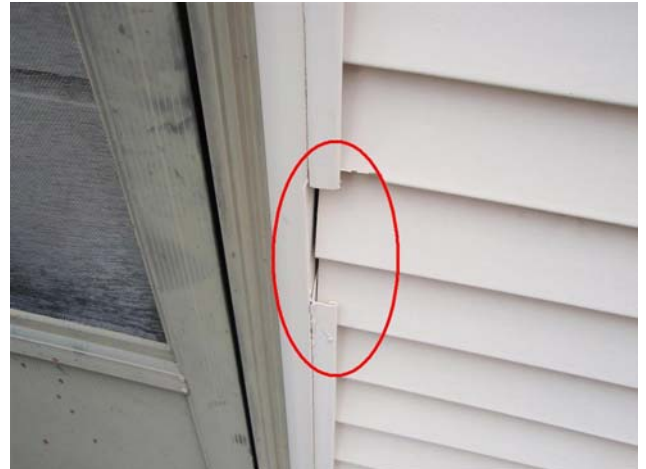
- **Monitor, Repair:** Localized damage of the vinyl siding was noted at back door trim. This should be repaired and/or caulked to prevent water entry. There is extra risk of hidden damage in such areas. Localized minor damage at trim wrap at overhead garage door was noted.

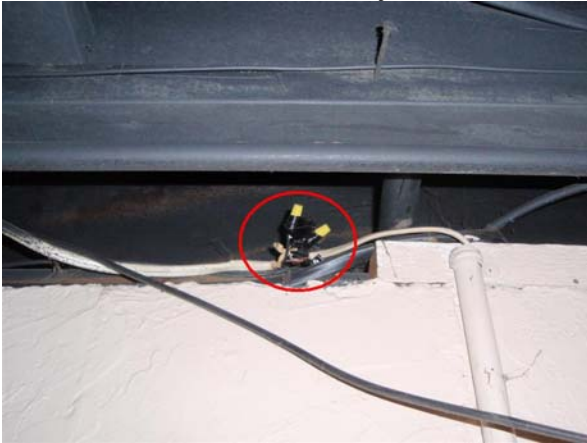
- **Repair:** Loose cable wiring in the basement should be secured.
- **Repair:** Improper electrical connections should be repaired (example at basement ceiling west side). All electrical connections should be made inside junction boxes fitted with cover plates.

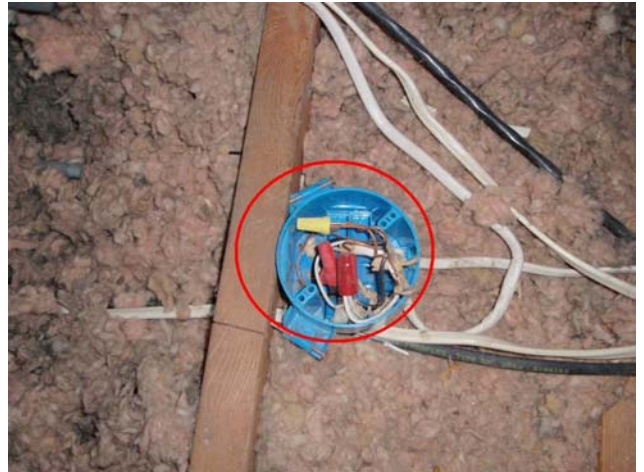
- **Repair:** All junction boxes should be fitted with cover plates, in order to protect the wire connections (examples at basement ceiling and west attic).

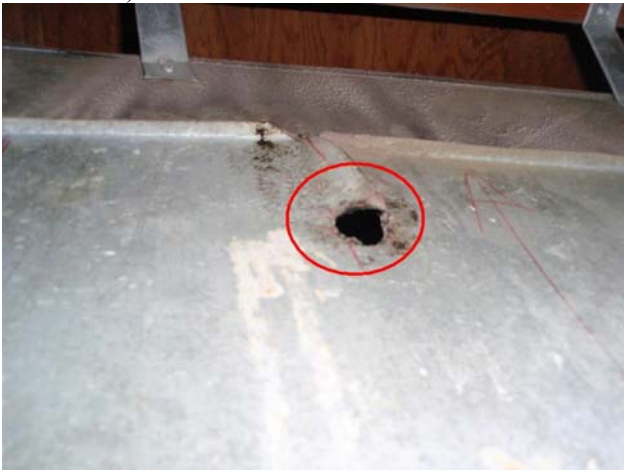
- **Repair:** Loose fitting joints and/or openings in the ductwork should be improved (i.e. furnace room opening at back side of duct).
