**Star
Home
Inspection Services**

Home Inspection Report

10331 Bond St Overland Park, KS 66214

Inspection Date: 01/11/2010

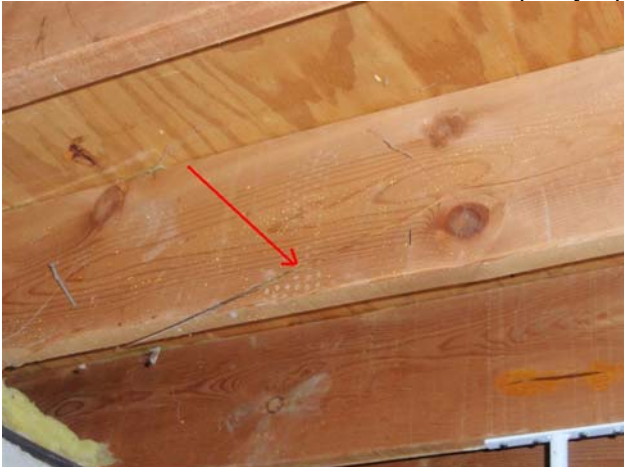
- **Monitor, Repair:** Floor joist in the unfinished basement is cracked. Cracked joists are repaired by replacement, “sister” joists along side, or additional support. Where one or very few damaged joists are found, this work is not high priority and can be combined with other structural or carpentry repairs at the property.

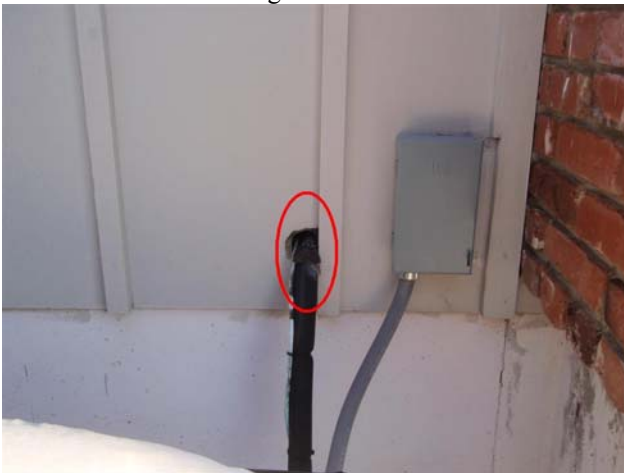
- **Repair:** The exterior siding paint is peeling and/or worn thin in localized areas (i.e. bottom edge of siding). These areas should be painted to prevent water damage or rot in the future.
- **Repair:** Any openings in the exterior siding should be sealed. An example is where the air conditioner refrigerant lines enter the house. Caulking is needed.

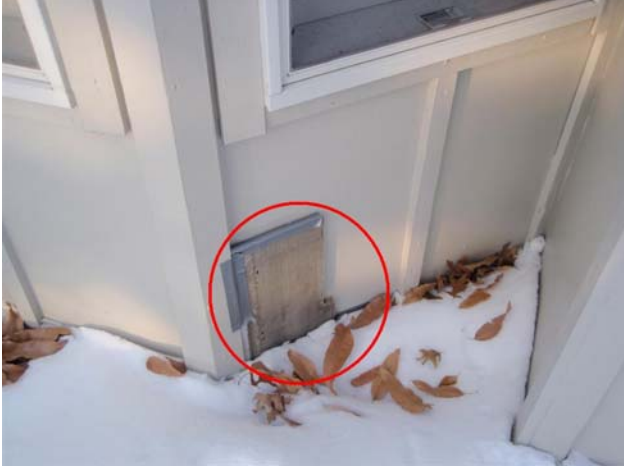
- **Repair:** Localized rot was observed in the siding and damage to the back siding was observed. Following repair of the damaged areas (which should be combined with exterior painting/maintenance) proper maintenance of the siding and control of water from roof or surface runoff can avoid further damage.

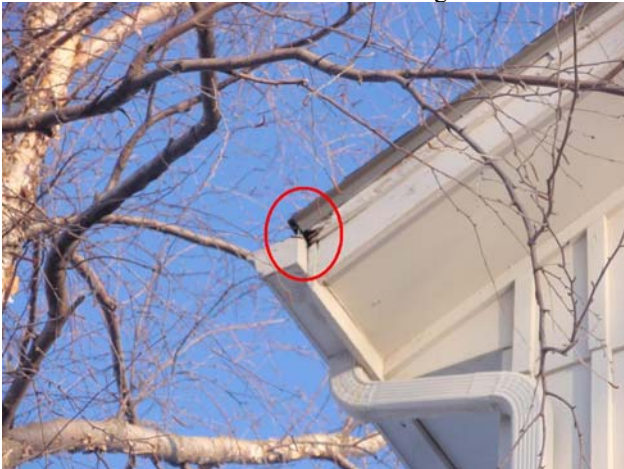
- **Repair:** The eaves are peeling and they should be painted to prevent water damage and rot.
- **Repair:** Localized rot was observed in the eaves (i.e. southwest corner). Following repair of the damaged areas (which should be combined with exterior painting/maintenance) proper maintenance of the siding and control of water from roof or surface runoff can avoid further damage.

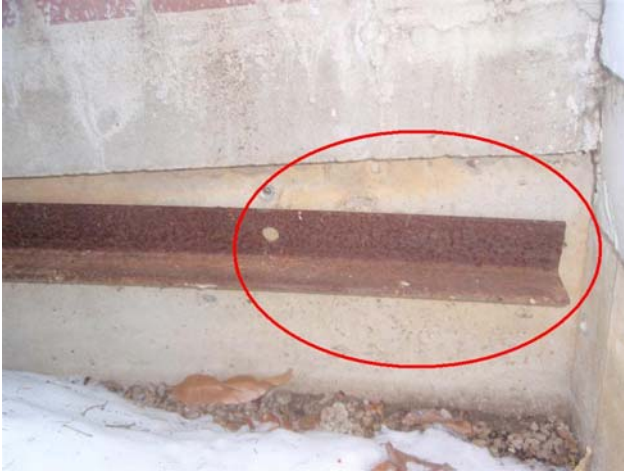
- **Repair:** The front porch reinforcement steel is loose and should be better secured.

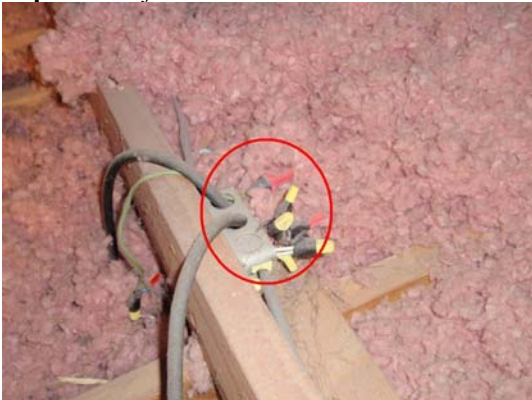
- **Repair:** Extension cords should not be used as permanent wiring. This wiring in the garage should be removed and replaced with permanent wiring and an outlet(s).
- **Repair:** All junction boxes should be fitted with cover plates, in order to protect the wire connections (i.e. attic).
