**Star
Home
Inspection Services**

Home Inspection Report

10400 E 79th Terr Raytown, MO 64138

Inspection Date: 05/19/2010

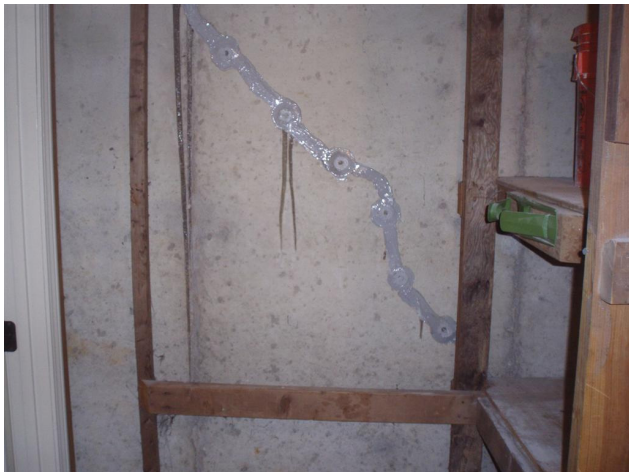
- **Monitor:** Larger than typical foundation settlement cracking was observed. The amount of movement which has occurred is not likely to have caused other damage to the structure but this area should be monitored. If additional movement occurs, repairs might be necessary. The rate of movement cannot be predicted during a one-time inspection.

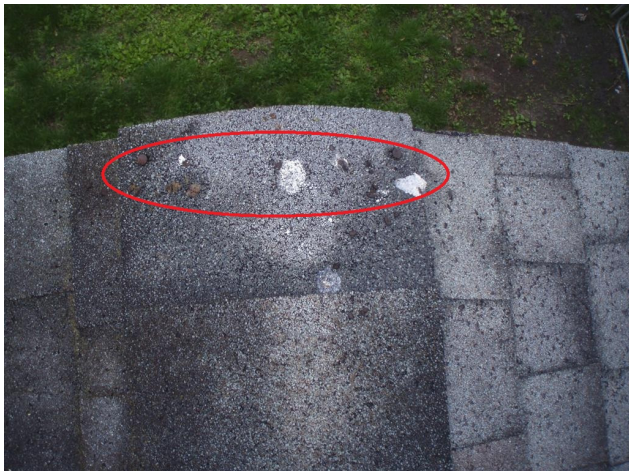
- **Recommend:** Exposed nail heads were observed in the roofing shingles and/or ridge caps. All exposed nail heads should be caulked to reduce the potential of leaks.

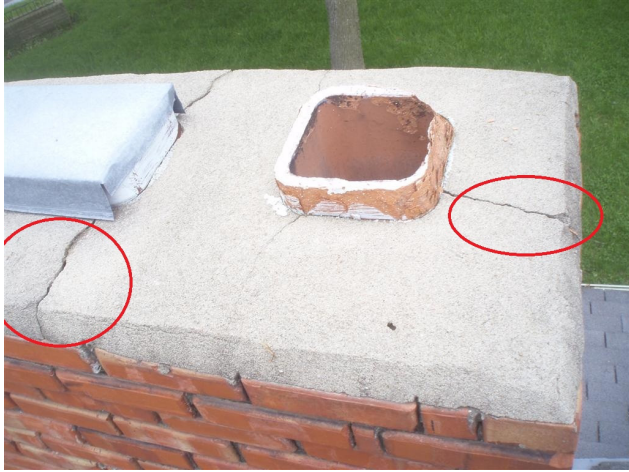
- **Monitor, Repair:** The cap of the masonry chimney is cracked. These cracks should be sealed or caulked before winter to prevent damage from freezing water.

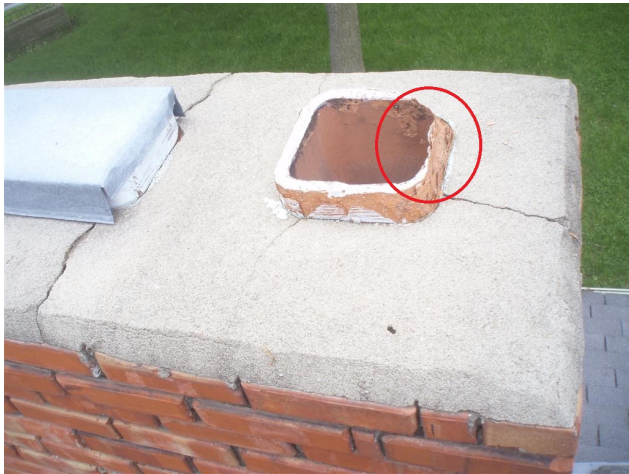
- **Repair:** A rain cap and vermin screen should be installed on the masonry chimney and the chimney flue should be checked for damage. Damaged flues can be unsafe.
- **Repair:** The top of the flue liner of the masonry chimney is deteriorating. The flue should be repaired.

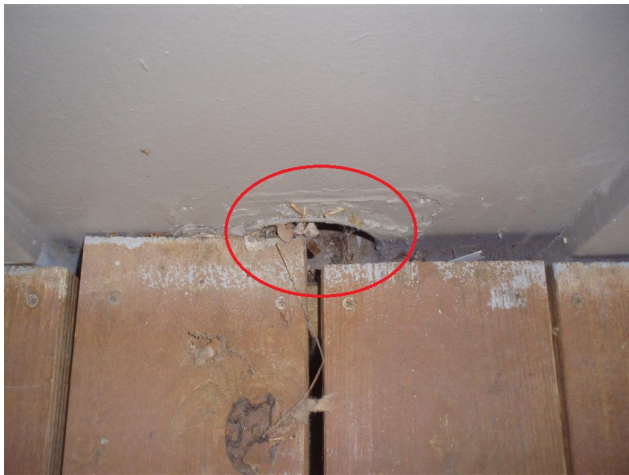
- **Monitor, Repair:** A laundry vent no longer in use should be covered to prevent vermin from entering the house.

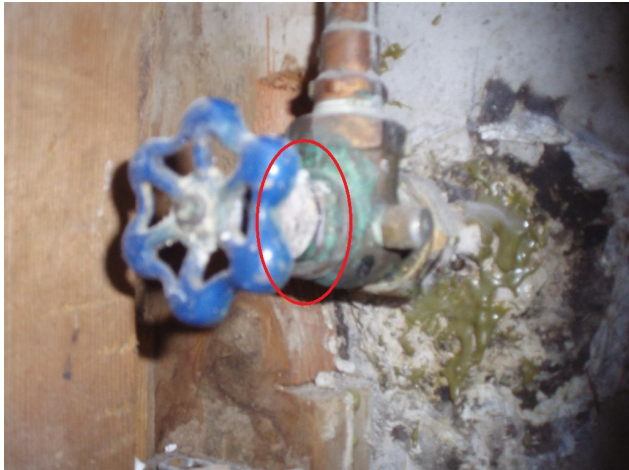
- **Repair:** The supply piping shutoff valve is leaking.

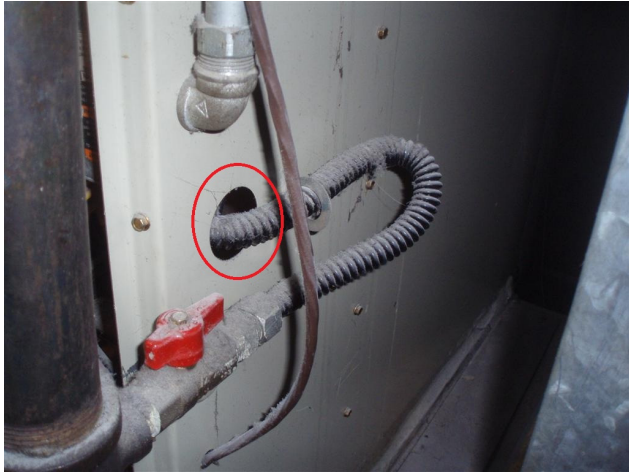
- **Repair:** Flexible gas appliance connections should not pass through walls, floors or the appliance housing as is the case of the furnace. This connector should be replaced with one of suitable solid gas piping.
