**Star  
Home  
Inspection Services**

*Home Inspection Report*

**10480 W 157th Terr Overland Park, KS 66221**

**Inspection Date: 01/25/2012**

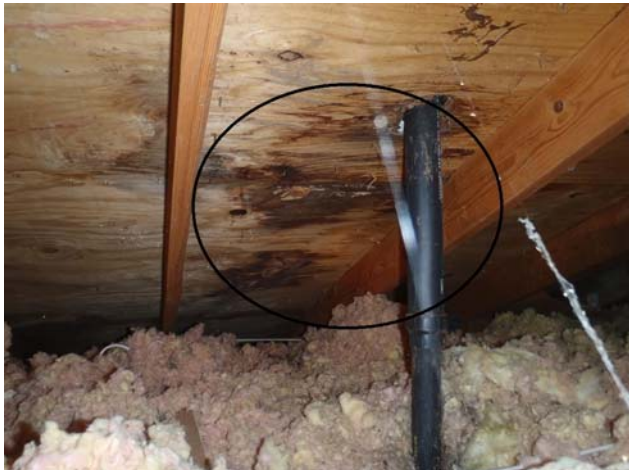
- **Monitor:** Stains on the underside of the roof sheathing were observed as evidence of prior roof leaks.

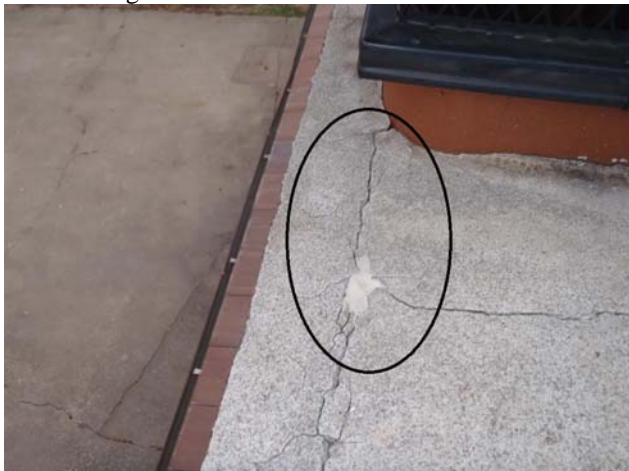
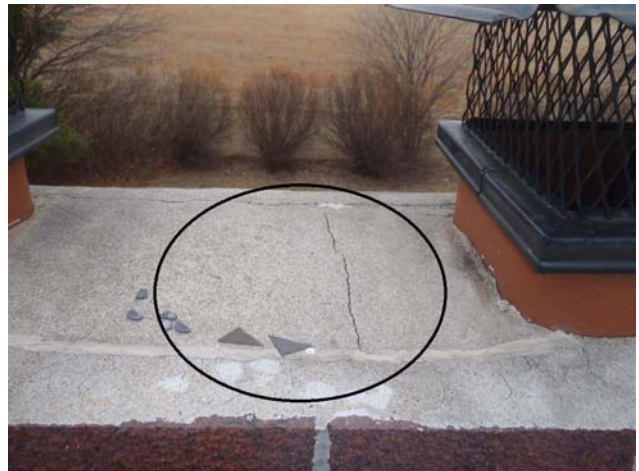
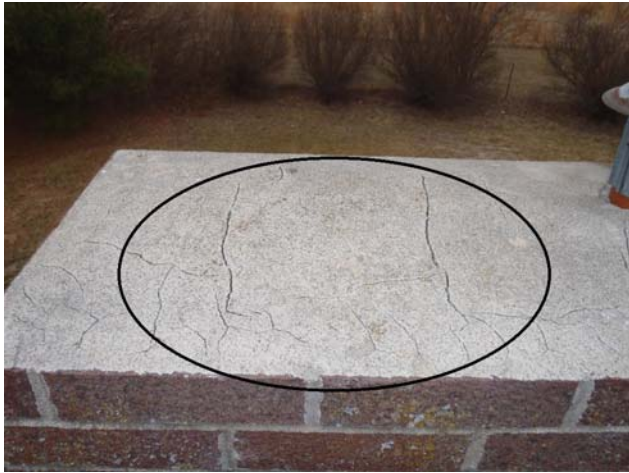
- **Repair:** The cap of the masonry chimney is cracked. These cracks should be sealed or caulked to prevent damage from freezing water.

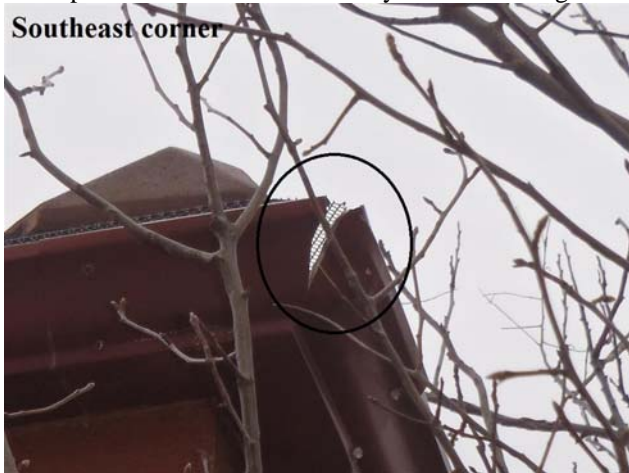
- **Repair:** Damaged gutters should be repaired or replaced as necessary to avoid spilling roof runoff around the building – a potential source of water entry or water damage.

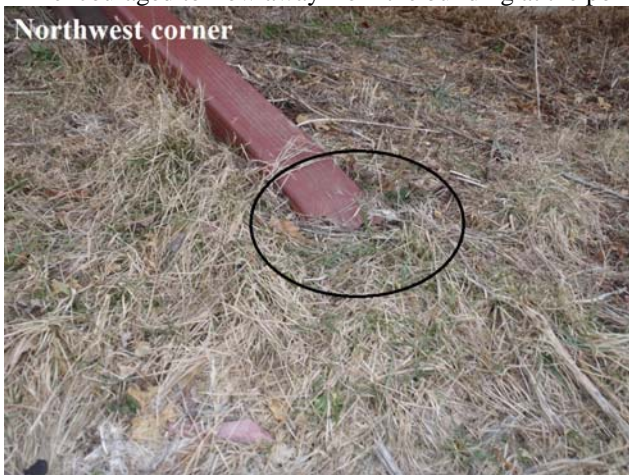
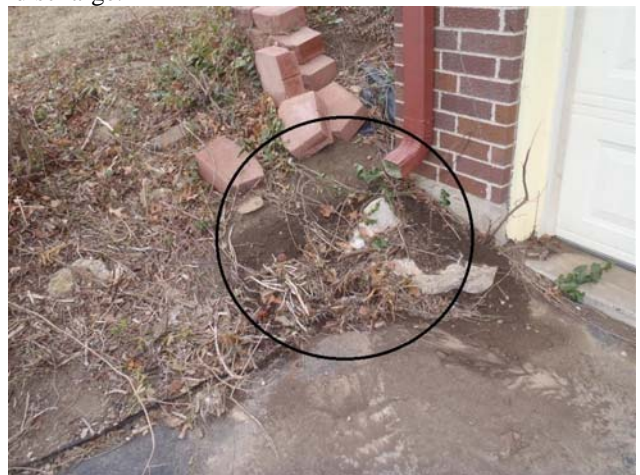
- **Repair:** The downspout(s) should discharge water at least five (5) feet from the house. Storm water should be encouraged to flow away from the building at the point of discharge.

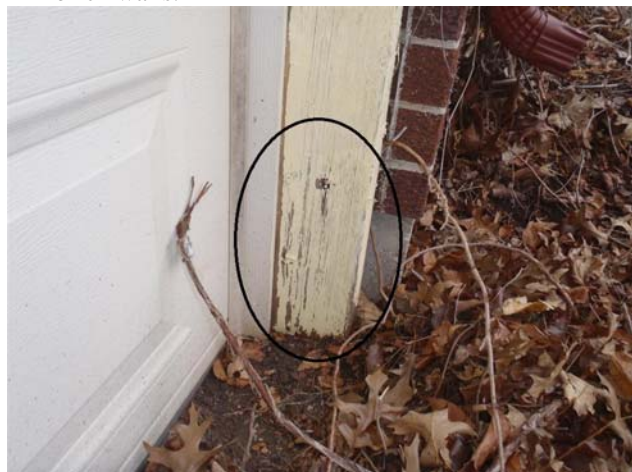
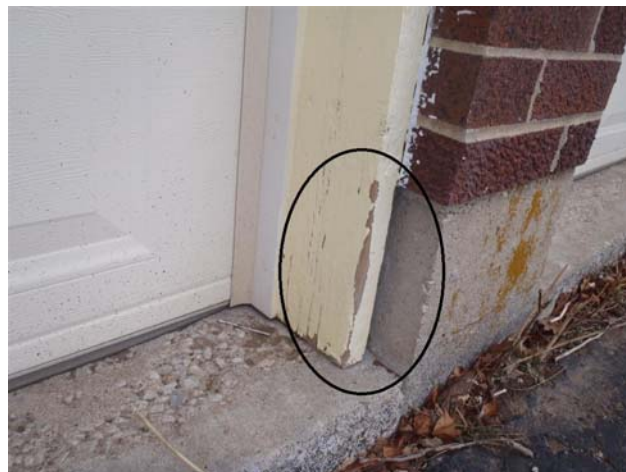
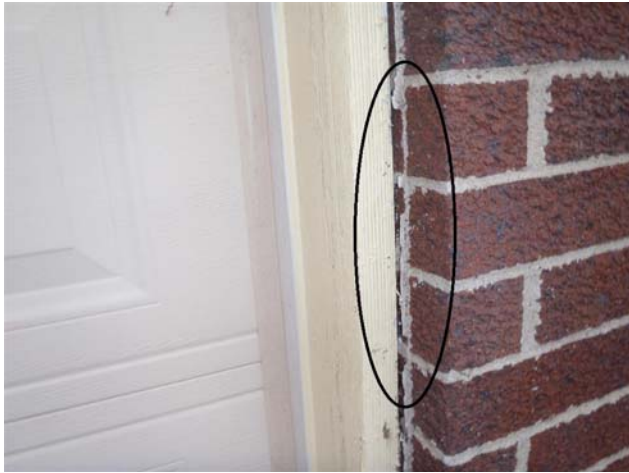
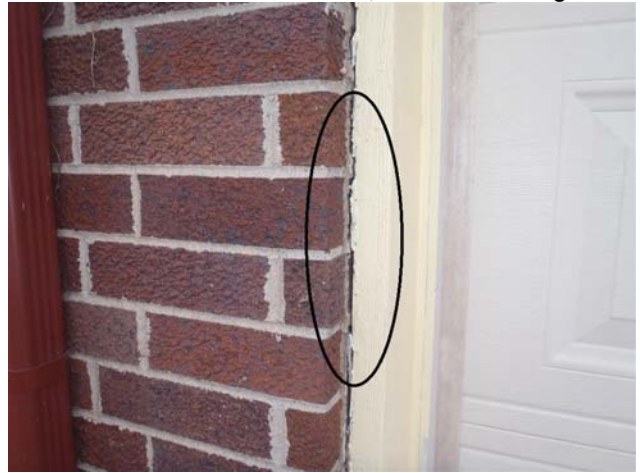
- **Repair:** The paint on the garage door frame/ trim is peeling and requires painting and caulking between the frame and brick walls.

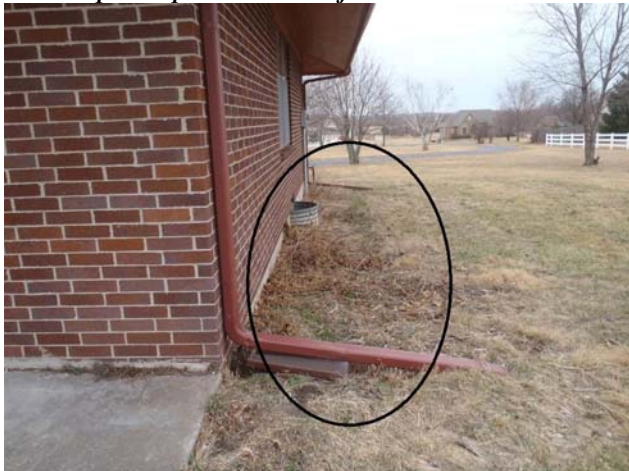
- **Recommend:** The grading should be improved to promote the flow of storm water away from the house. This can often be accomplished by the addition of top soil. The ground should slope away from the house at a rate of one inch per foot for at least the first five feet. At least eight (8) inches of clearance should be maintained between soil level and the bottom of exterior wall siding. *It should be understood that it is impossible to predict whether moisture penetration will pose a problem in the future.*

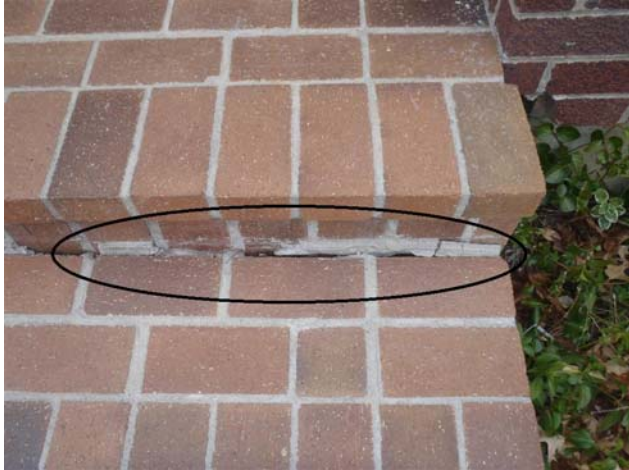
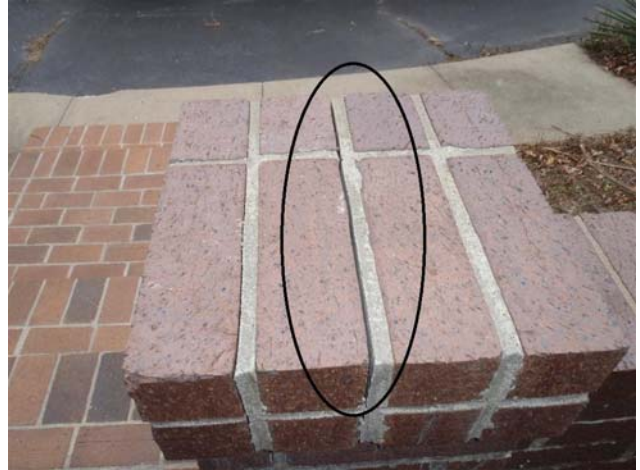
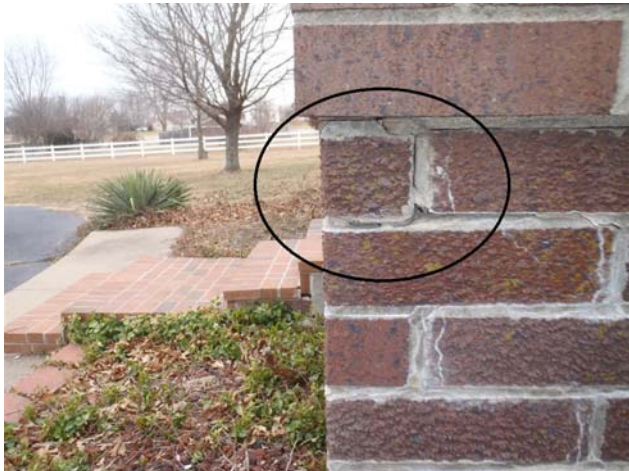
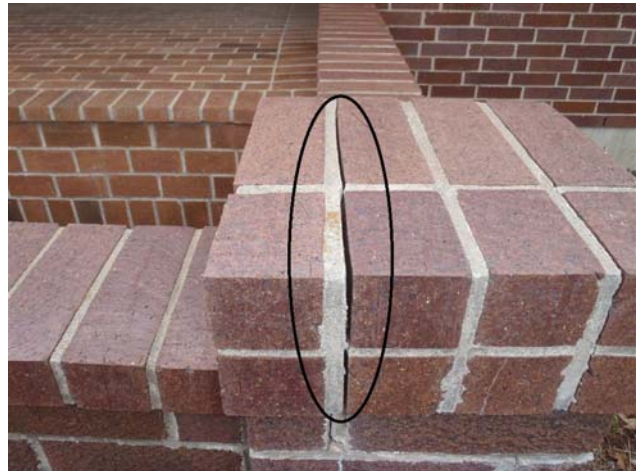
- **Repair:** The brick porch and steps need minor re-pointing.

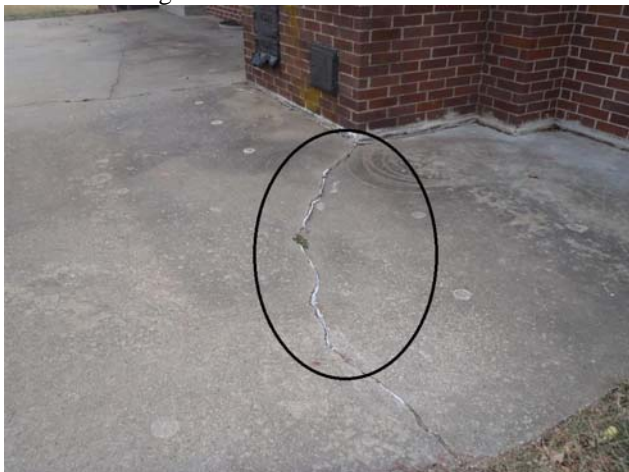
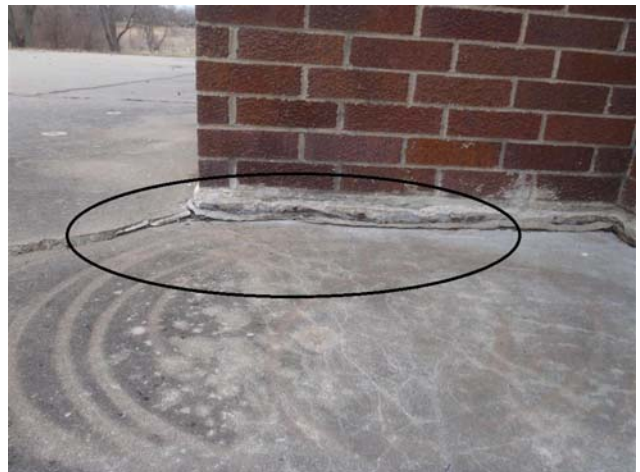
- **Monitor, Repair:** The soil below the patio has settled and/or heaved. Persisting movement may result in the need for resurfacing.

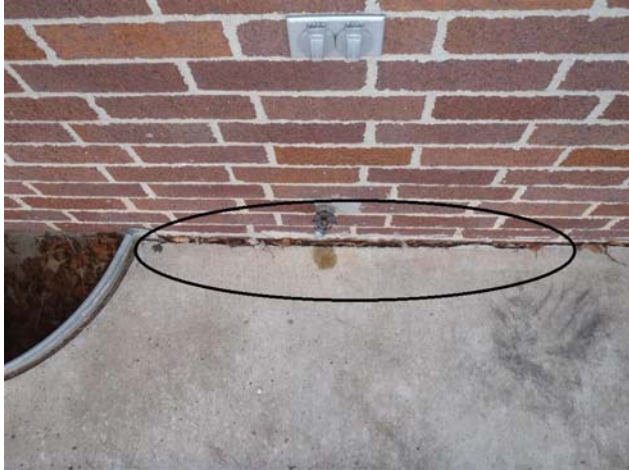
- **Recommend:** The patio has settled leaving a gap between at the foundation. It's recommended the gap be filled to prevent water intrusion.

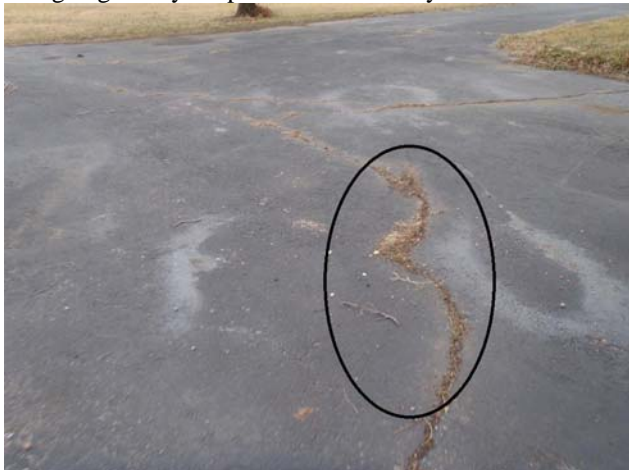
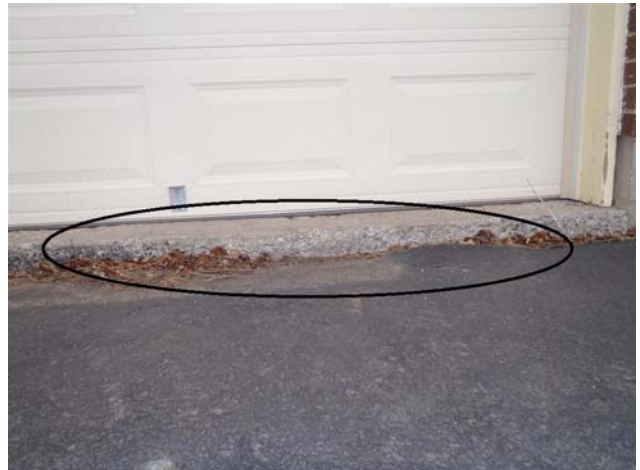
- **Monitor, Repair:** The soil below the driveway has settled and/or heaved resulting in cracks and a considerable lip at the garage entry. Repair is discretionary.

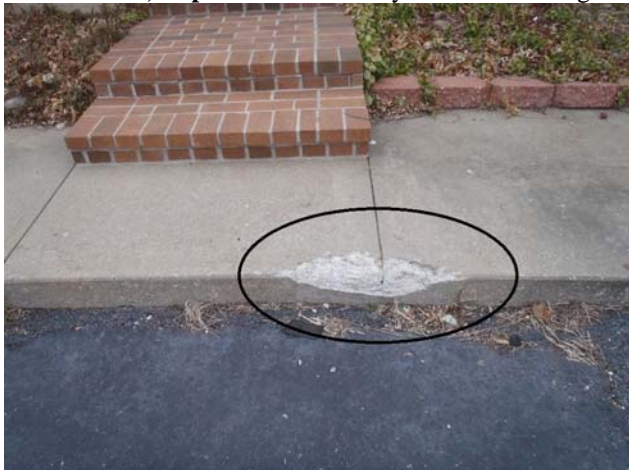
- **Monitor, Repair:** The walkway surface is damaged.

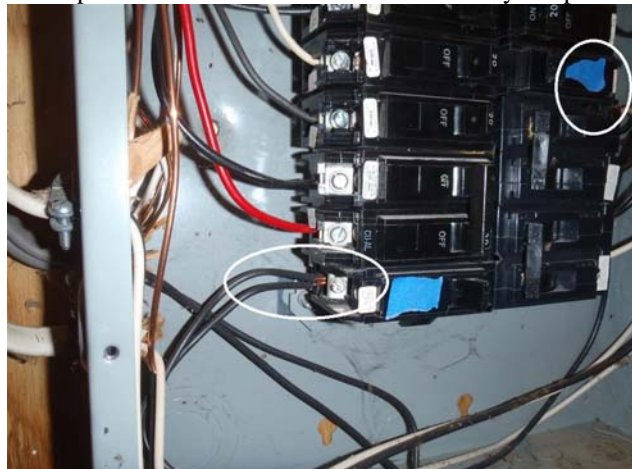
- **Repair:** Circuits within the main distribution panel that are doubled up (referred to as "double taps") should be separated. Each circuit should be served by a separate fuse or breaker.

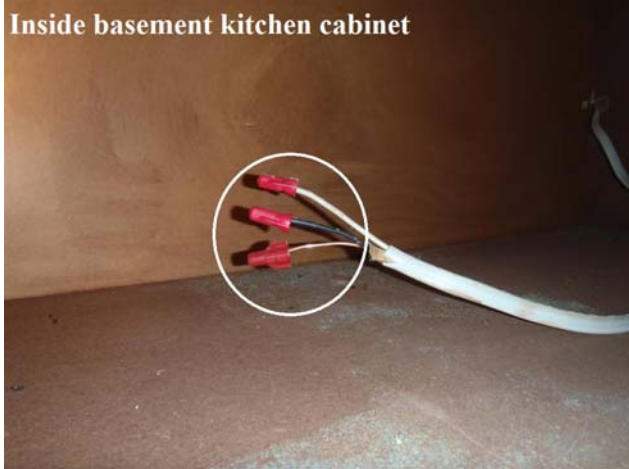
Inside basement kitchen cabinet

- **Repair:** Abandoned wiring in the basement kitchen cabinet should be replaced or appropriately terminated.

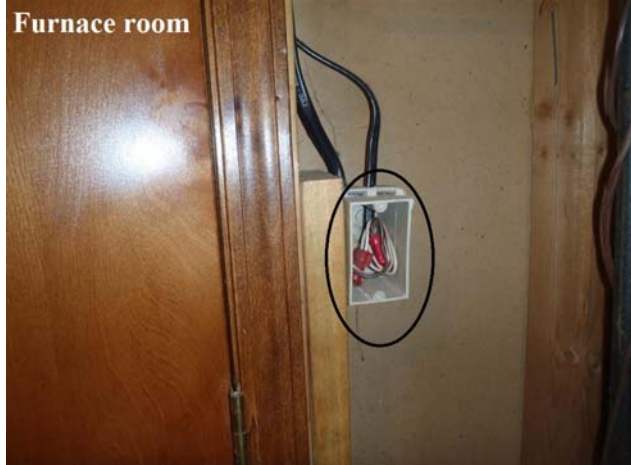
- **Repair:** All junction boxes in the furnace room should be fitted with cover plates, in order to protect the wire connections.

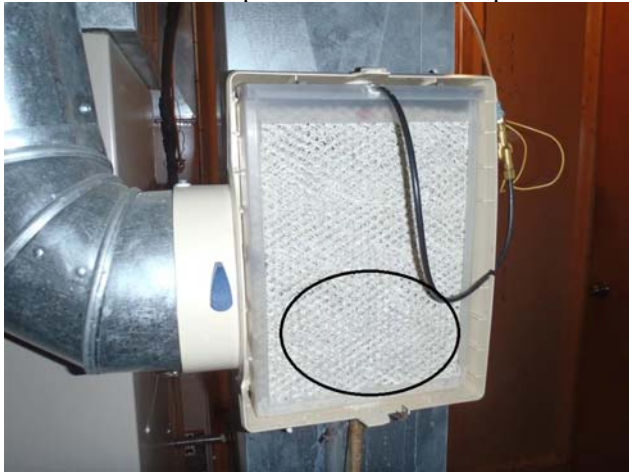
- **Repair:** The magic Chef furnace is aging and shows signs of rust. The electronic air cleaner for this furnace did not appear to be functioning at the time of inspection. This should be repaired and the furnace evaluated by a qualified HVAC technician.
- **Monitor, Repair:** There is no access to the east Lennox system humidifier.
- **Repair:** Water did not pass through the humidifier on the west Lennox system. Cleaning and repairs should be undertaken and replacement of the water panel is also recommended.

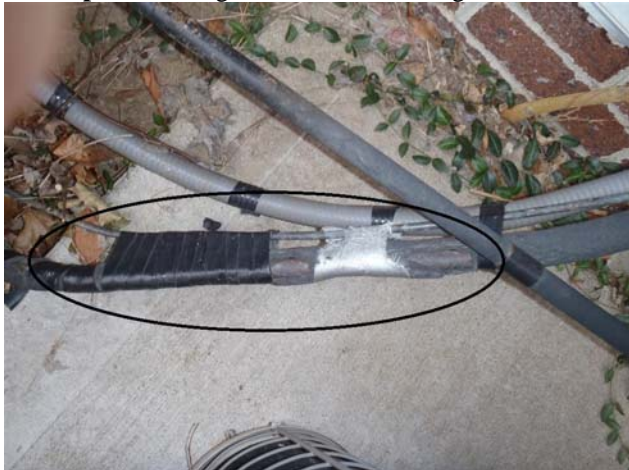
- **Monitor:** As is not uncommon for homes of this age and location, the Magic Chef air conditioning system is old. It may require a slightly higher level of maintenance, and may be more prone to major component breakdown. Predicting the frequency or time frame for repairs on any mechanical device is virtually impossible.
- **Repair:** Damaged insulation on refrigerant lines for the magic Chef unit should be repaired.

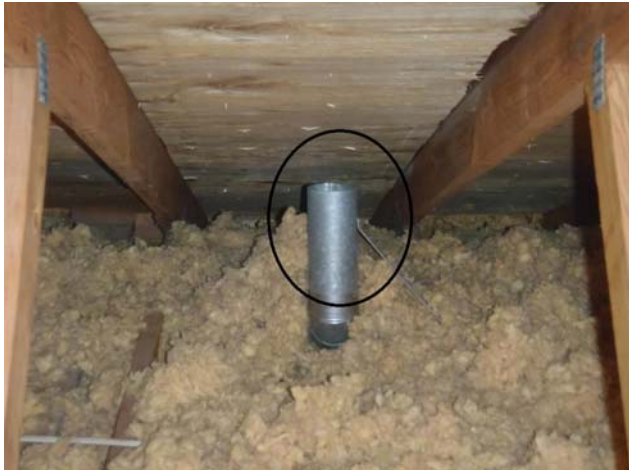
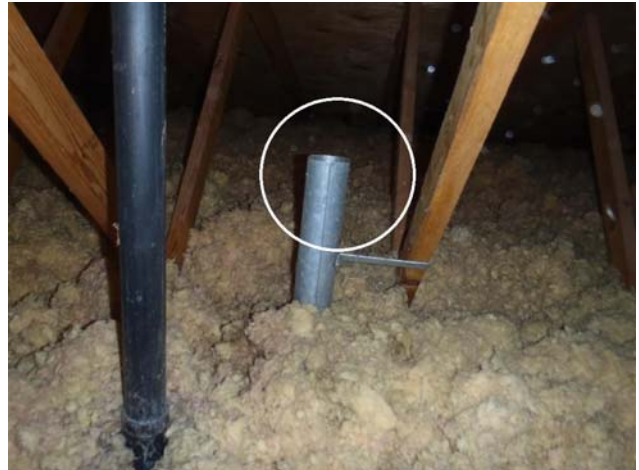
- **Monitor, Repair:** The bathroom exhaust vents discharge close to the underside of the roof. Caution should be taken if venting hot moisture air to the attic in cold weather as it could cause condensation on the roof. Improvement is recommended.

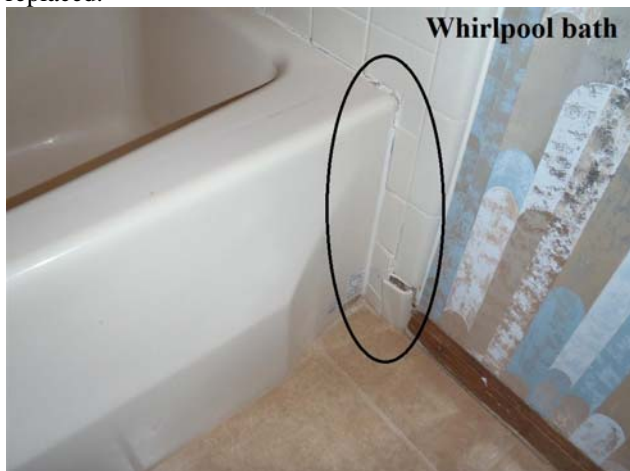
- **Repair:** The cold water faucet handle in the basement bathroom sink is stiff.
- **Monitor, Repair:** The shower diverter in the basement bathroom does not divert 100% of the water to the shower head. Repair is discretionary.
- **Repair:** The kitchen sprayer nozzle is inoperative and needs repair.
- **Repair:** The half bath sink drain plug is inoperative and needs repair.
- **Repair:** The shower head is missing in the master bedroom bath.
- **Repair:** Cracked, deteriorated and/or missing bathtub enclosure grout and caulk around the whirlpool bathtub should be replaced.

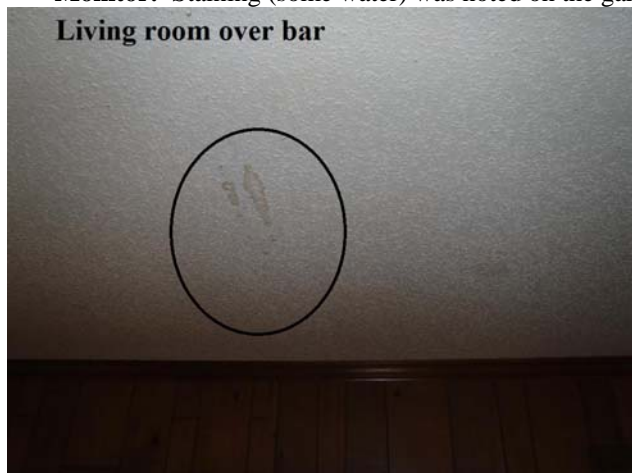
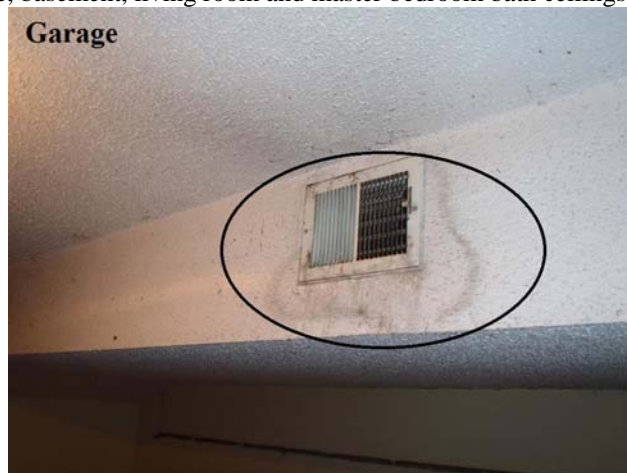
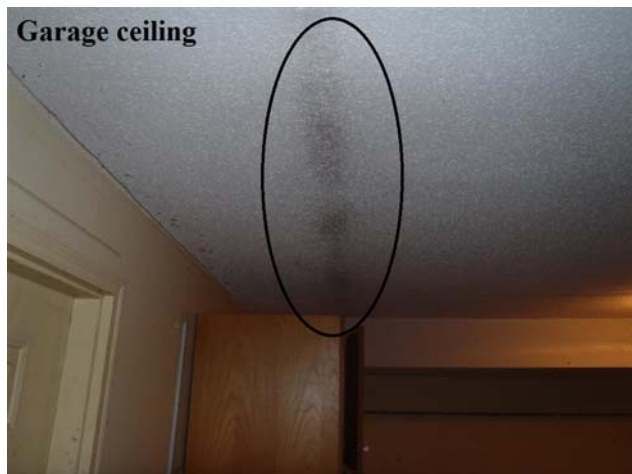
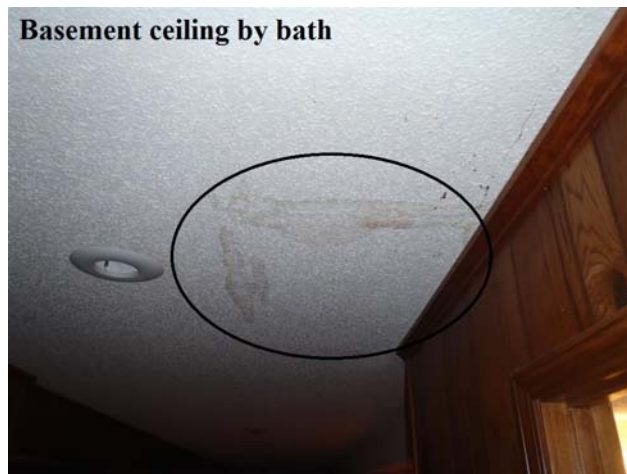
- **Monitor:** Staining (some water) was noted on the garage, basement, living room and master bedroom bath ceilings.

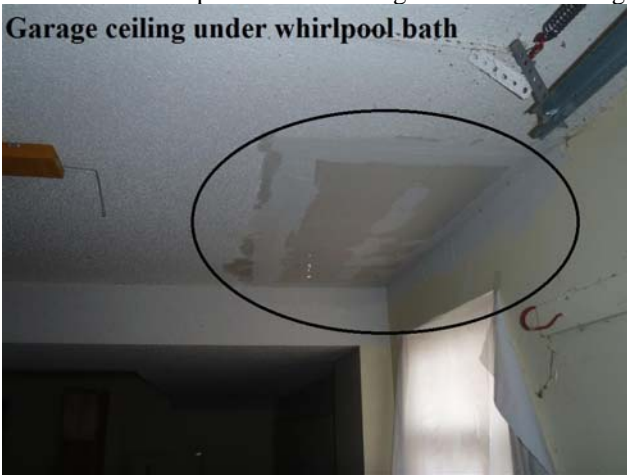
Garage ceiling under whirlpool bath

- **Monitor:** Repaired water damage was noted on the garage ceiling below the whirlpool bath.

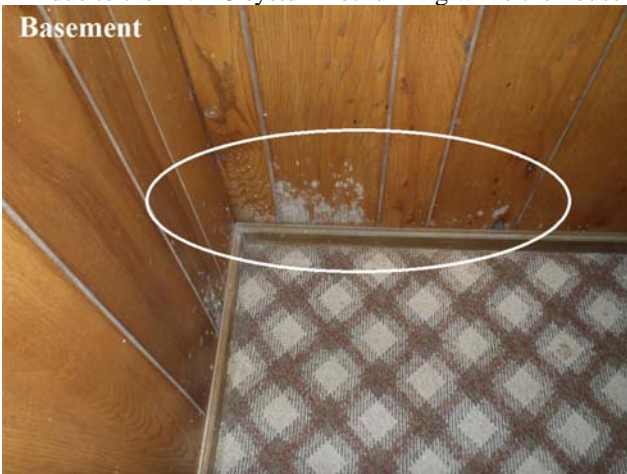
Basement

- **Monitor:** Typical drywall and/or plaster flaws were observed that could include loose tape, minor cracks, rough seams, peeling paper, nail popping, minor patching, loose or bulging plaster, etc. Any repairs would be discretionary.
- **Monitor, Repair:** Signs of mildew/mold were observed on the basement paneled walls and in the garage. This could be due to the HVAC system not running while the house was not occupied.

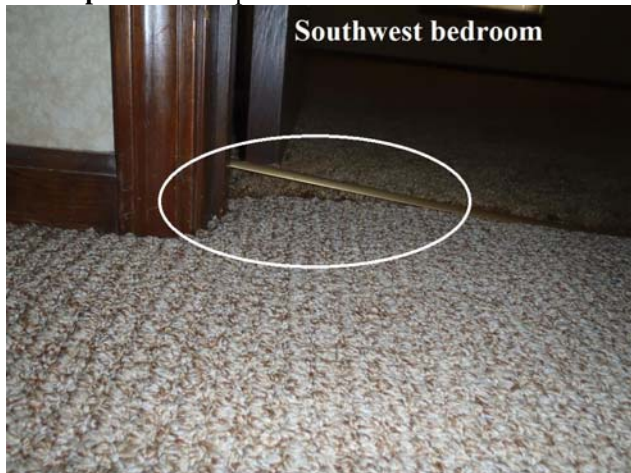
- **Monitor, Repair:** The basement kitchen tile floor is loose and crackles when walking on it. Repair is discretionary.
- **Monitor:** The carpet shows typical wear and/or soiled spots and stains.
- **Repair:** The carpet trim is loose under the southwest bedroom door.
