# Star Home Inspection Services

## *Home Inspection Report*

**10528 W 129th St, Overland Park, KS 66213**

**Inspection Date: 04/12/2010**

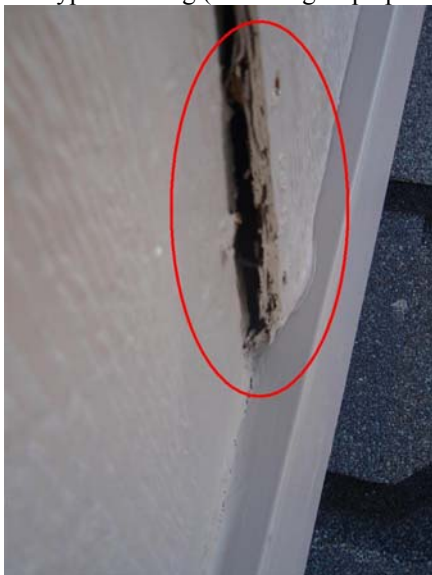
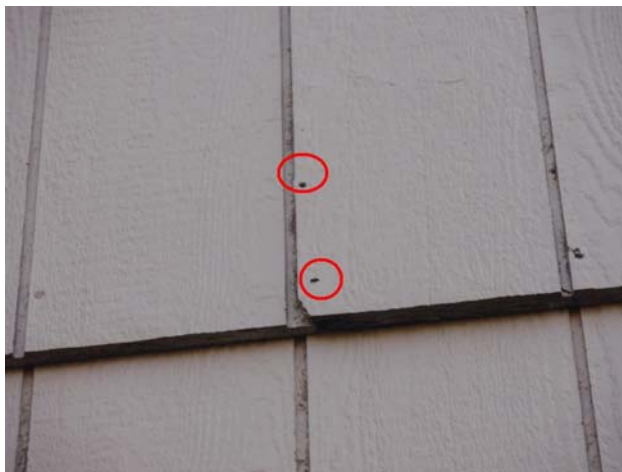
- **Repair:** Siding of this type requires monitoring and maintenance. It has a tendency to pop out past nail heads creating a space where two panels join together. Re-securing and caulking the seams and nail holes is standard maintenance for this type of siding (i.e. siding step up over garage and nail holes at back southwest siding second story.)

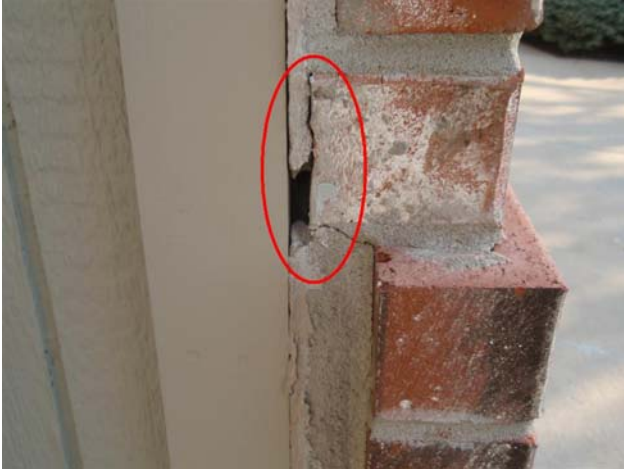
- **Repair:** Localized pointing of deteriorated mortar between the bricks of the exterior walls is advisable at the south garage corner to prevent further deterioration.

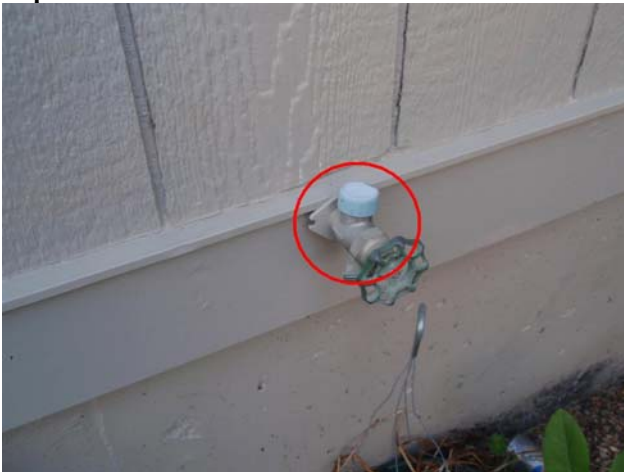
- **Repair:** The loose back hose bib should be secured.

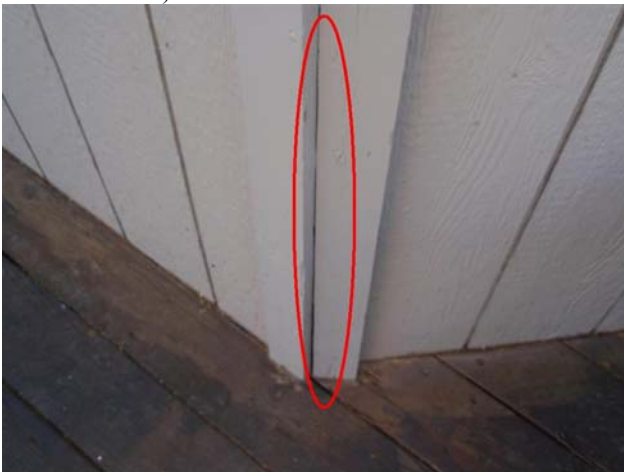
- **Repair:** The siding trim needs caulking improvements in localized areas to prevent water damage and rot (i.e. at siding trim near deck.)

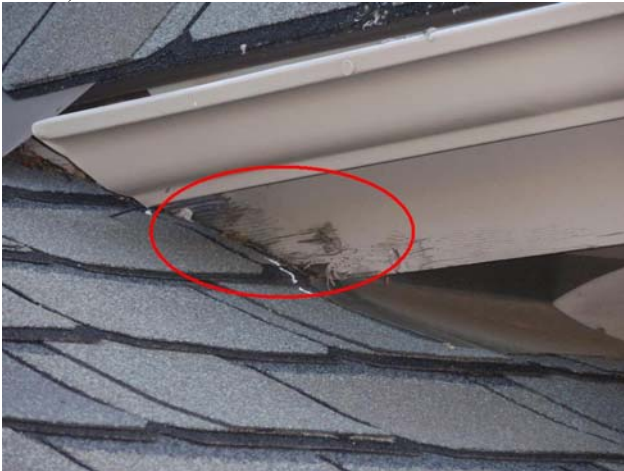
- **Monitor, Repair:** Localized peeling paint or open seams was observed in the fascia (the wooden board to which the gutter is typically fastened) (i.e. gap as fascia at south side, fascia paint peel over garage, and eave paint peel at back of home.)

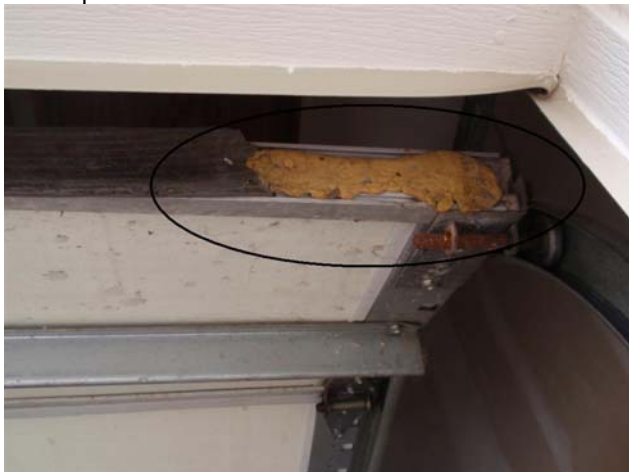
- **Repair, Safety Issue:** No safety springs/cables were noted on the garage door springs. The installation of the springs/cables would improve safety during operation.
- **Repair:** The weather strips on the bottom of the overhead garage doors are damaged or cut short and do not seal tightly. Repair is recommended.

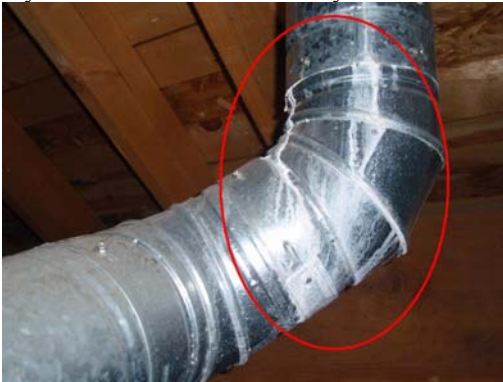
- **Monitor:** While in the attic water stains were observed on the lower sections of the furnace flue. The insulation below the elbow also showed signs of past moisture. It appears that rain blew in under the rain cap and came down the interior of the flue until it got to the first joint where it then transferred to the outside surface and dripped off the elbow. This is a common condition in 80% of homes but very seldom is enough to penetrate completely through the insulation to the drywall below. Monitor for any additional wetness after rains.
