**Star
Home
Inspection Services**

Home Inspection Report

10601 W 89th Terr Overland Park, KS 66214

Inspection Date: 04/07/2011

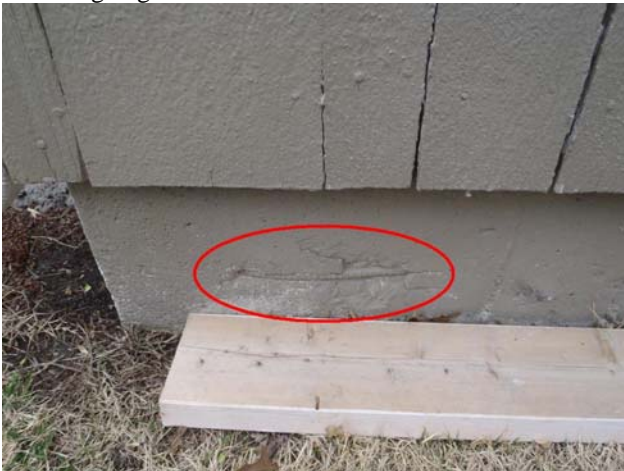
- **Monitor:** Common minor settlement cracks were observed in the foundation walls. This implies that some structural movement of the building has occurred. Cracks of this type should be watched for any sign of additional movement. In the absence of any sign of ongoing movement, repair should not be necessary. Surface deterioration was noted on the exterior garage side of the home.

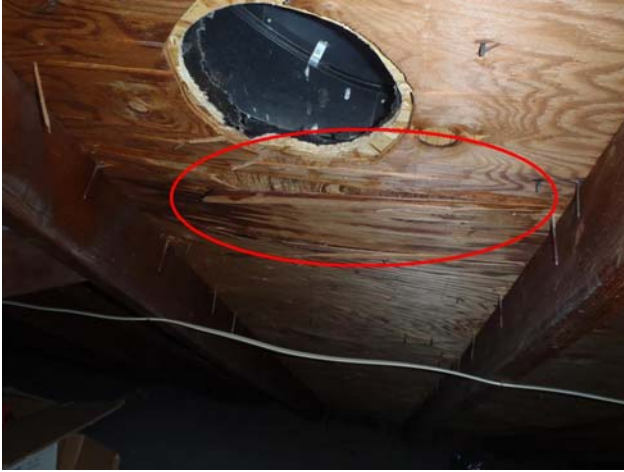
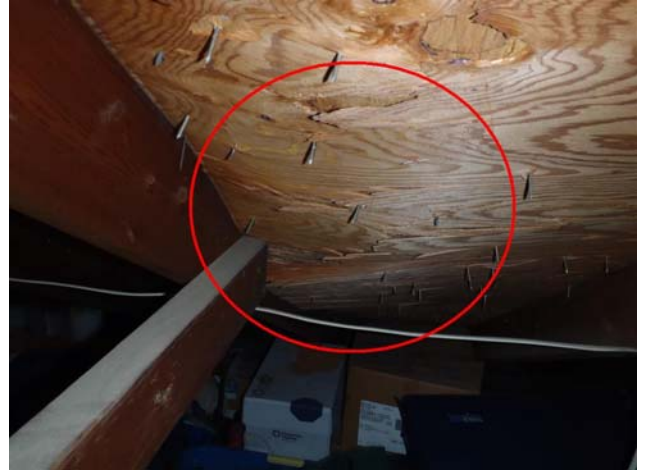
- **Monitor, Repair:** The roof sheathing is delaminating (deterioration caused by moisture). In most cases, damaged roof sheathing must be replaced prior to re-roofing. Improved roof and attic ventilation (see Insulation and Ventilation) reduce moisture levels and cut future damage to the roof structure. Damaged sheathing should be replaced when re-roofing.

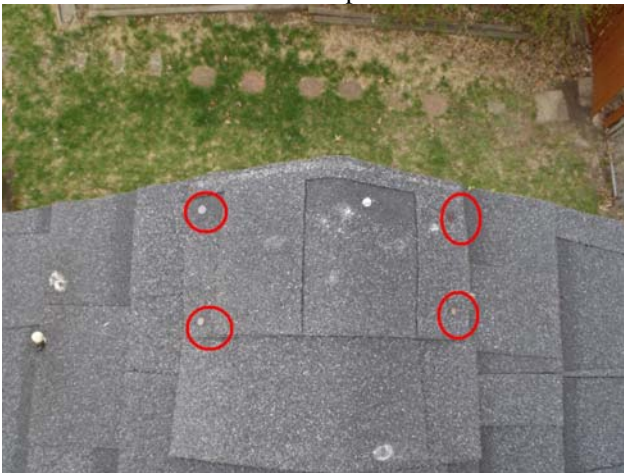
- **Recommend:** Exposed nail heads were observed in the roofing shingles and/or ridge caps. All exposed nail heads should be caulked to reduce the potential of leaks.

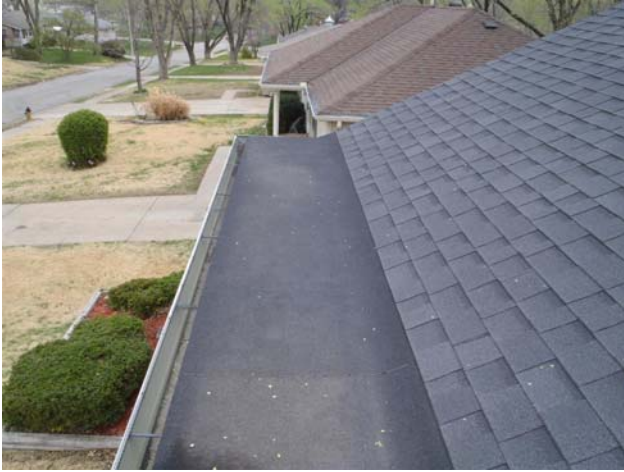
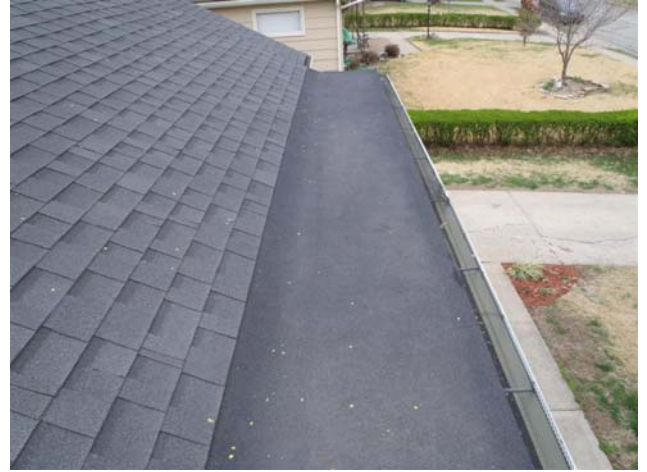
- **Note:** Rolled roofing over the front porch is prone to leaking and requires close monitoring and higher than normal maintenance.

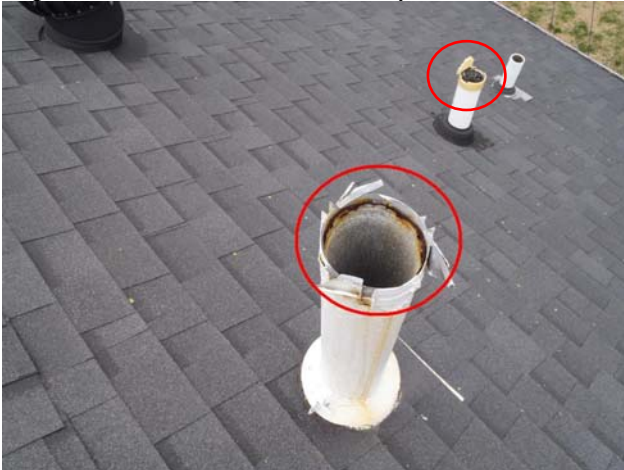
- **Repair:** The furnace exhaust flue cap and radon vent elbow is missing and should be replaced.

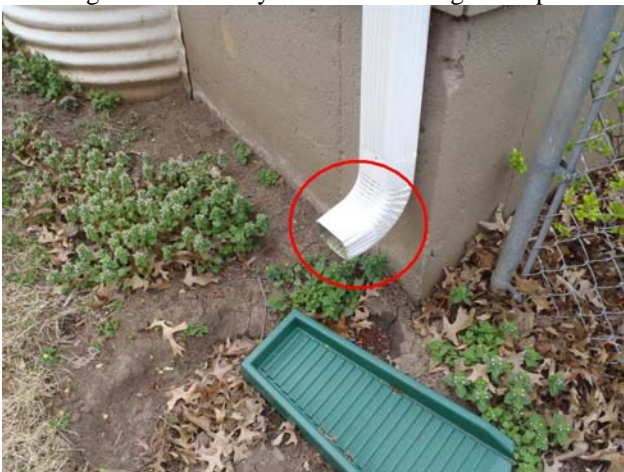
- **Recommend:** The downspout(s) should discharge water at least five (5) feet from the house. Storm water should be encouraged to flow away from the building at the point of discharge.

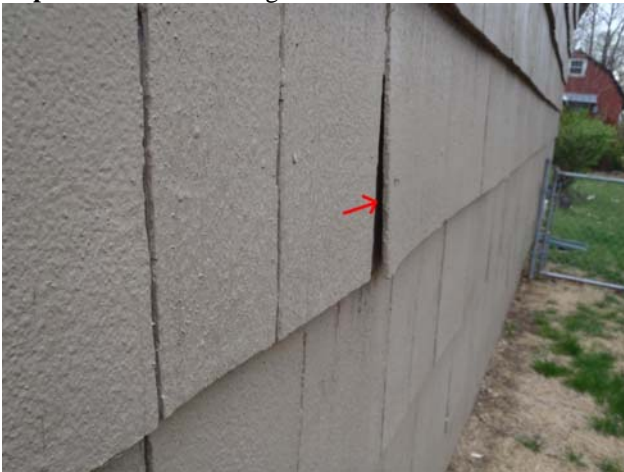
- **Repair:** The loose siding should be re-secured to avoid water and/or wind damage.

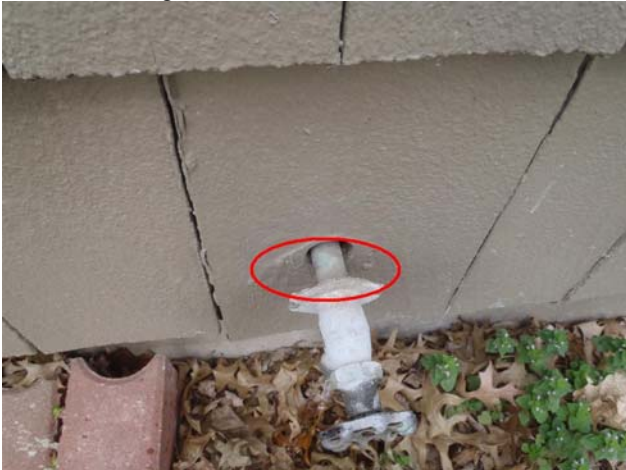
- **Repair:** Any openings in the exterior siding should be sealed. An example is where the back hose bib line enters the house. Caulking is needed.

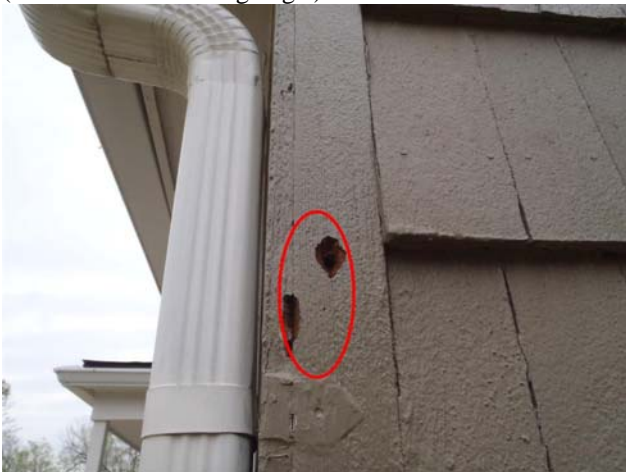
- **Repair:** The siding trim needs caulking and painting improvements in localized areas to prevent water damage and rot (i.e. front corner near garage.)

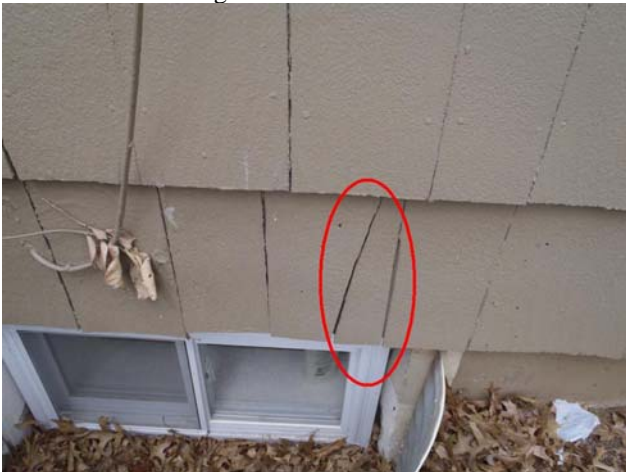
- **Repair:** Localized damage of the exterior siding should be repaired (i.e. cracked siding on back of home.) There is extra risk of hidden damage in such areas.

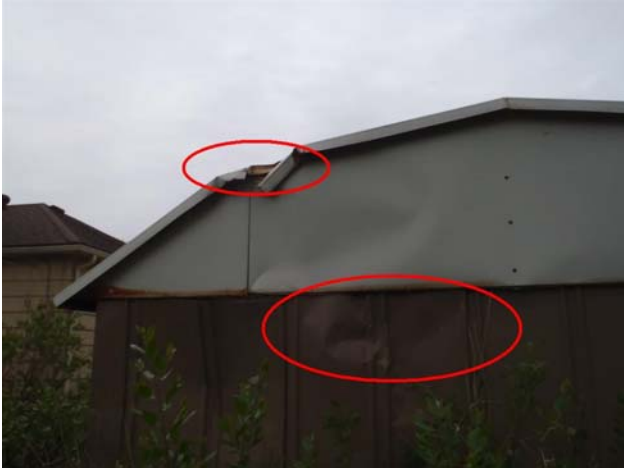
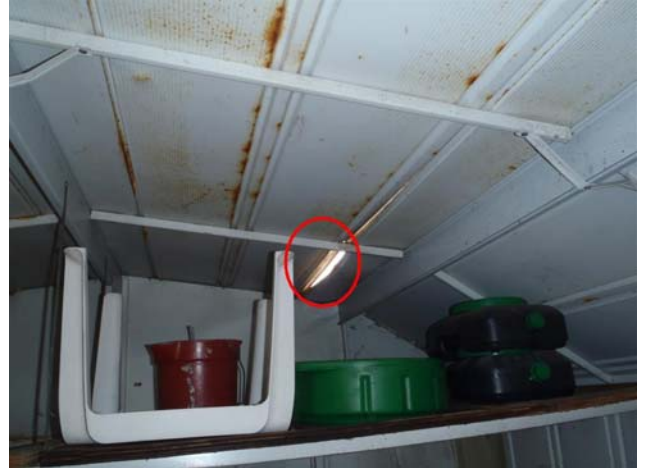
- **Repair:** The metal storage building is a low quality structure. With the exception of keeping the roof watertight and having functional doors, it may not be worth investing in repairs. Replacement would be the better long term approach.

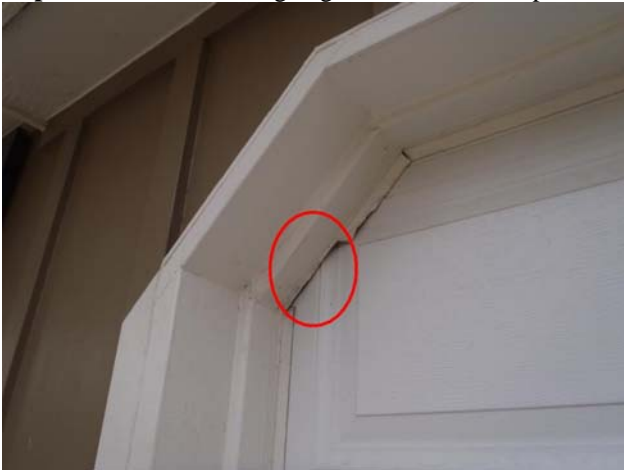
- **Repair:** The paint on the garage door frame/ trim is peeling and requires painting and caulking.
- **Improve:** The overhead garage door weather strip is damaged and needs repair.

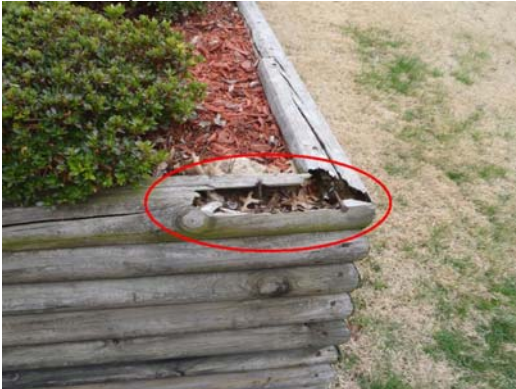
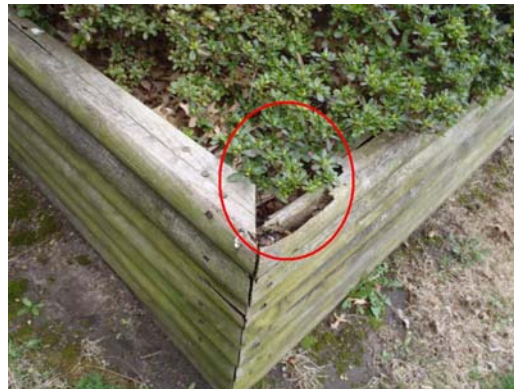
- **Monitor:** The landscaping timbers retaining wall shows evidence of rot. This condition should be monitored. It is impossible to determine the rate of movement and/or deterioration during a one time visit to the house. Repairs are discretionary.

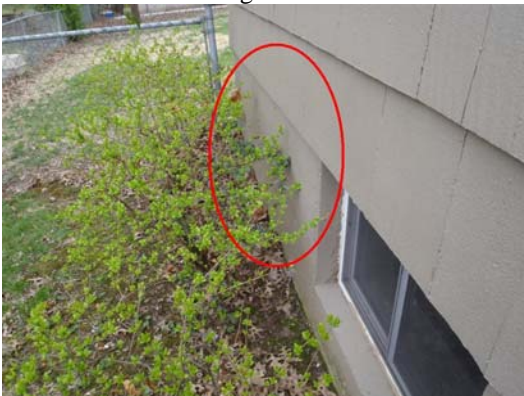
- **Repair:** Shrubs, bushes and/or vines growing on exterior walls need to be trimmed away from the structure to reduce the risk of water damage and insect infestation.

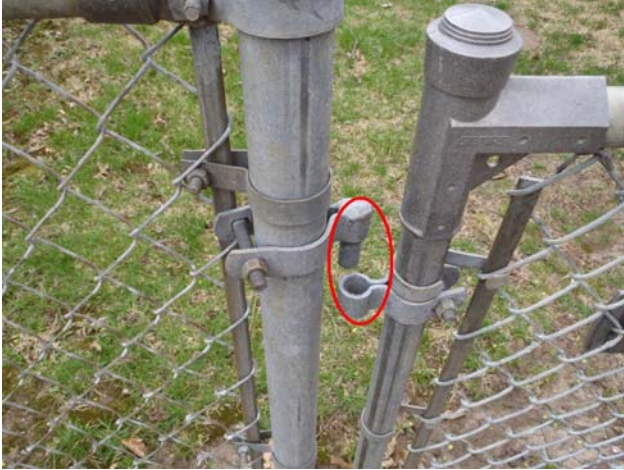
- **Repair:** The gate needs adjustment to function properly.

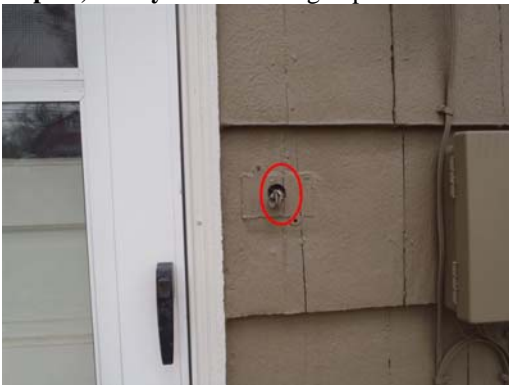
- **Repair, Safety Issue:** Wiring exposed on exterior near back door should be repaired.

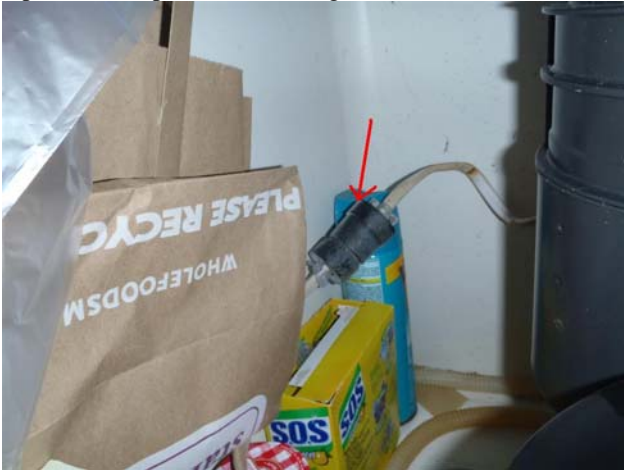
- **Repair:** Extension cords should not be used as permanent wiring. This wiring for the disposer should be removed and replaced with permanent wiring and an outlet(s).

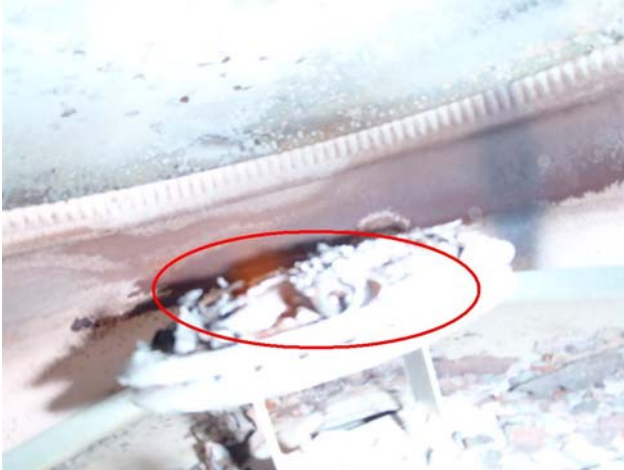
- **Monitor:** Water heaters have a typical life expectancy of 7 to 12 years. The existing unit is approaching or has exceeded this age range. One cannot predict with certainty when replacement will become necessary.
- **Repair:** The water heater burner is dirty. It should be cleaned and adjusted.

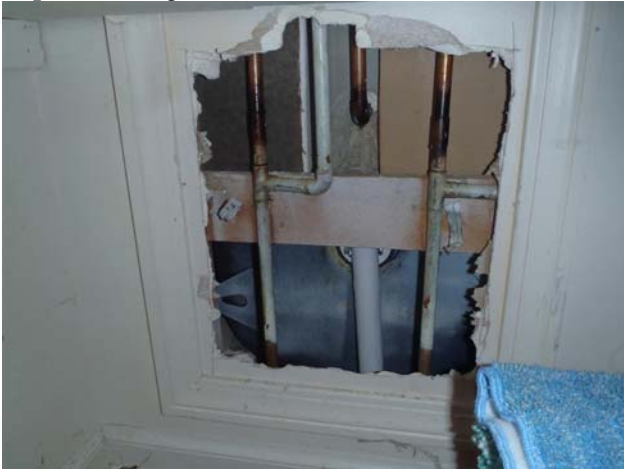
- **Monitor, Repair:** Damaged suspended tile ceiling panels should be replaced.
- **Repair:** Damage to the wall in the main floor hall closet (access to bathtub plumbing) was observed.

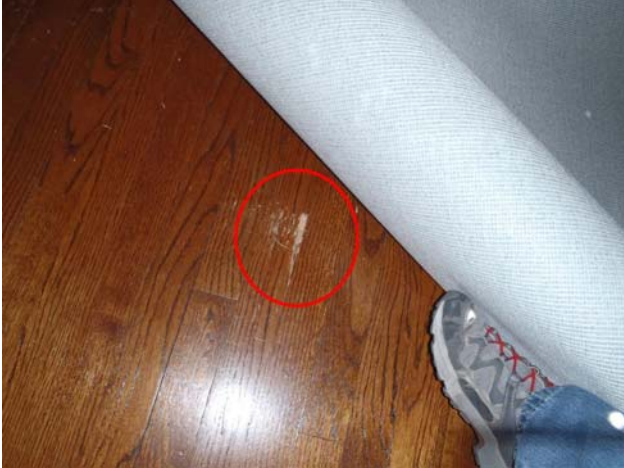
- **Monitor:** The carpet shows typical wear and/or soiled spots and stains.
- **Monitor:** The hardwood floor is scuffed and/or worn (i.e. minor area below carpet in front northeast bedroom.)
