**Star  
Home  
Inspection Services**

*Home Inspection Report*

**10603 W 115th Terr, Overland Park, KS 66210**

**Inspection Date: 06/11/2009**

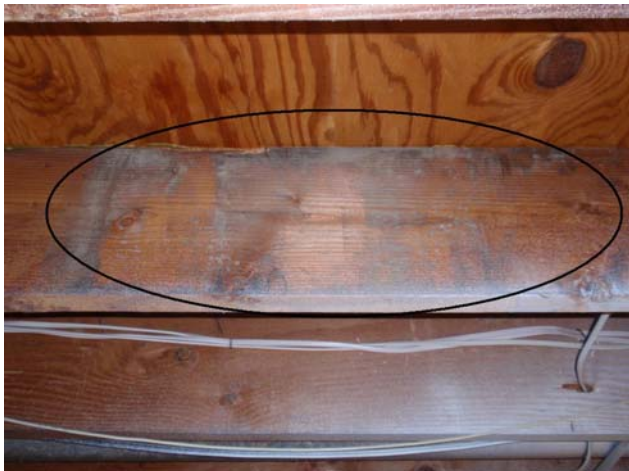
- **Monitor:** Floor joist is are cracked under the dining room. Cracked joists are repaired by replacement, “sister” joists along side, or additional support. Where one or very few damaged joists are found, this work is not high priority and can be combined with other structural or carpentry repairs at the property. No repair is needed at this time.
- **Monitor:** Construction mold was visible on some floor joists. This is mold that grows on the lumber while lying in the weather during construction as evidenced by the strap marks. Most homes have some level of this mold and it goes dormant once removed from the elements and normally does not present any problems.

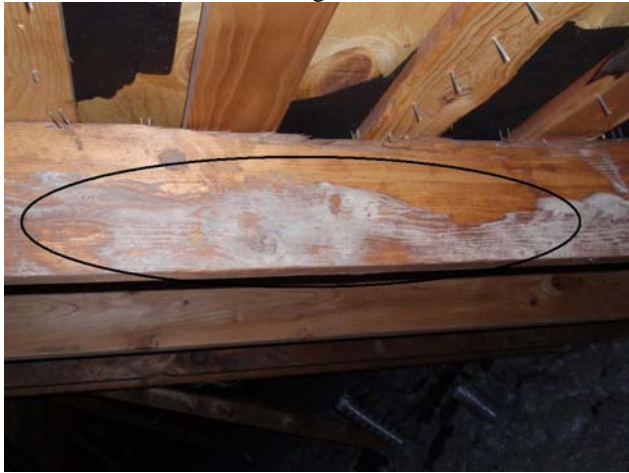
- **Monitor:** Construction mold (could also just be mud or dirt) was visible on some roof rafters. This is mold that grows on the lumber while lying in the weather during construction as evidenced by the strap marks. Most homes have some level of this mold and it goes dormant once removed from the elements and normally does not present any problems.

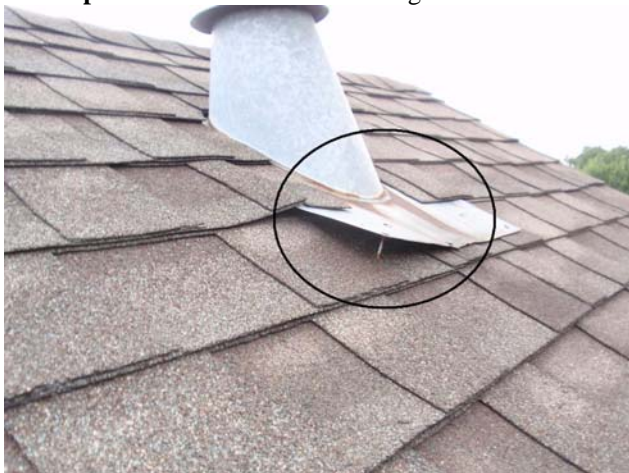
- **Repair:** The furnace flue flashing is loose and should be re-secured to avoid leaks.

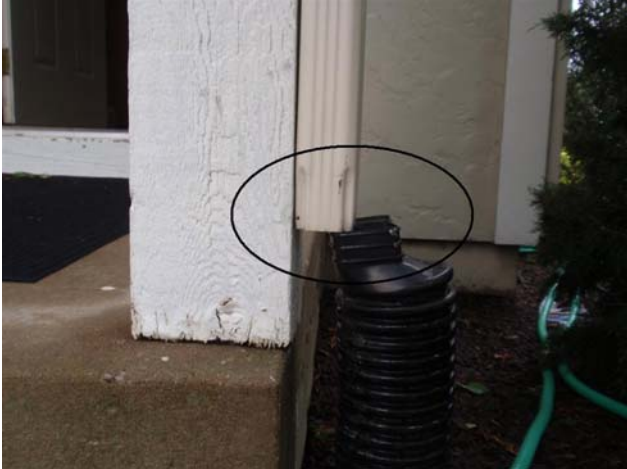
- **Monitor:** The gutter over the front porch does not appear to have sufficient slope to drain properly. If it does not perform as intended, the slope should be adjusted to avoid spilling roof runoff around the building – a potential source of water entry or water damage.
- **Repair:** The downspout on the front porch is not inside the underground piping. This should be repaired so the water flows away from the foundation.

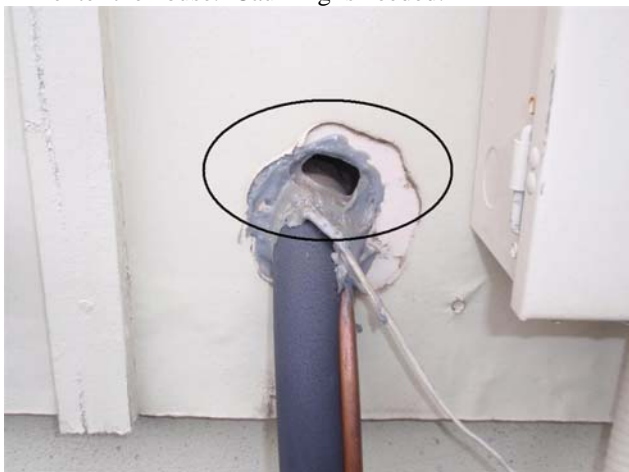
- **Repair:** Any openings in the exterior siding should be sealed. An example is where the air conditioner refrigerant lines enter the house. Caulking is needed.

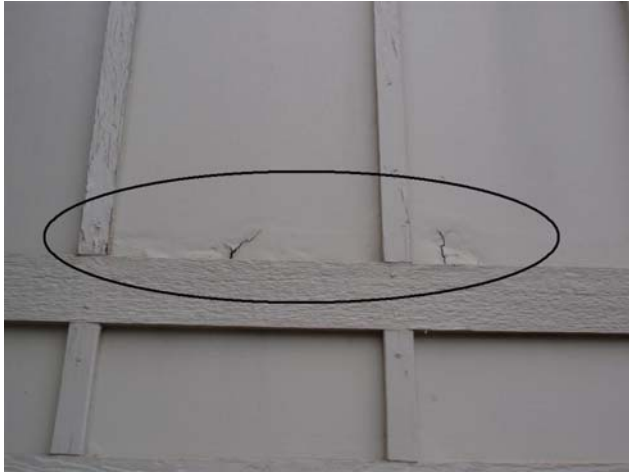
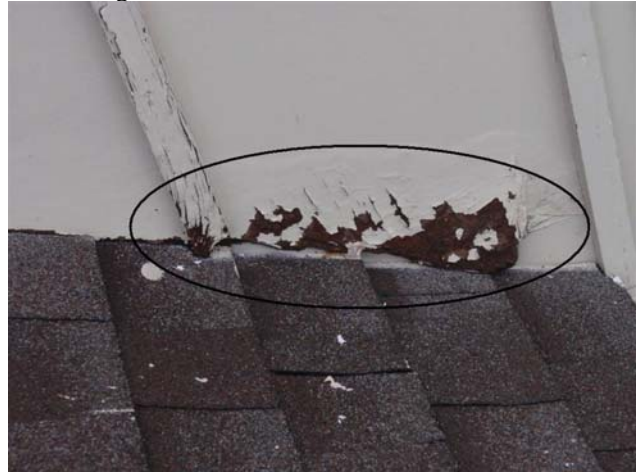
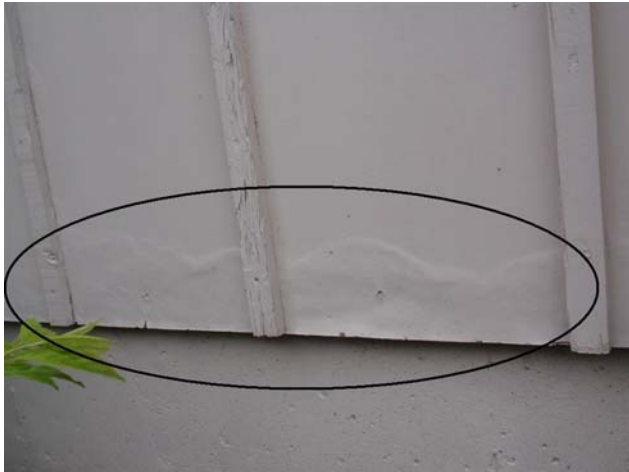
- **Repair:** Localized rot and/or water damage was observed in the bottom edges of the siding panels. Following repair of the damaged areas (which should be combined with exterior painting/maintenance) proper maintenance of the siding and control of water from roof or surface runoff can avoid further damage.

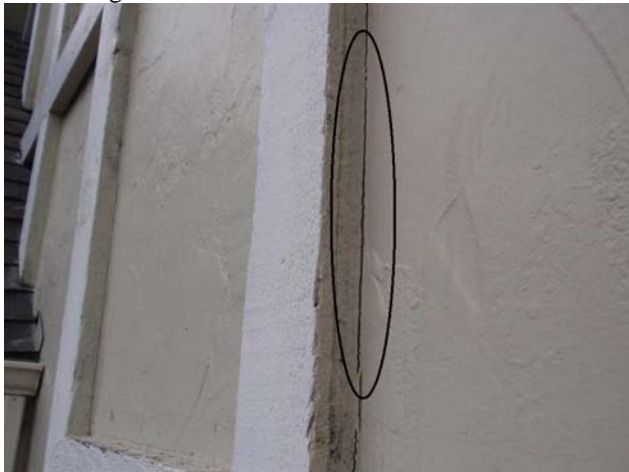
- **Repair:** The staccato board needs caulking improvements in localized areas around the wood trim to prevent water damage and rot.

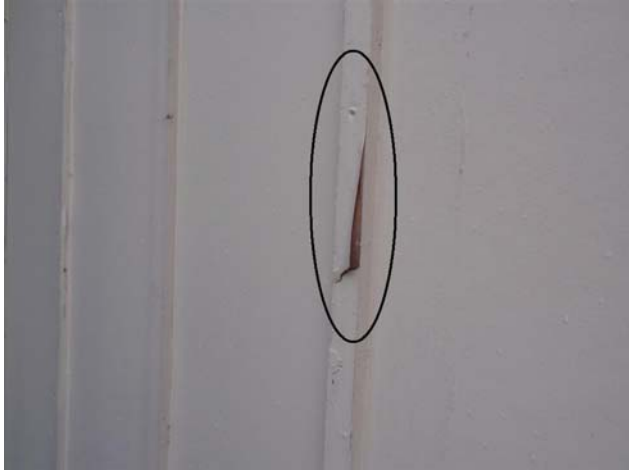
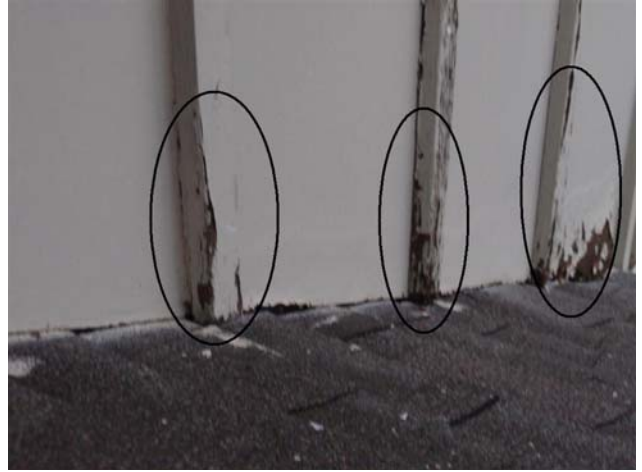
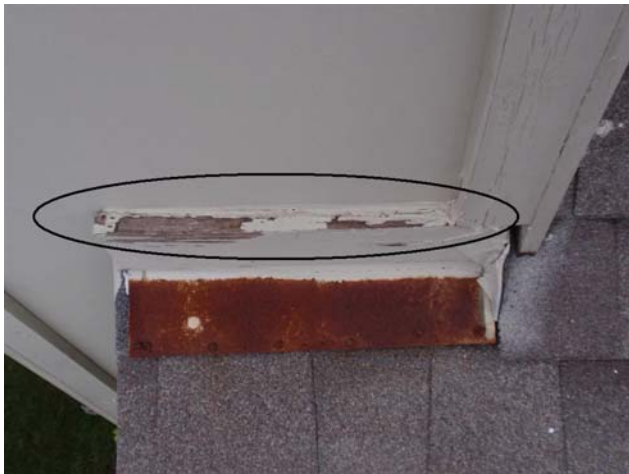
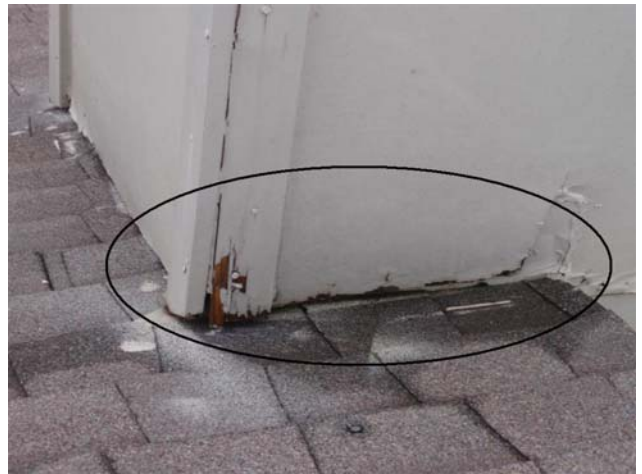
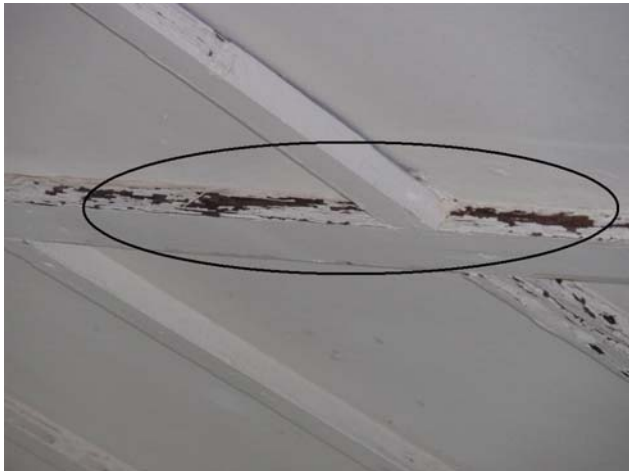
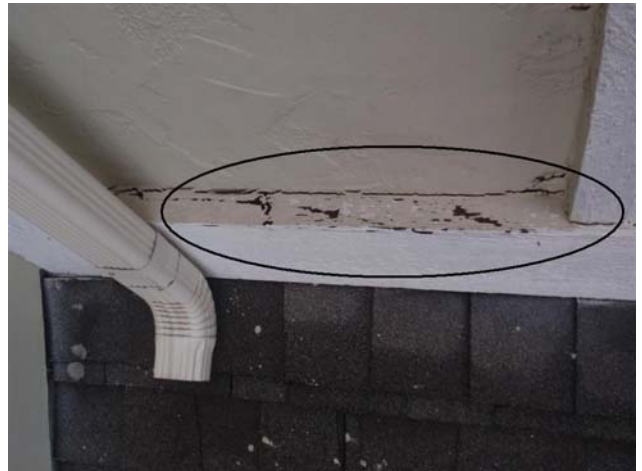
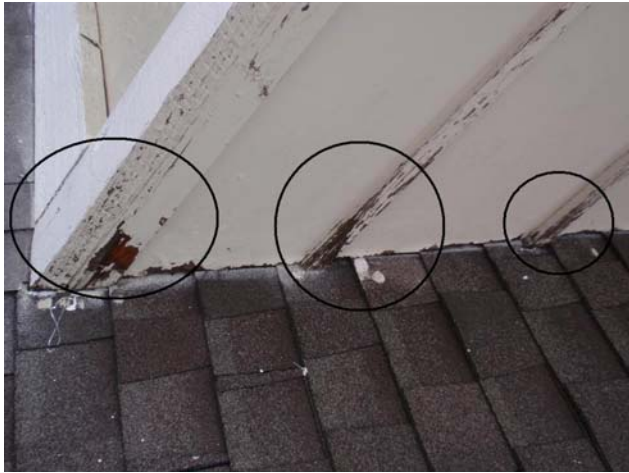
- **Repair:** The paint on the trim around the siding is peeling. These areas should be painted to prevent water damage and rot.

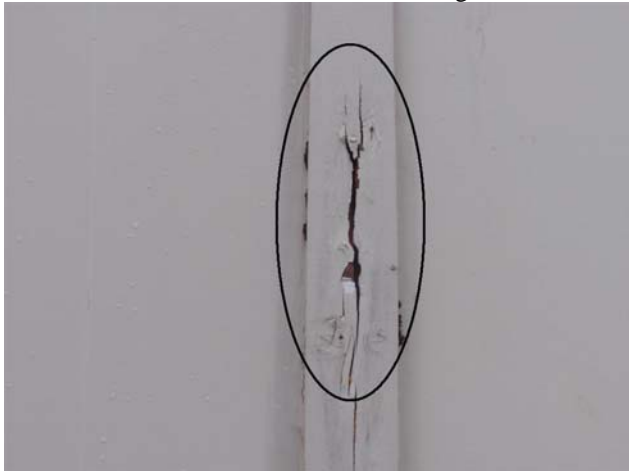
- **Repair:** Localized rot was observed in the trim around the siding. Following repair of the damaged areas (which should be combined with exterior painting/maintenance) proper maintenance of the siding and control of water from roof or surface runoff can avoid further damage.

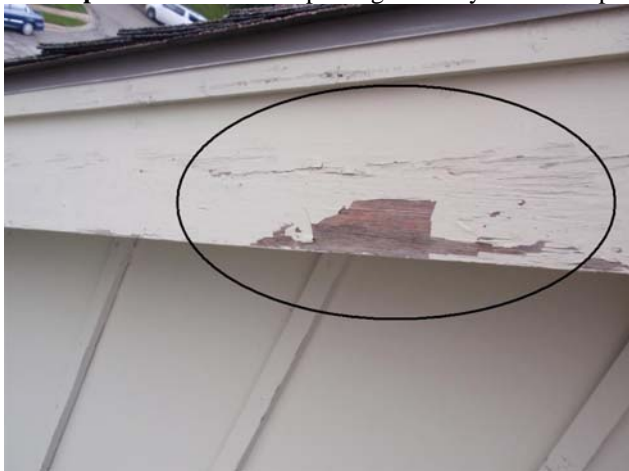
- **Repair:** The eaves are peeling and they should be painted to prevent water damage and rot.

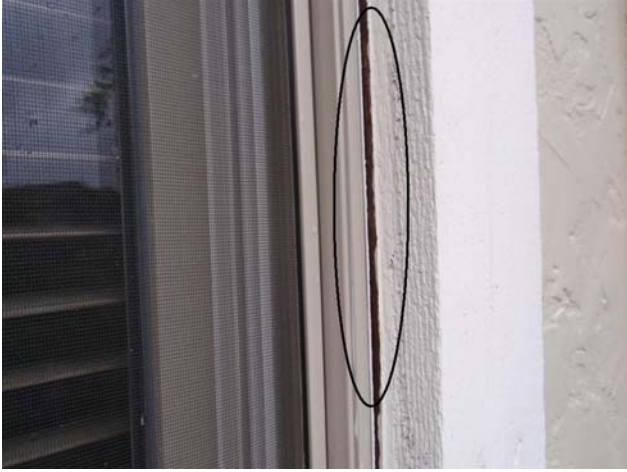
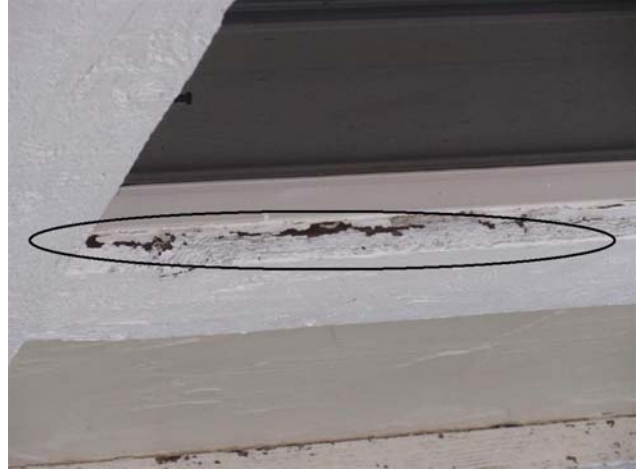
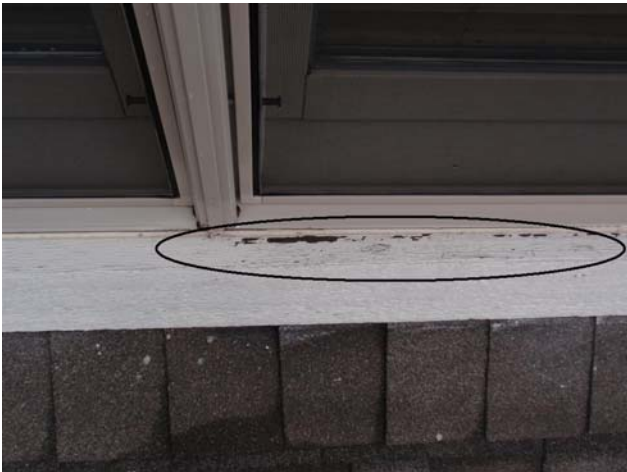
- **Repair:** The front window frames require painting and caulking.

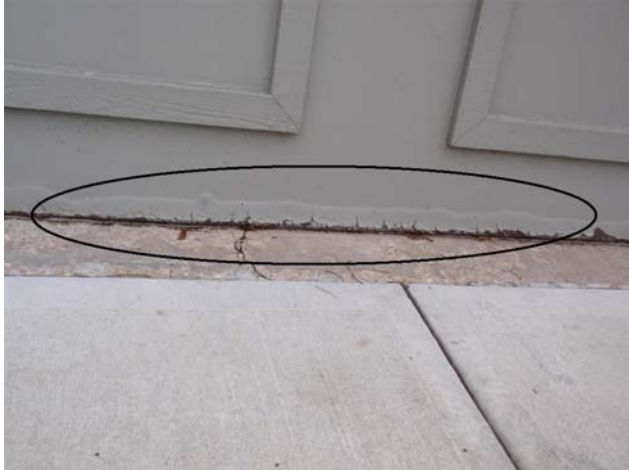
- **Repair:** The overhead garage door lower panel shows evidence of localized rot and/or water damage and needs repairs.  
**Replaced**

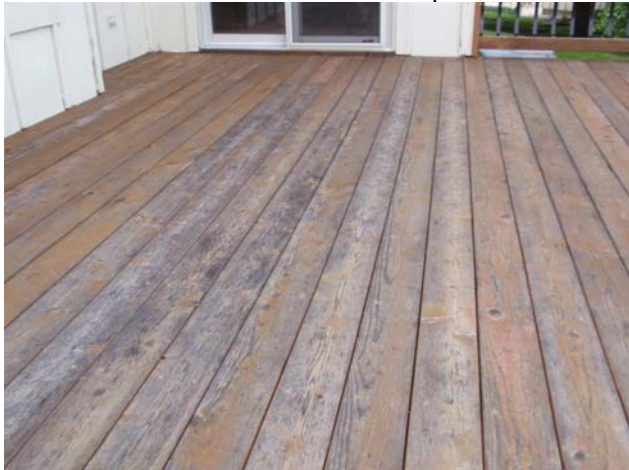
- **Recommend:** The deck should be painted or stained to improve durability.

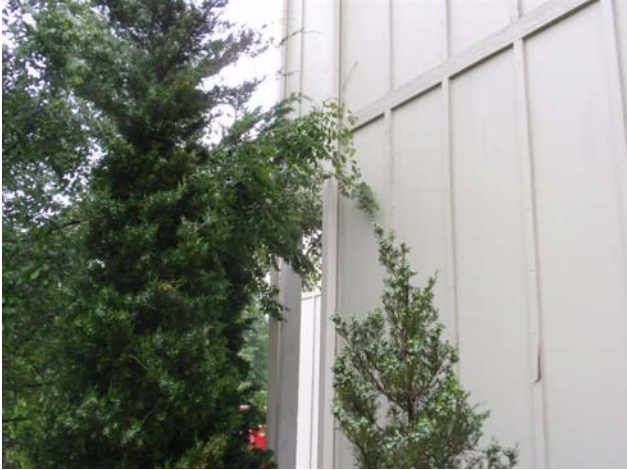
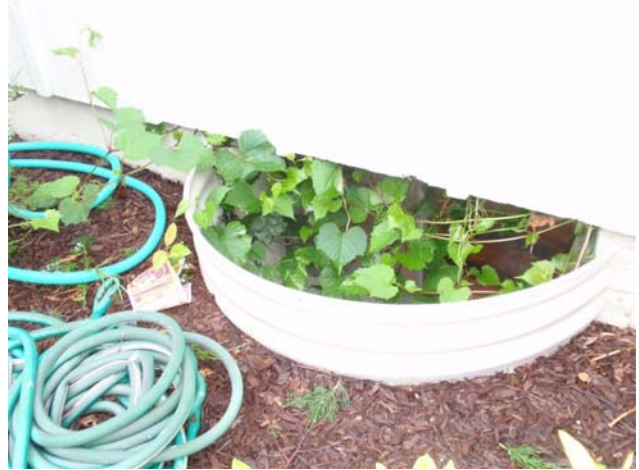
- **Repair:** Shrubs, bushes and/or vines growing on exterior walls need to be trimmed away from the structure to reduce the risk of water damage and insect infestation.

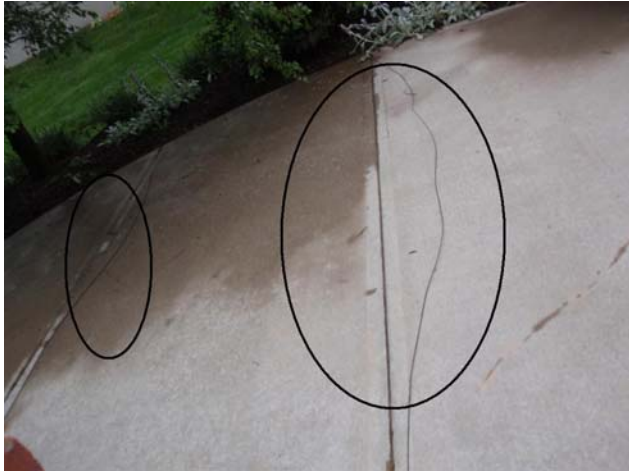
- **Repair:** The wires for the pet fence cross the walkway and create a trip hazard. The wires should be removed or re-routed.

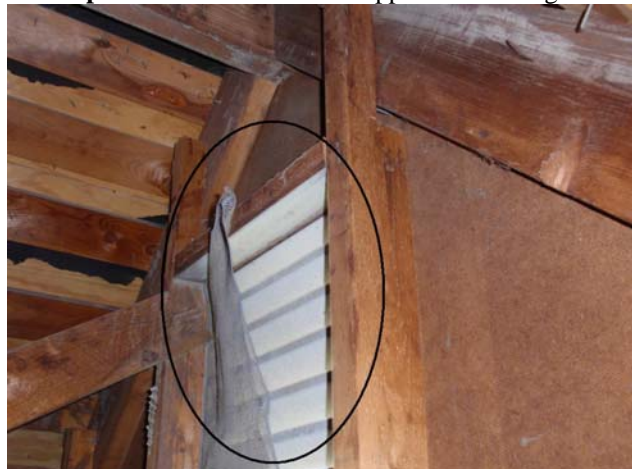
- **Repair:** Gable vent screens appear to be damaged. They should be repaired or replaced to prevent vermin activity.

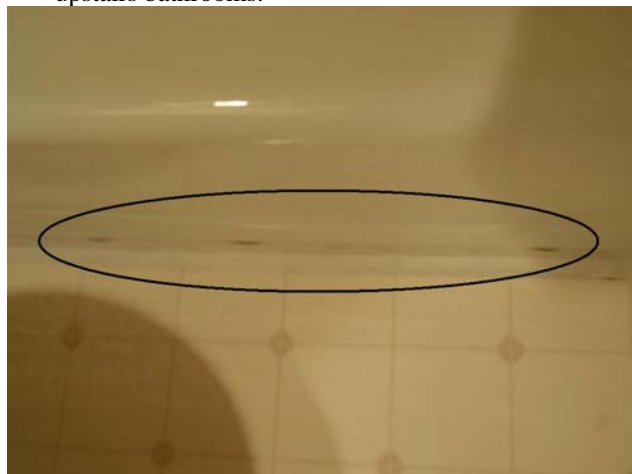
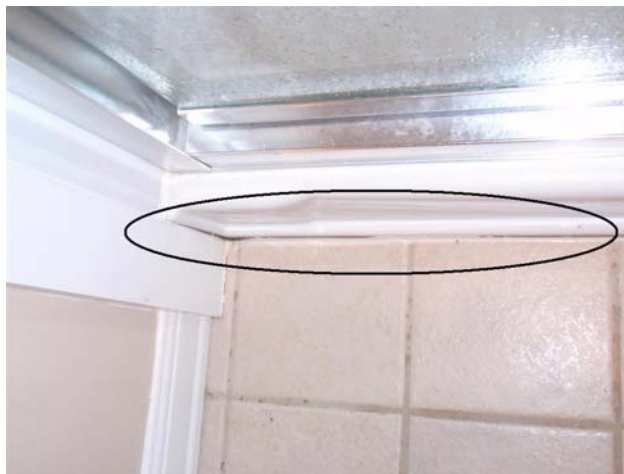
- **Monitor, Repair:** Cracked, deteriorated and/or missing bathtub and shower enclosure caulk could be improved in both upstairs bathrooms.

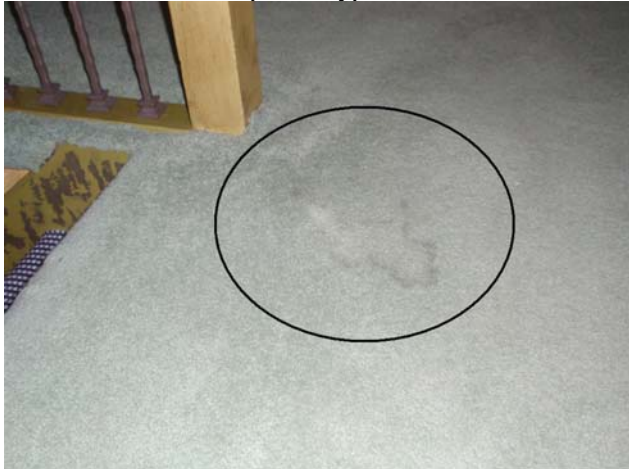
- **Monitor:** The carpet has typical wear and stains.

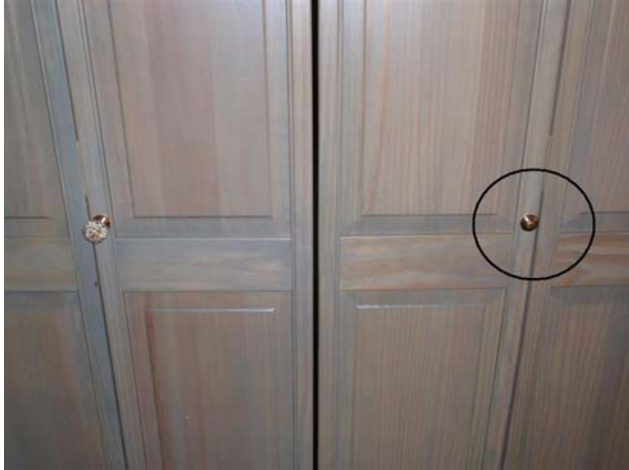
- **Repair:** One door knob is missing on the northeast bedroom closet door.
