**Star
Home
Inspection Services**

Home Inspection Report

10604 W 115th St, Overland Park, KS 66210

Report Number: 06112009-3L

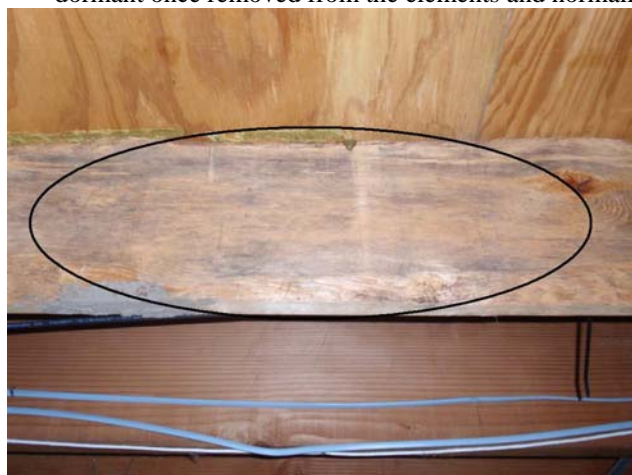
- **Monitor:** Construction mold was visible on some floor joists. This is mold that grows on the lumber while lying in the weather during construction as evidenced by the strap marks. Most homes have some level of this mold and it goes dormant once removed from the elements and normally does not present any problems. **As Is**

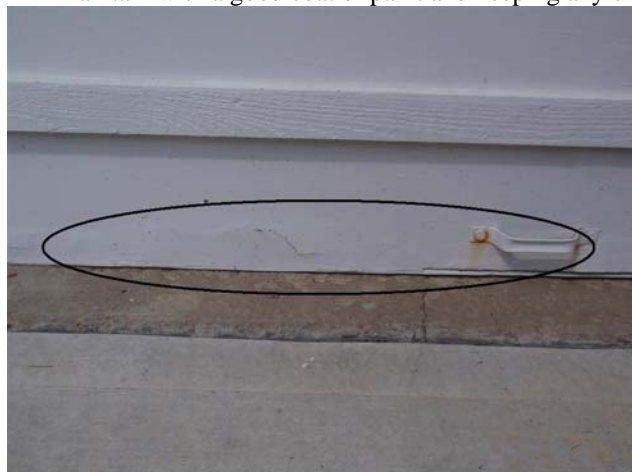
- **Monitor, Repair:** The overhead garage door shows evidence of minor water damage. This should be monitored closely. Maintain with a good coat of paint and keeping any cracks or open areas closed up. **Replaced**

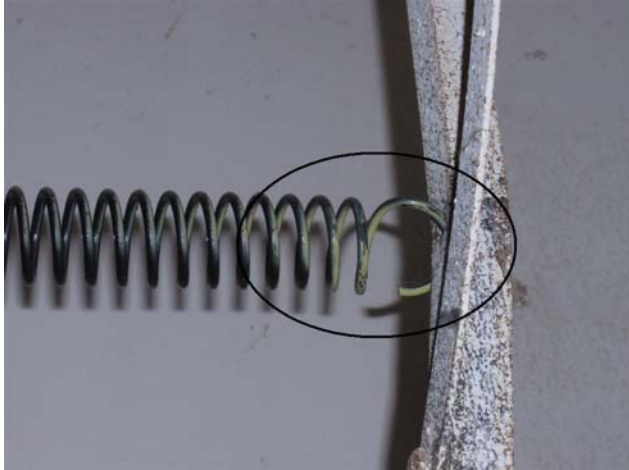
- **Repair, Safety Issue:** No safety springs/cables were noted on the garage door springs. The installation of the springs/cables would improve safety during operation. **Repaired**

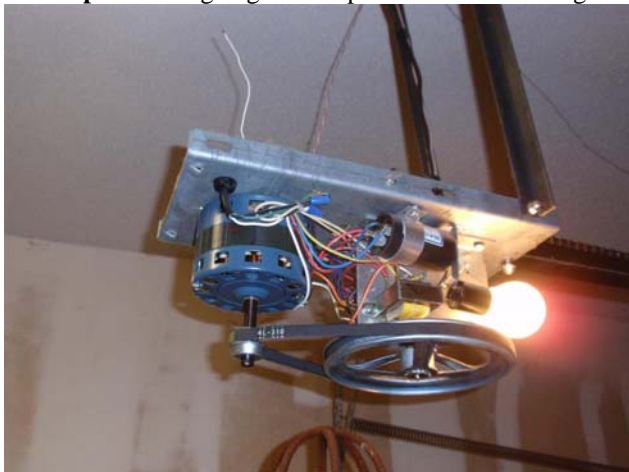
- **Repair:** The garage door opener cover is missing. It should be repaired as necessary. **Repaired**

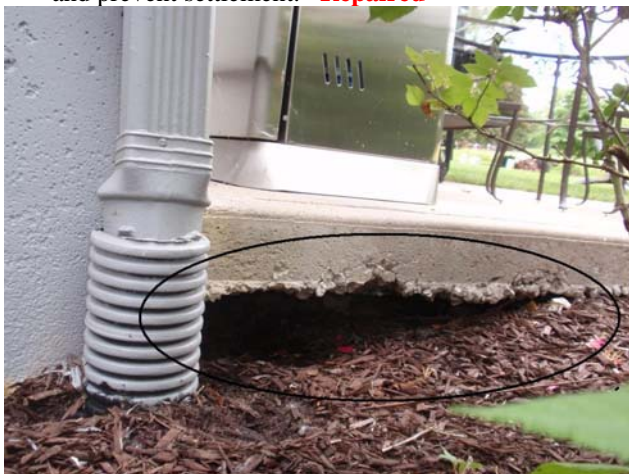
- **Monitor:** The soil under the patio has settled or eroded. It's recommended this cavity be filled to help support the patio and prevent settlement. **Repaired**

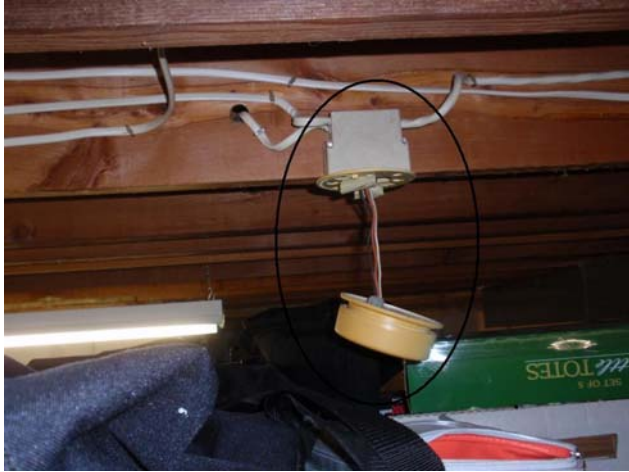
- **Repair:** Missing smoke detector was observed in the upstairs hallway **Repaired**
- **Repair:** The basement smoke detector is hanging by its wires and should be secured. **Repaired**

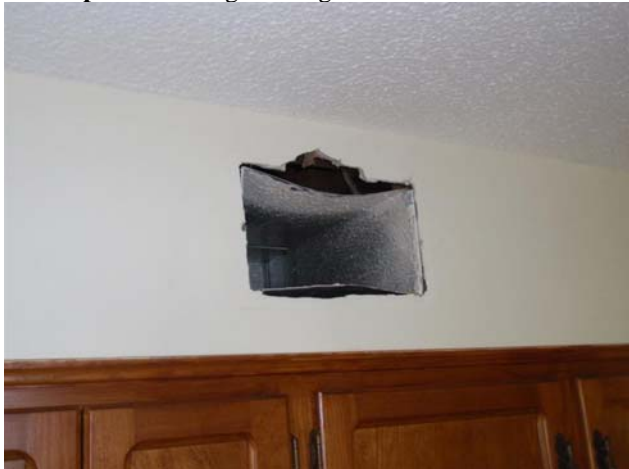
- **Repair:** Missing vent register in the kitchen should be replaced. **Repaired**

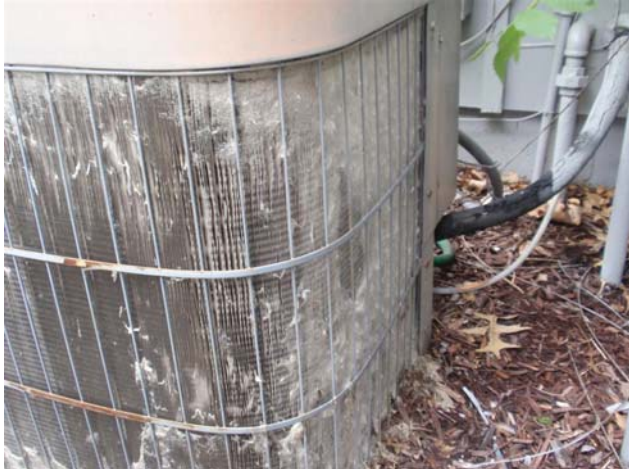
- **Improve:** The outdoor unit of the air conditioning system requires cleaning. **Repaired**

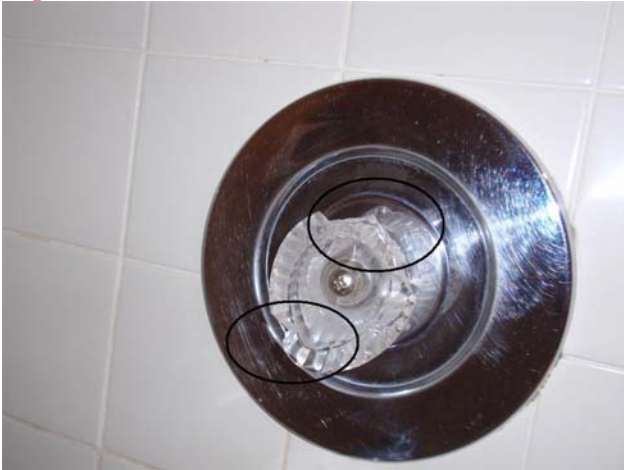
- **Repair:** The hallway bathroom shower faucet plastic handle is broken but still functional. Repair is discretionary.

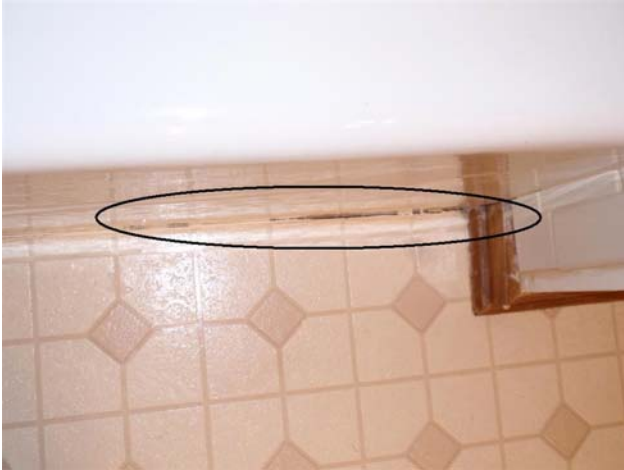
- **Improve:** Cracked, deteriorated and/or missing bathtub enclosure caulk in the hallway bathroom should be replaced. **Repaired**

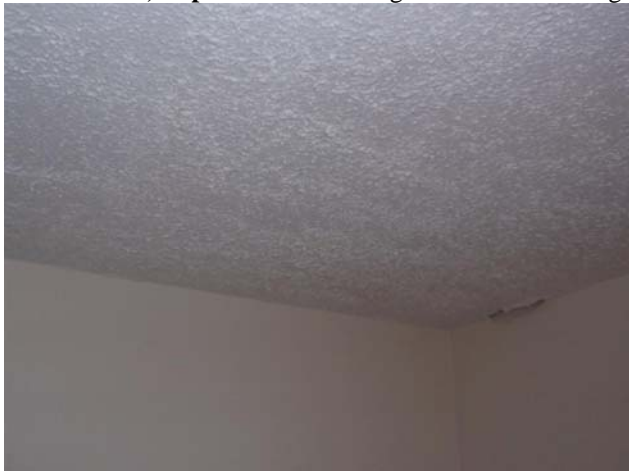
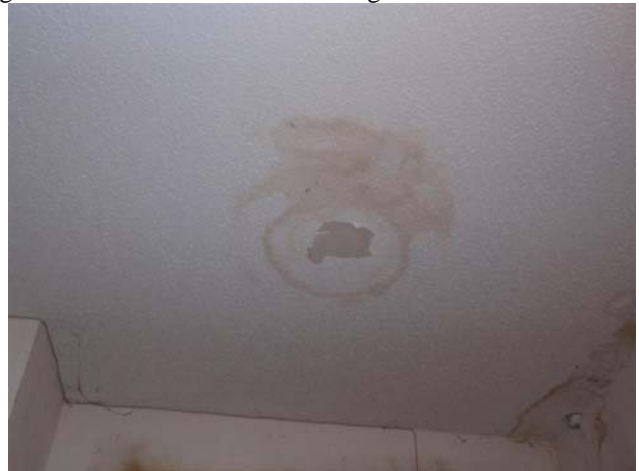
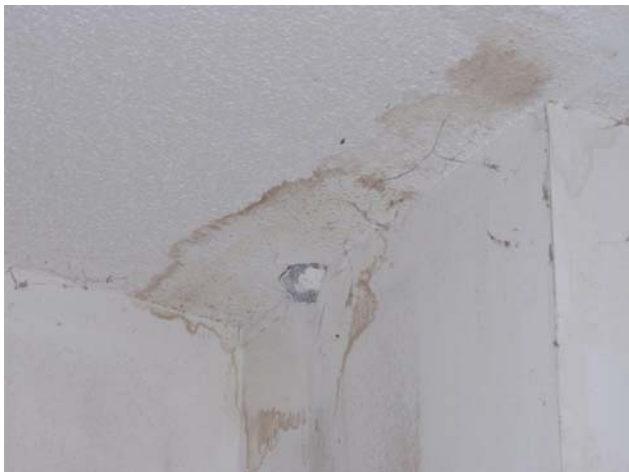
- **Monitor, Repair:** Water damage was noted on the garage and master bedroom bath ceilings. **As Is**

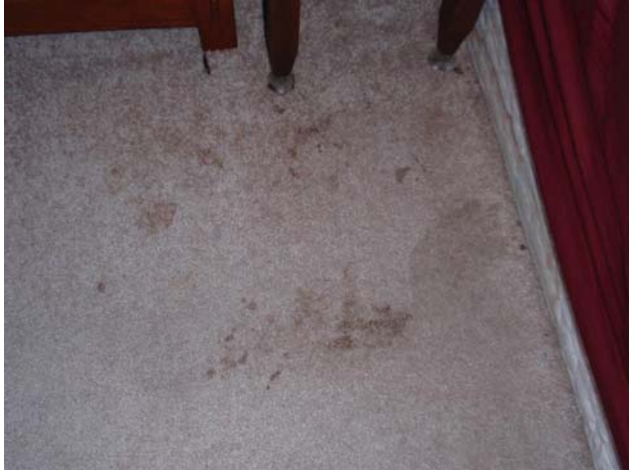
- **Monitor:** The carpet has typical wear and stains. **As Is but will try cleaning**

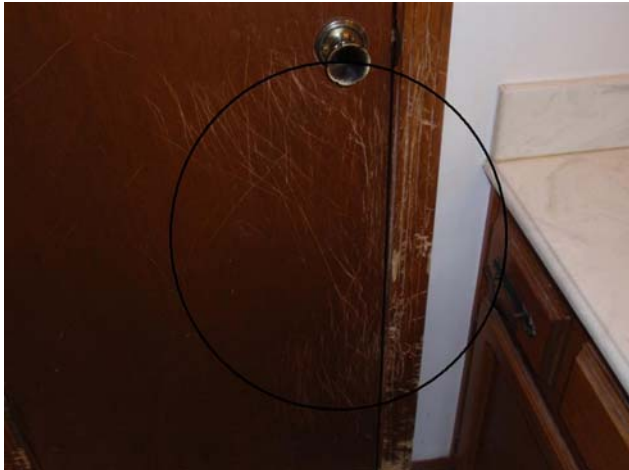
- **Monitor:** The master bedroom bathroom door and trim has pet damage. Repair is discretionary. **Repaired**

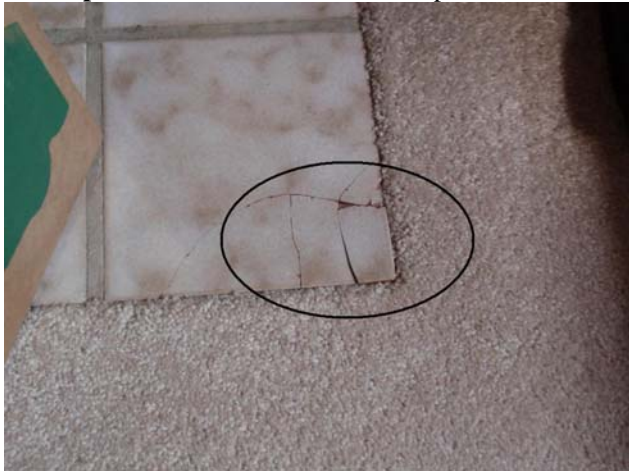
- **Repair:** The hearth outside the fireplace is cracked. Repair is discretionary. **As Is**
