Home Inspection Report

10853 S Cedar Niles Cr, Olathe, KS 66061

Inspection Date: 12/03/2009

Report Number: 12032009-2A

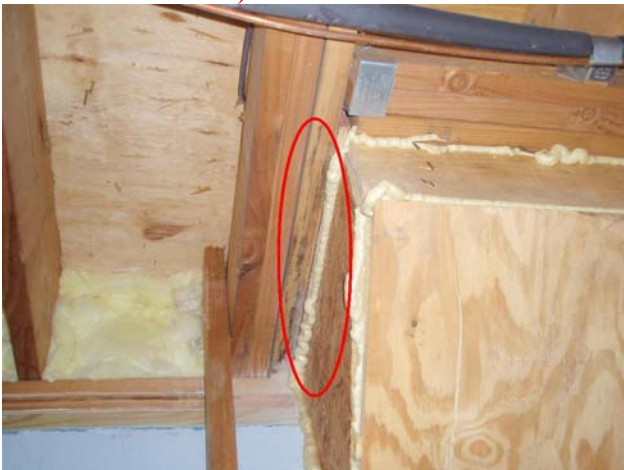
- **Monitor:** Construction mold was visible on floor joist(s) at the unfinished northeast corner of basement. This is mold that grows on the lumber while lying in the weather during construction. Most homes have some level of this mold and it goes dormant once removed from the elements and normally does not present any problems. **REPAIRED (Wire brushed and cleaned)**

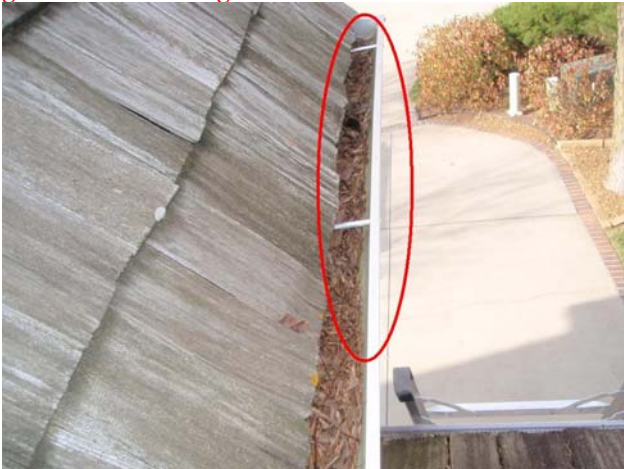
- **Repair:** The gutters require cleaning to avoid spilling roof runoff around the building – a potential source of water entry or water damage. **REPAIRED - Short interior gutter run cleaned by owner on 3/8. Also installed snap-in gutter screens along this run**

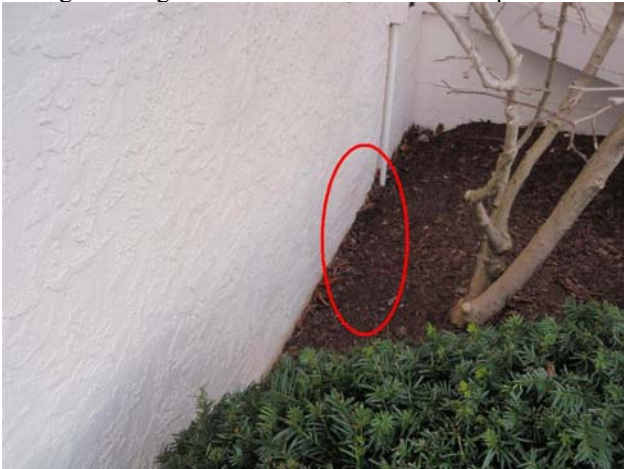
- **Repair:** Wood/soil contact at the base of the siding at west side of garage exterior should be eliminated. Rotted or damaged siding that is uncovered should be repaired.. **REPAIRED (No damage to wall base)**

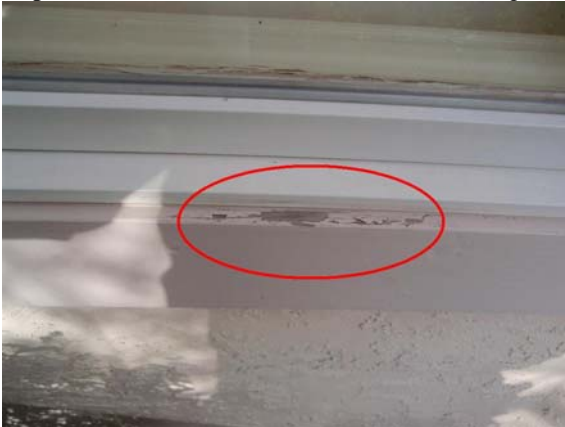
- **Repair:** The back southwest window frame requires painting. **REPAIRED**

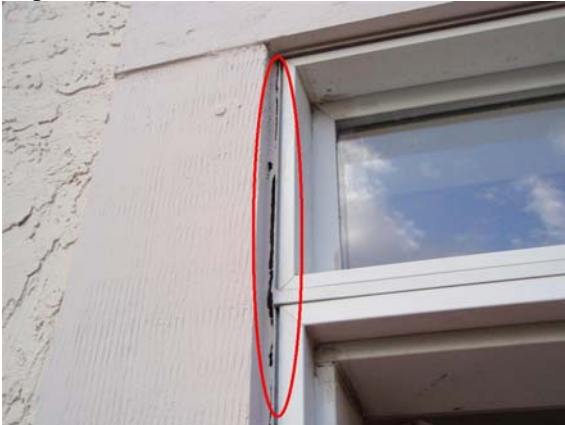
- **Repair:** The southwest basement door frame/ trim requires caulking. **REPAIRED**

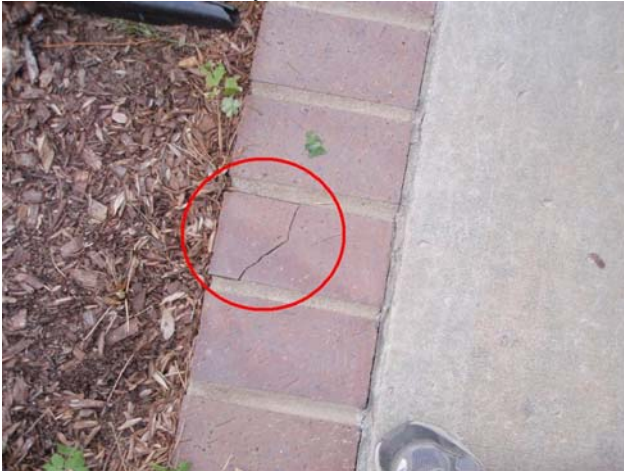
- **Monitor:** The driveway and walkway have typical cracks usually the result of shrinkage and/or settling of the slab as it cures. Shrinkage cracks are very common and are not normally a concern. These cracks have been sealed.
- **Monitor:** The driveway brick was observed to have a localized cracked brick.

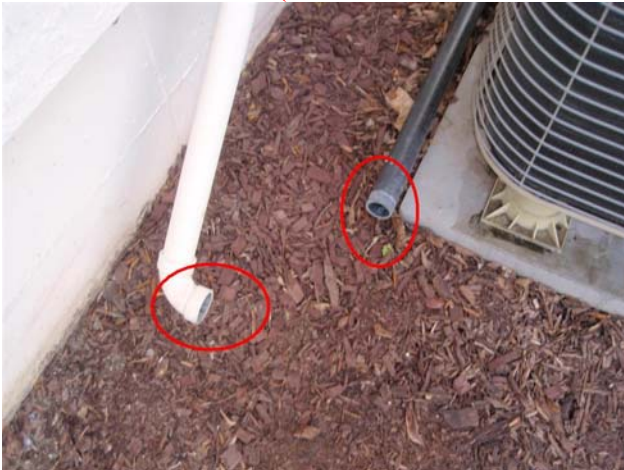
- **Improve:** The sump pump discharges in close proximity to the house. It is recommended the extension tube be reattached. **REPAIRED (Extension tube was reattached)**

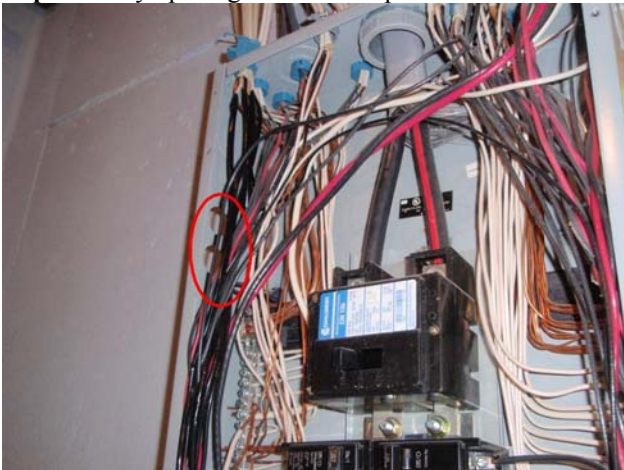
- **Repair:** Any openings in the main panel should be covered. **REPAIRED with approved metal snap-in covers**

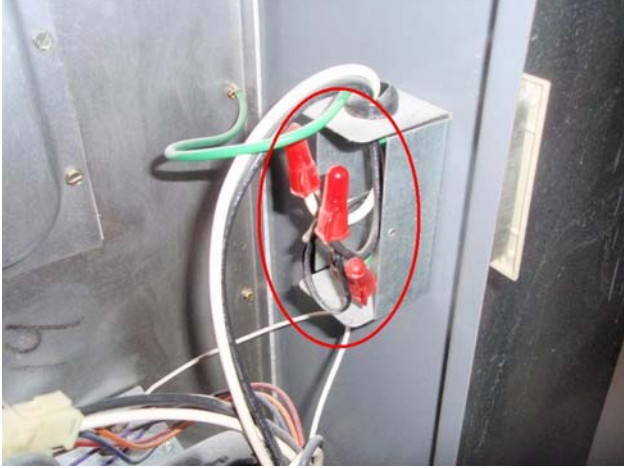
- **Repair:** All junction boxes should be fitted with cover plates, in order to protect the wire connections (i.e. inside west furnace housing). **REPAIRED (remounted existing cover plate on junction box inside west furnace housing)**

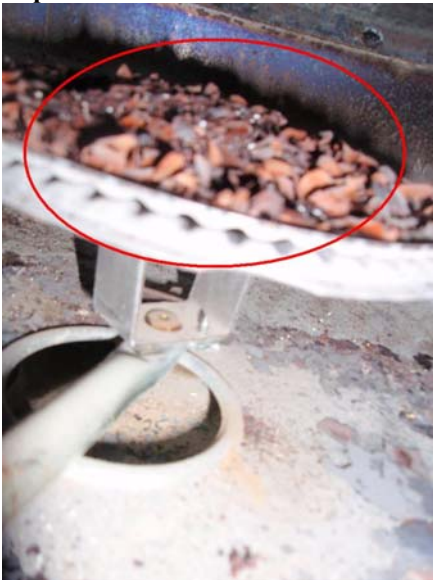
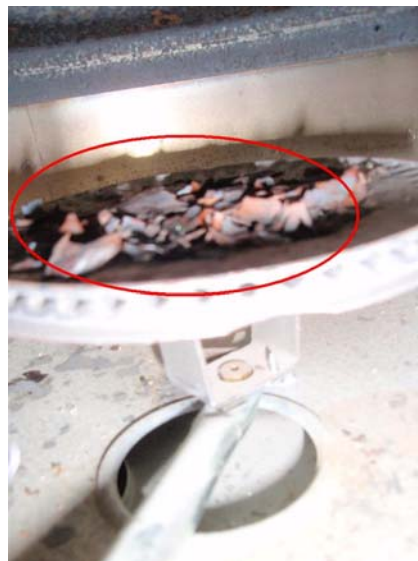
- **Monitor:** Water heaters have a typical life expectancy of 7 to 12 years. The existing units are approaching or have exceeded this age range. One cannot predict with certainty when replacement will become necessary.
- **Repair:** The water heater burners are dirty. They should be cleaned and adjusted. **REPAIRED**
