**Star
Home
Inspection Services**

Home Inspection Report

10907 W 115th Terr, Overland Park, KS 66210

Inspection Date: 05/13/2009

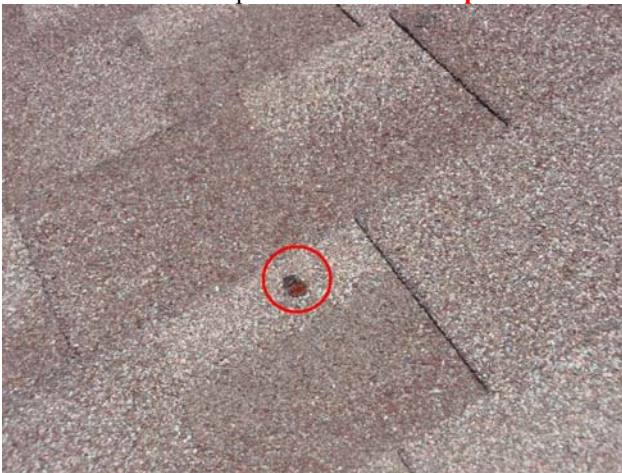
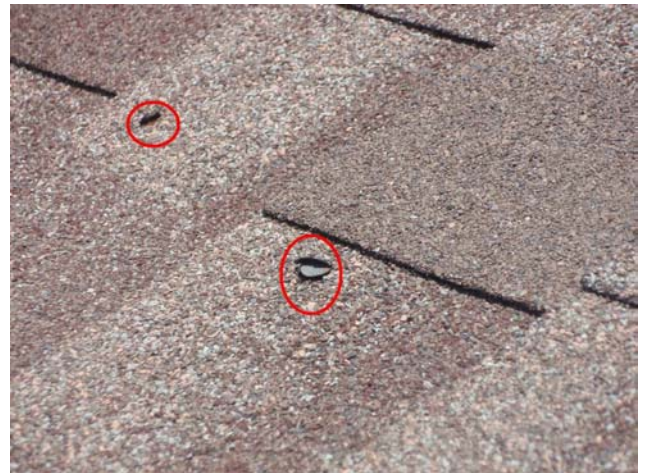
- **Repair:** Exposed nail heads were observed in the roofing shingles and/or ridge caps. All exposed nail heads should be caulked to reduce the potential of leaks. **Repaired**

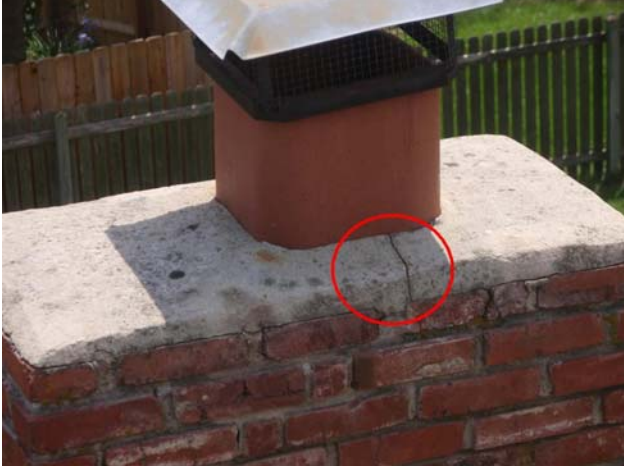
- **Monitor, Repair:** The cap of the masonry chimney is cracked. These cracks should be sealed or caulked before winter to prevent damage from freezing water. **Repaired**

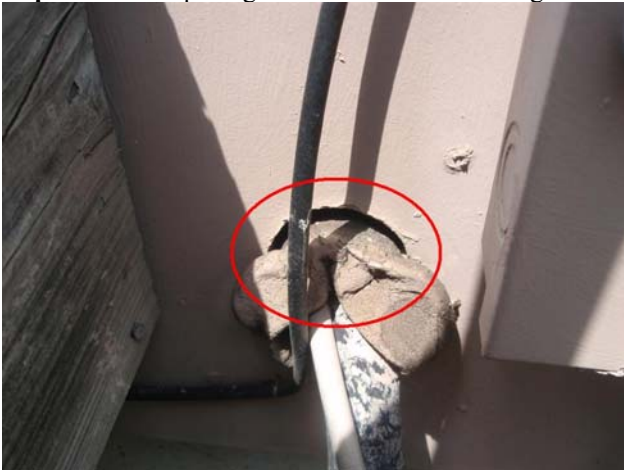
- **Monitor:** Siding of this type (hardboard) requires monitoring and maintenance. It has a tendency to pop out past nail heads creating a space where two panels join together. Re-securing and caulking these areas is standard maintenance for this type of siding.
- **Improve:** The opening where the air conditioning lines enter the siding should be sealed to prevent insect entry.

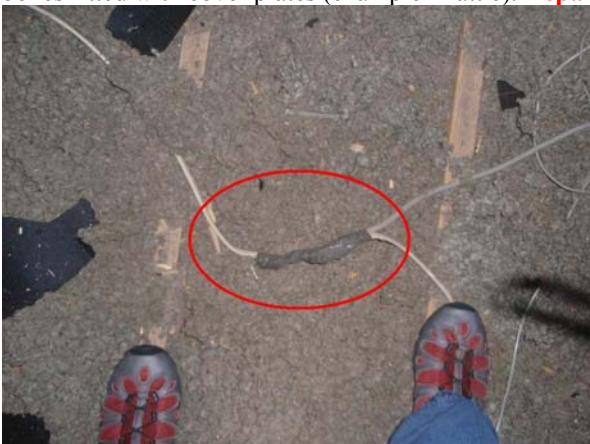
- **Repair:** Improper electrical connections should be repaired. All electrical connections should be made inside junction boxes fitted with cover plates (example in attic). **Repaired**

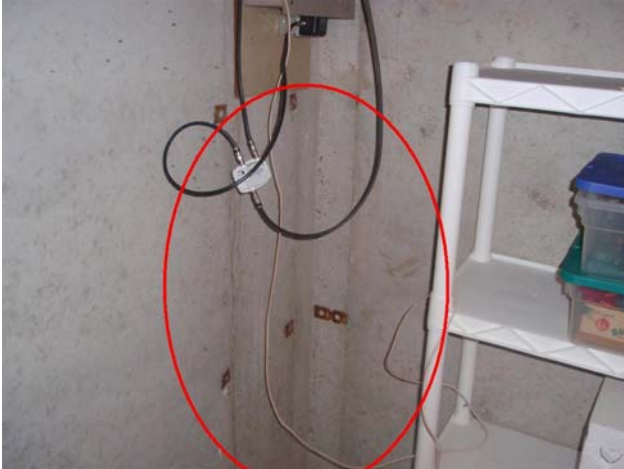
- **Repair:** Loose cable and phone wiring (example in front of the main electrical panel) should be secured. **Repaired**

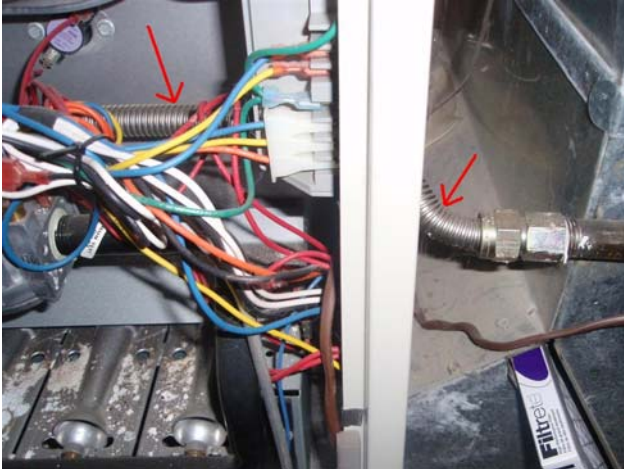
- **Repair:** Flexible gas appliance connections should not pass through walls, floors or the appliance housing as is the case of the furnace. This connector should be replaced with one of suitable solid gas piping. **Repaired**
