**Star
Home
Inspection Services**

Home Inspection Report

111 S Prairie Ct Liberty, MO 64068

Inspection Date: 06/07/2010

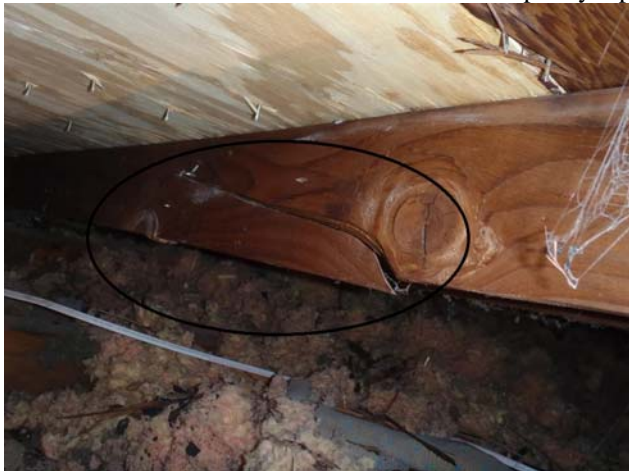
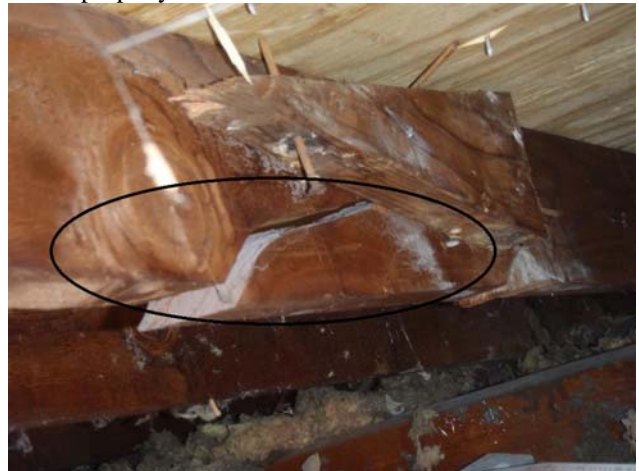
- **Monitor:** One roof rafter in the upper attic is cracked. Cracked rafters are repaired by replacement, “sister” rafters along side, or additional support. Where one or very few damaged rafters are found, this work is not high priority and can be combined with other structural or carpentry repairs at the property.

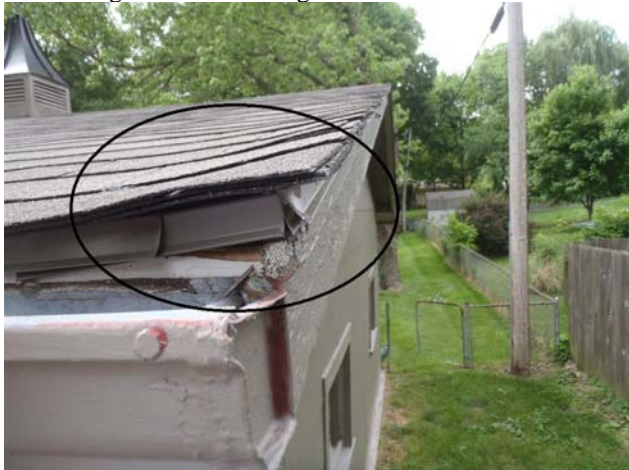
- **Repair:** The drip rail flashing on the northeast corner over the garage is a poor fit and should be repaired to avoid water damage to the sheathing.

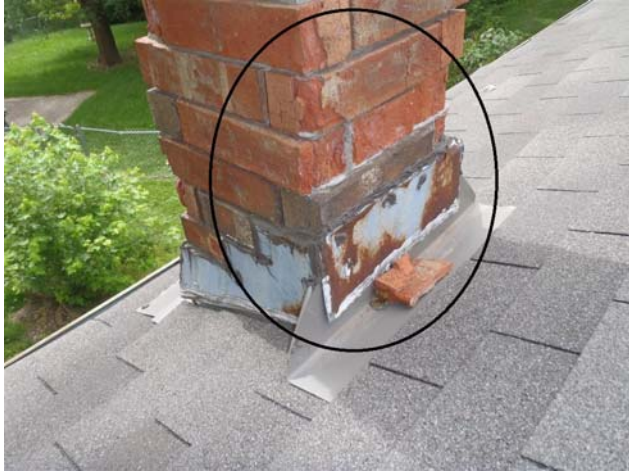
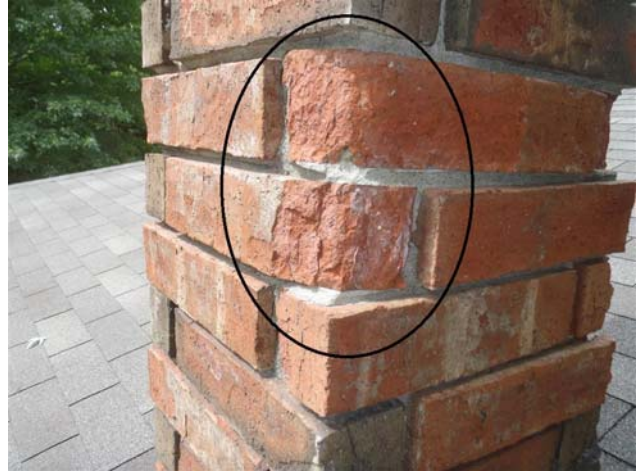
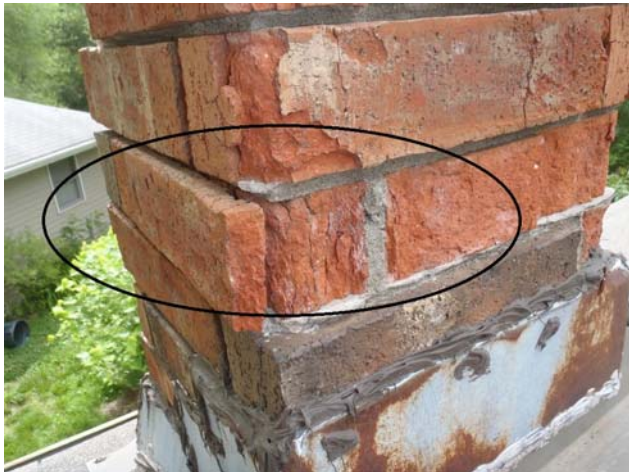
- **Repair:** The masonry chimney shows evidence of substantial spalling (surface deterioration of the masonry). Rebuilding of this chimney is needed.

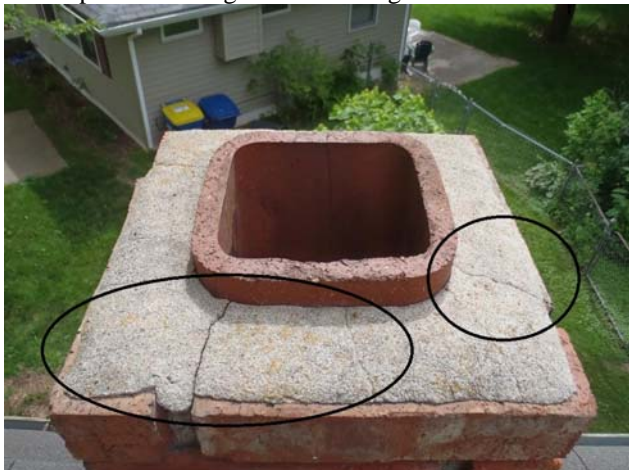
- **Monitor, Repair:** The cap of the masonry chimney is cracked. These cracks should be sealed or caulked before winter to prevent damage from freezing water.

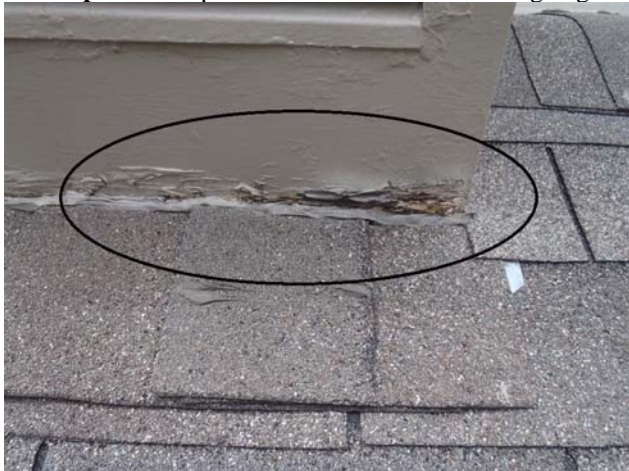
- **Repair:** The paint on the roof vent over the garage should be touched up to prevent water damage and rot.

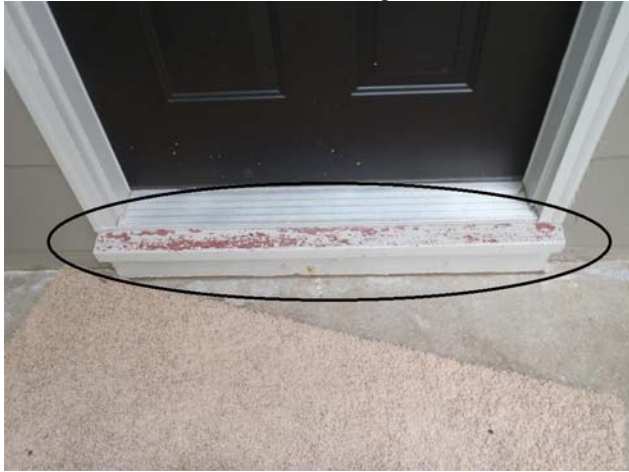
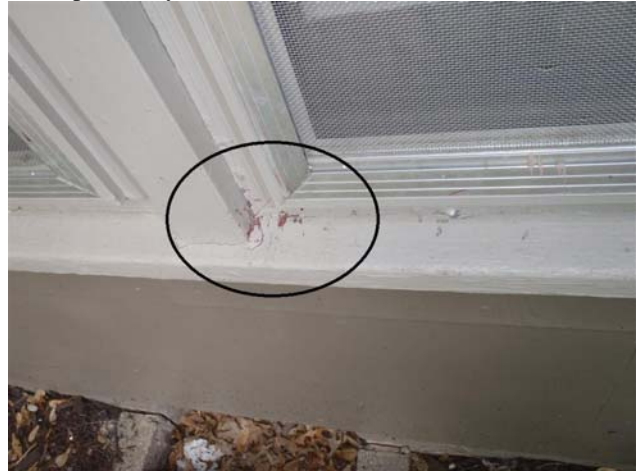
- **Monitor, Repair:** The paint on the front door threshold is peeling and the red undercoating is showing. The same holds true for the corners of the living room windows. A new coat of paint may be desirable.

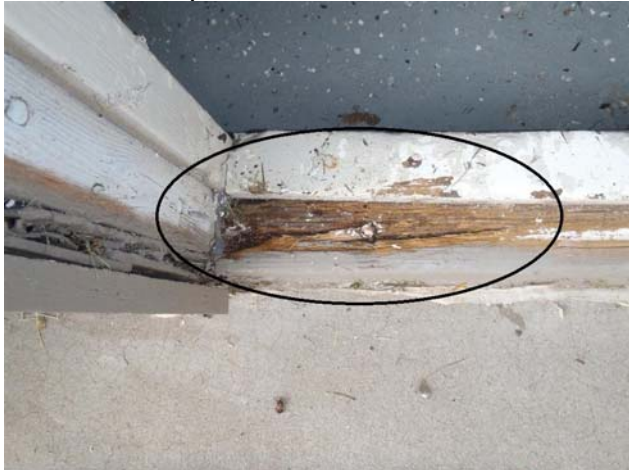
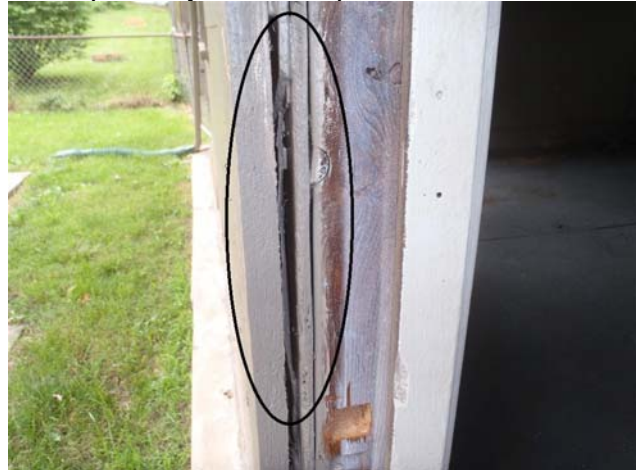
- **Repair:** Localized rot was visible on the garage walkout door threshold and there are gaps in the trim around the siding and door. Repair to the threshold and frame can usually be accomplished by a skilled carpenter.

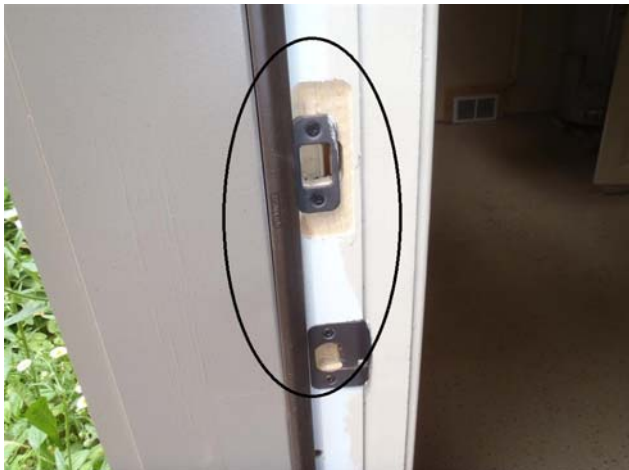
- **Repair:** The basement walkout door frame should be painted around the locking hardware to prevent water damage and rot.

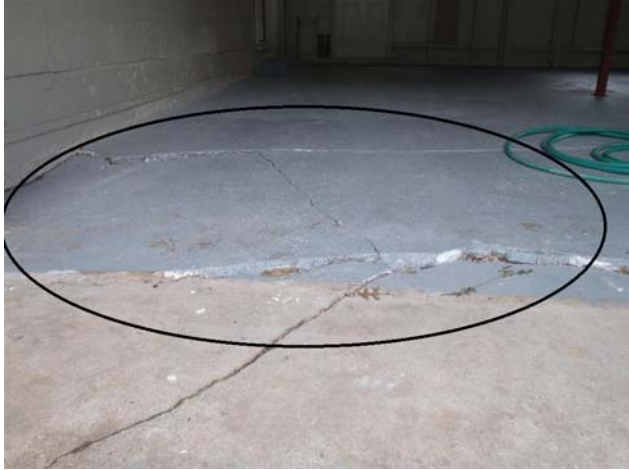
- **Monitor, Safety Issue:** Pronounced floor cracks were noted in the garage. While this amount of cracking is unusual, this slab is not a structural component you should be aware of the trip hazard.

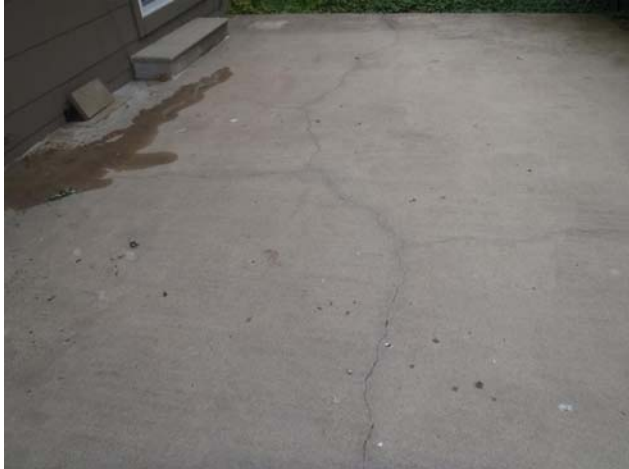
- **Monitor:** The patio has settled and cracked. Persisting movement may result in the need for repairs.

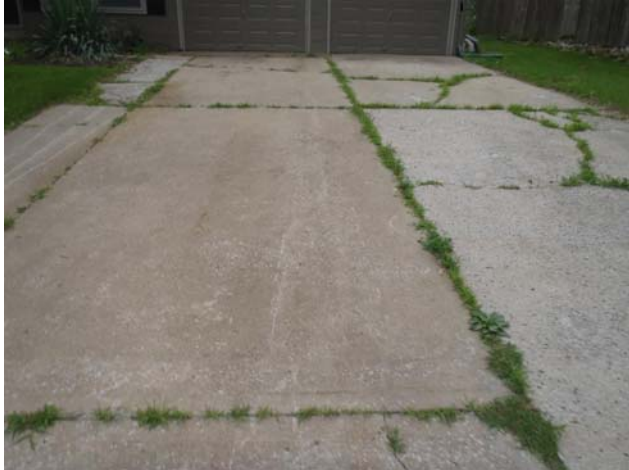
- **Monitor:** The soil below the driveway has settled and/or heaved resulting in major cracking and there is also some surface deterioration. Persisting movement may result in the need for resurfacing.

Re-surfacing of the driveway would be a logical improvement.

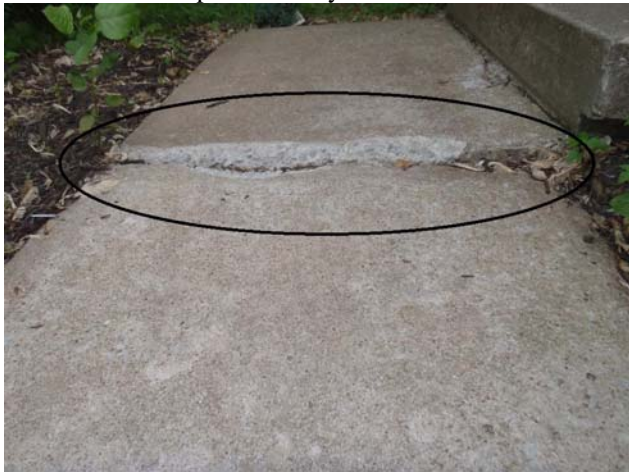
- **Recommend, Safety Issue:** The walkway has settled and cracked resulting in a trip hazard. This condition should be altered for improved safety.

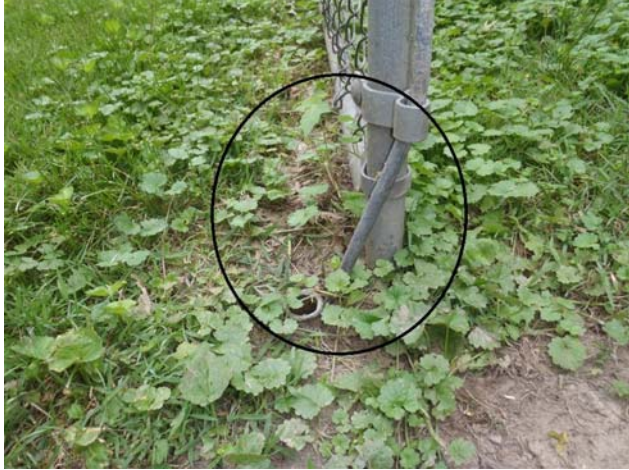
- **Repair:** The fencing is in fair condition. Minor repairs are needed, especially to the gates and/or latch mechanism for them to function properly.

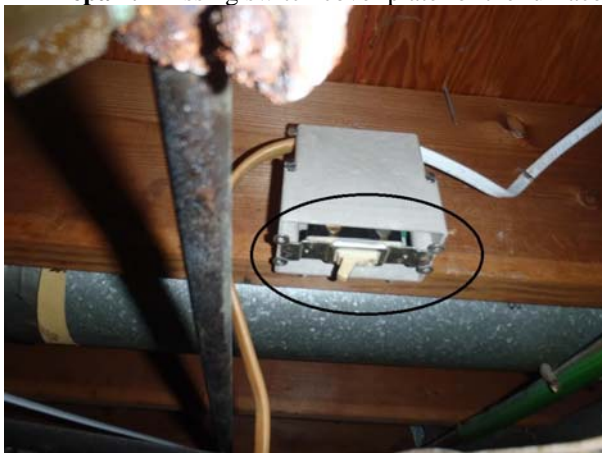
- **Repair:** Missing switch cover plate for the furnace service switch should be replaced to avoid a shock hazard.

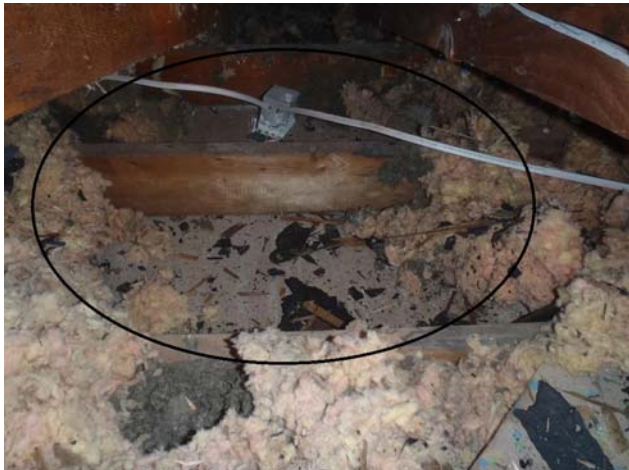
- **Recommend:** Insulation should be evened out.

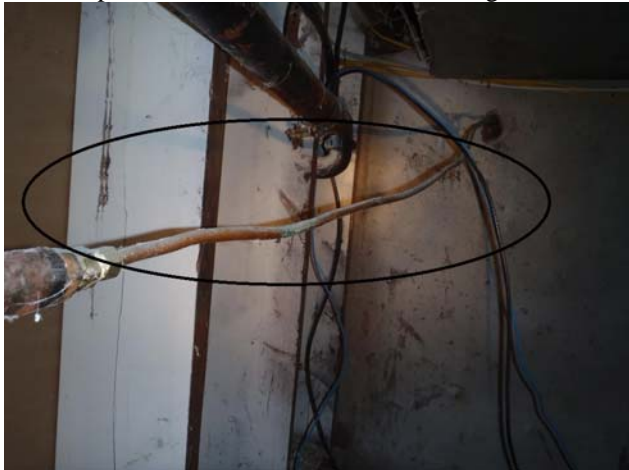
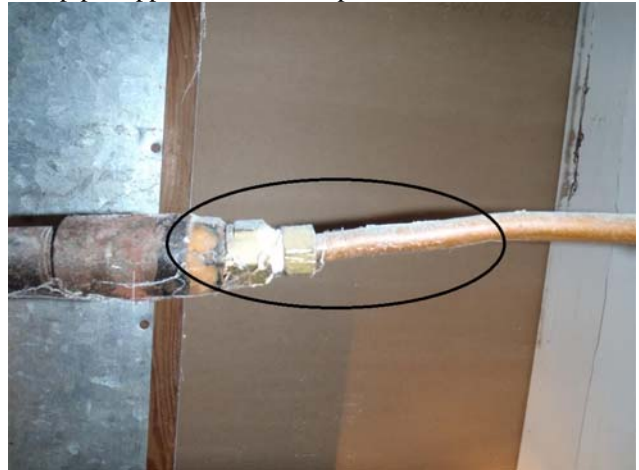
- **Monitor, Repair:** Copper tubing was observed going through the rear foundation wall and appears to be open ended in the patio for a gas grill that is no longer present. Copper tubing is no longer suitable for gas piping by most gas utility companies. It's recommended this tubing be removed and the pipe capped in the crawl space.

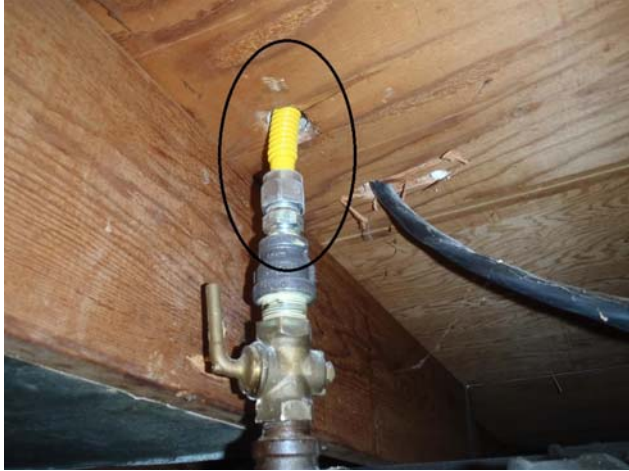
- **Repair, Safety Issue:** Flexible gas appliance connectors should not pass through walls, floors or the appliance housing as is the case of the gas range. This connector should be replaced with one of suitable solid gas piping and a shut off installed in the kitchen.

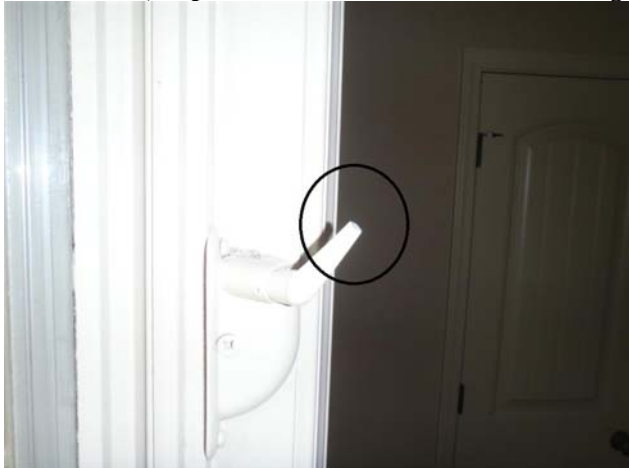
- **Monitor, Repair:** The southwest bedroom awning window does not seal properly. Improvement can be undertaken as desired.
- **Monitor, Repair:** Window crank handles are damaged on both awning windows in the bedrooms but are functional.

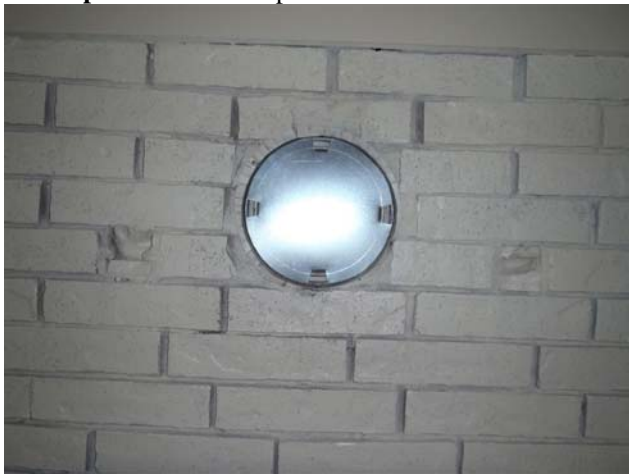
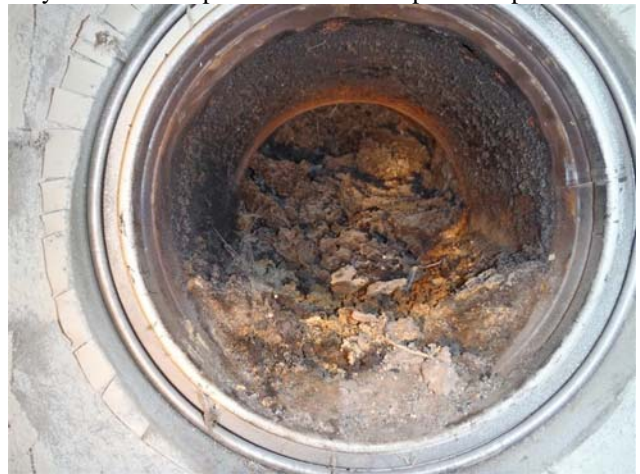
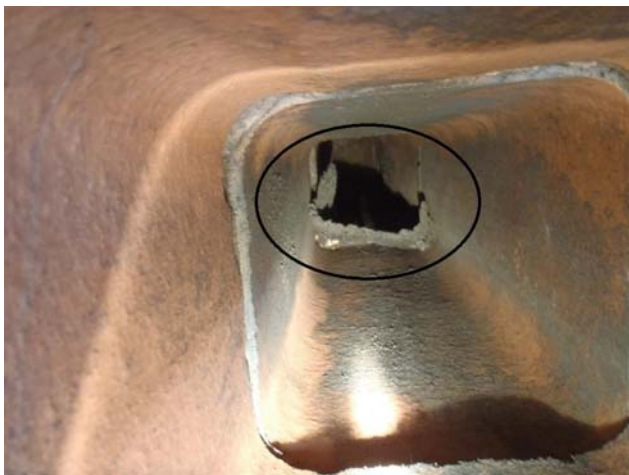
- **Repair:** If there are plans to install a wood stove the chimney should be inspected and cleaned prior to operation.
