Star Home Inspection Services

Home Inspection Report

11119 W 120th Terr, Overland Park, KS 66210

Inspection Date: 2/12/2009

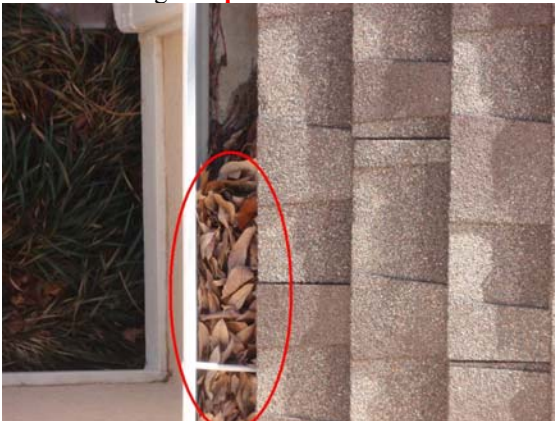
- **Repair:** The gutters require cleaning to avoid spilling roof runoff around the building – a potential source of water entry or water damage. **Repaired**

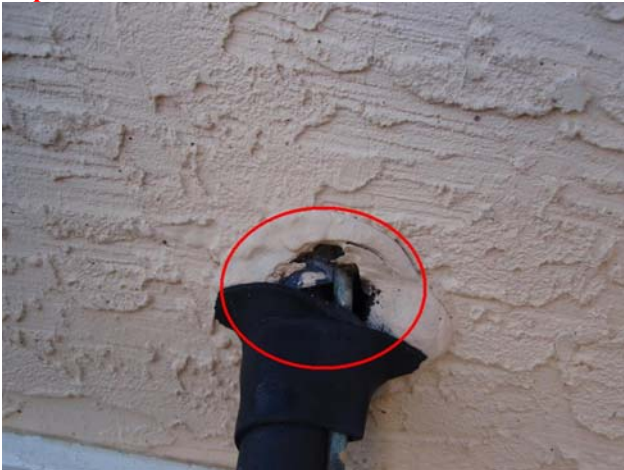
- **Repair:** The opening at the siding where the air conditioner refrigerant lines come through the siding should be sealed.

Repaired

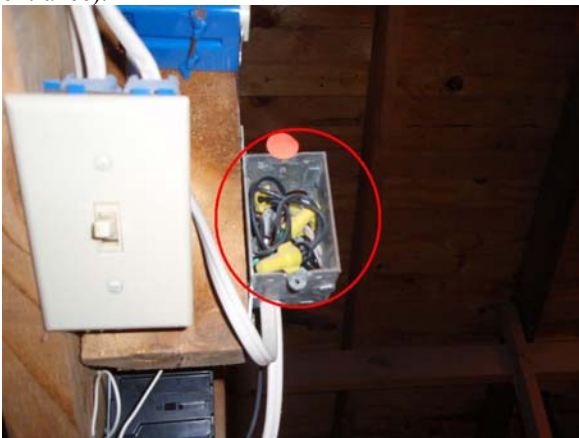
- **Repair:** All junction boxes should be fitted with cover plates, in order to protect the wire connections (example at attic entrance).

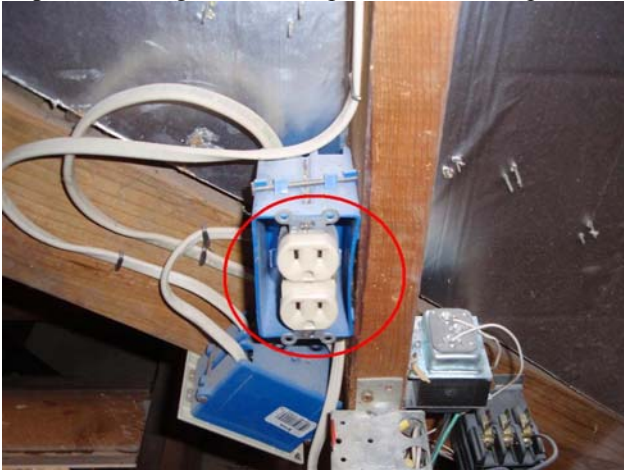
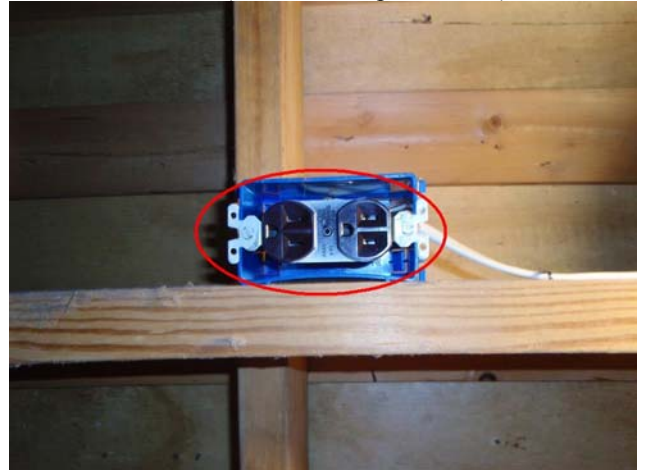
- **Repair:** Missing outlet cover plates should be replaced to avoid a shock hazard (2 outlet examples in attic).
