Star Home Inspection Services

Home Inspection Report

1112 S Liberty, Independence, MO 64050

Inspection Date: 05/13/2009

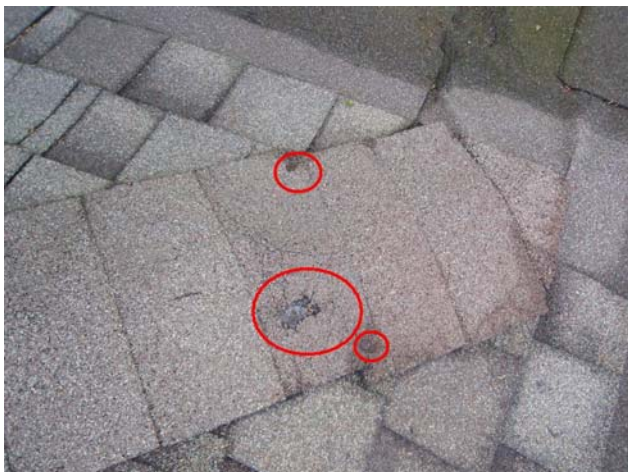
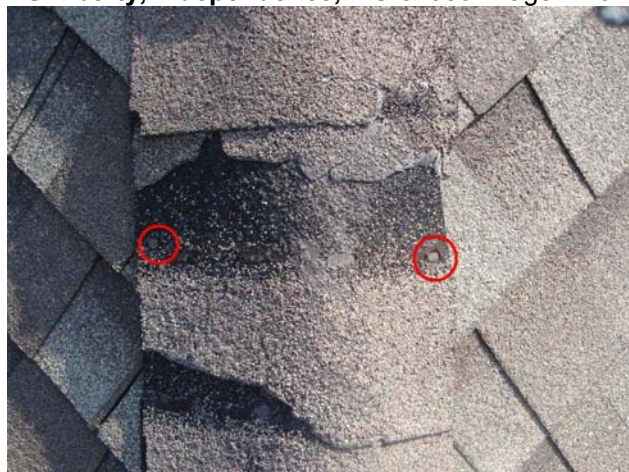
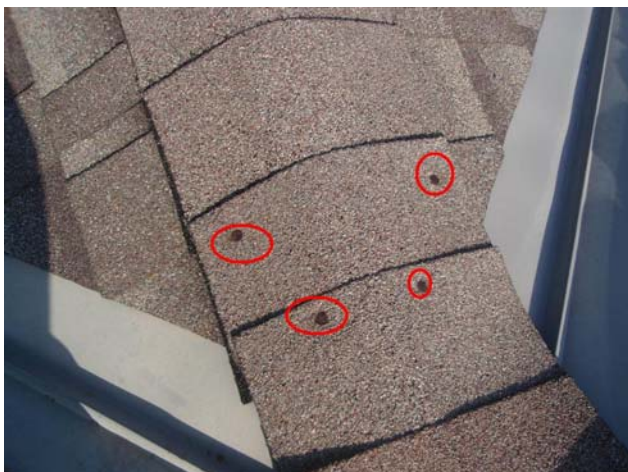
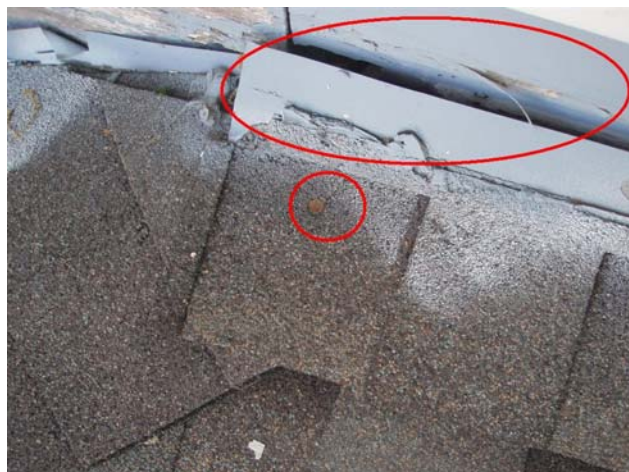
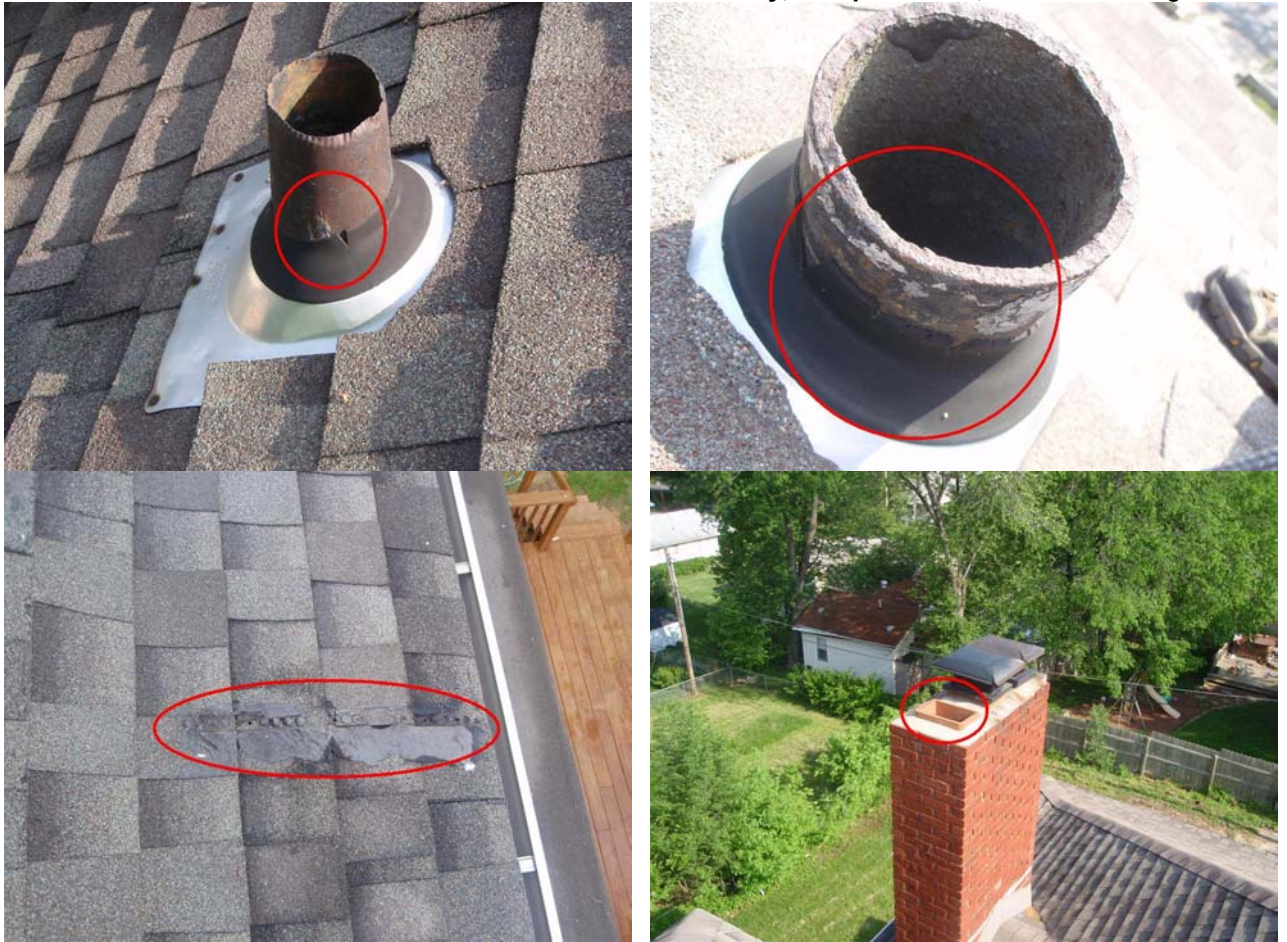
- **Repair:** Exposed nail heads were observed in the roofing shingles and/or ridge caps. All exposed nail heads should be caulked to reduce the potential of leaks.
- **Monitor:** Minor damage to the roofing material was observed (example at the southwest side of the roof).
- **Monitor:** Prior repairs to the roof were observed. This suggests previous problems have been experienced.

- **Monitor, Repair:** The rolled roofing is in fair condition. Water staining was noted at northwest room below flat roof. Water appears to pond on the membrane. Ponding shortens roof life and increases the potential for damage if leaks occur. When re-roofing the roof should be appropriately sloped, or drains should be provided.
- **Note:** Rolled roofing (example at west side of house) is prone to leaking and requires close monitoring and higher than normal maintenance.

- **Monitor, Repair:** The plumbing vent flashing boots are split making them vulnerable to leaks. It's recommended that the boots be caulked or the flashing replaced.
- **Repair:** The installation of the flashing is improper or incomplete and should be repaired to avoid leaks (flashing at roofing on west side).

- **Repair:** A rain cap and vermin screen should be installed on the masonry chimney and the chimney flue should be checked for damage. Damaged flues can be unsafe.

- **Repair:** The downspout(s) should discharge water at least five (5) feet from the house. Storm water should be encouraged to flow away from the building at the point of discharge.
- **Repair:** It is recommended that gutters and downspouts be installed to avoid spilling roof runoff around the building – a potential source of water entry or water damage (example at west side).

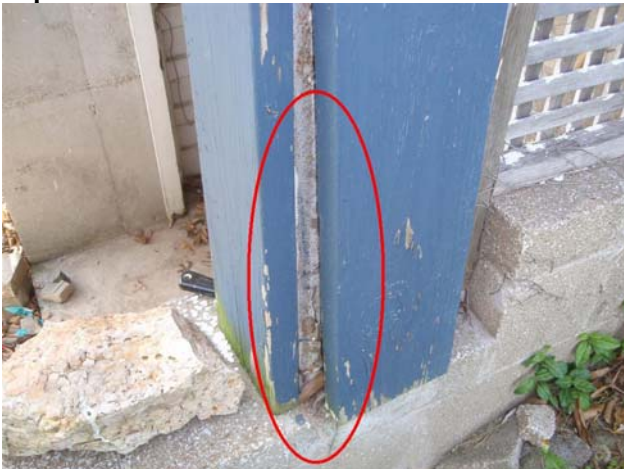
Exterior Walls

- **Major Concern, Repair:** The exterior of the house needs to be painted.
- **Repair:** Localized rot was observed in the trim around siding (example at the northwest basement man door trim). Following repair of the damaged areas (which should be combined with exterior painting/maintenance) proper maintenance of the siding and control of water from roof or surface runoff can avoid further damage.
- **Repair:** Tree branches should be trimmed away from the house to avoid damage to the building.
- **Repair:** The trim at the northwest corner of the house should be resecured and caulked.

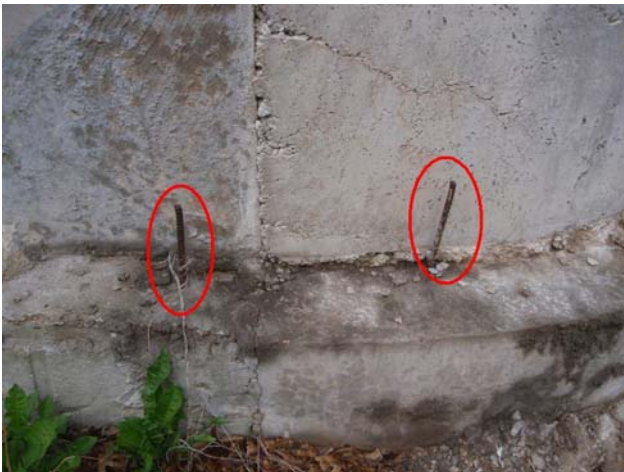
Retaining Wall

- **Monitor:** The driveway concrete block retaining wall shows evidence of slight movement. This condition should be monitored. It is impossible to determine the rate of movement during a one time visit to the house.
- **Repair, Safety Issue:** The rebar at the front east retaining wall should be cut flush with concrete. This represents a safety concern.

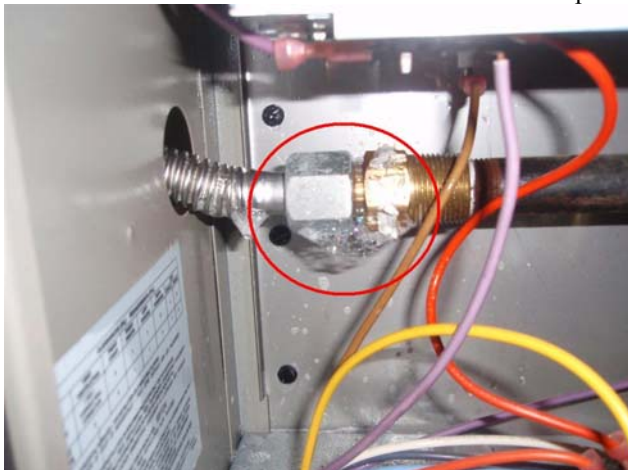
Gas Piping

- **Repair, Safety Issue:** *A gas leak was detected with a TIF 8800 gas/carbon monoxide detector and confirmed with soapy water (at flex piping connection in basement furnace marked with blue tape). This is a serious safety concern. It is recommended that the gas utility, HVAC company or plumber be engaged as soon as possible to make the necessary repairs. The current occupants of the home should also be notified.*
- **Repair:** Flexible gas appliance connections should not pass through walls, floors or the appliance housing as is the case of the basement furnace. This connector should be replaced with one of suitable solid gas piping.
