**Star
Home
Inspection Services**

Home Inspection Report

11319 Sycamore Terr, Kansas City, MO 64134

Report Number: 12222008-2A

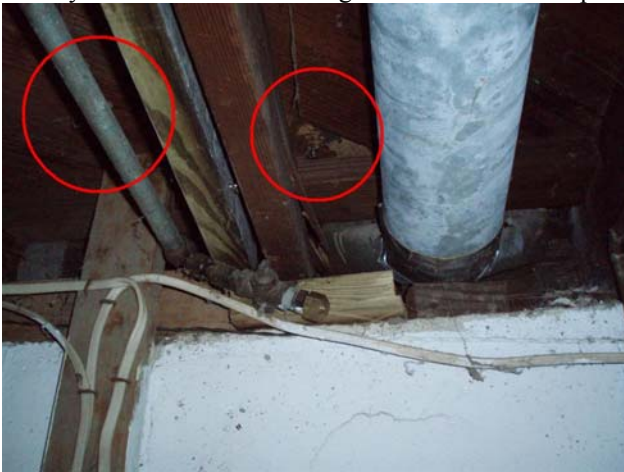
- **Monitor, Repair:** Evidence of termite damage was observed (example at subflooring in basement ceiling near front porch) and there is risk of additional hidden damage since termites can do a substantial amount of damage. If the property has not already been treated, a licensed pest control specialist should be engaged to eliminate further termite activity within the home. Damaged wood should be repaired or replaced. Any wood soil contact should be eliminated.

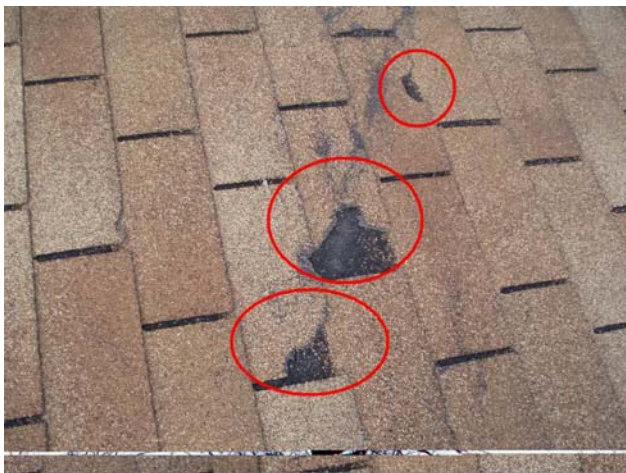
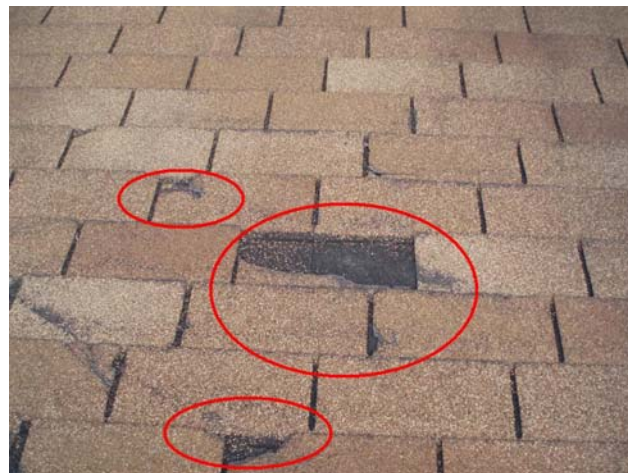
- **Monitor, Repair:** Missing tabs were observed. Repairs are needed. Older roofs are, by their nature, a high maintenance roof. Annual inspection and repair should be anticipated. In addition, the older flashings should be monitored. In some cases, a deteriorated flashing can result in expensive repairs, because sections of the roofing have to be removed. As a rule of thumb, replacement of the entire roof covering may be logical if more than ten percent of the roof requires repair.
- It is recommended that the present layers of roofing materials be removed prior to re-roofing. This adds cost of demolition and debris removal to the re-roof cost.

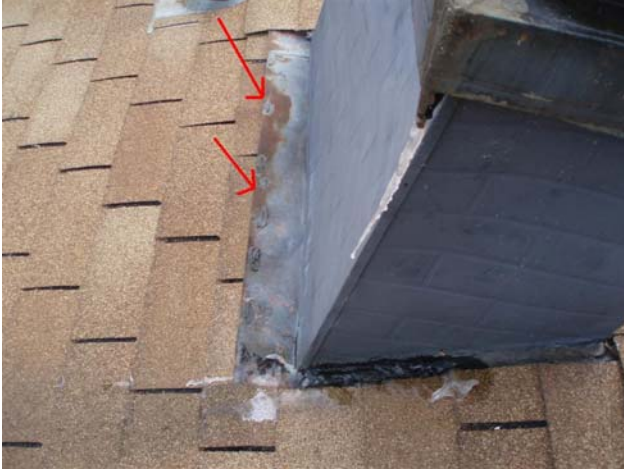
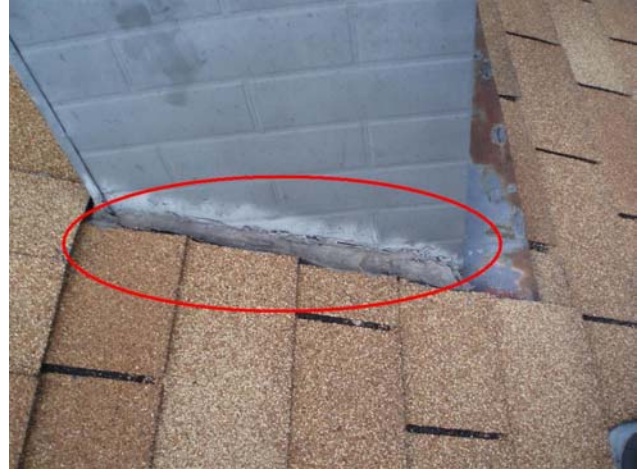
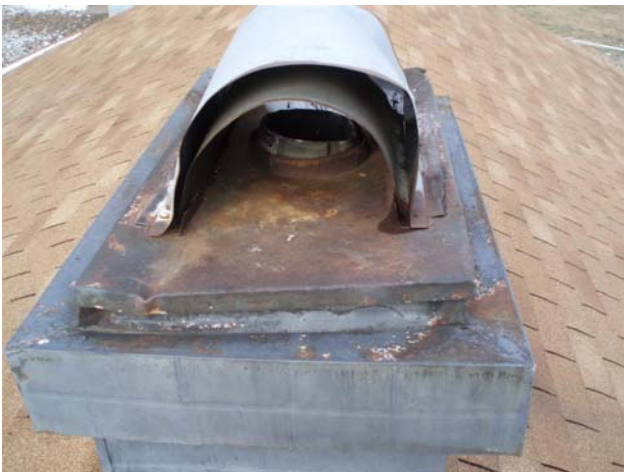
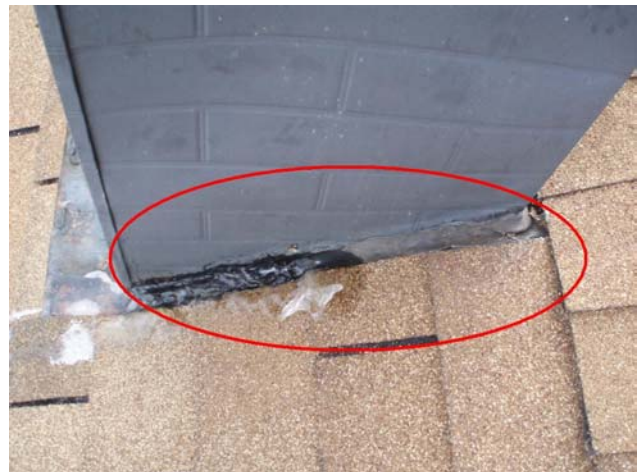
- **Repair:** The furnace chimney vent flashing is rusting. It should be painted to extend its life.
- **Repair:** The furnace chimney vent flashing should be caulked to avoid leaks.

- **Repair:** The metal furnace vent chimney is rusting. It should be painted with an appropriate paint or replaced.

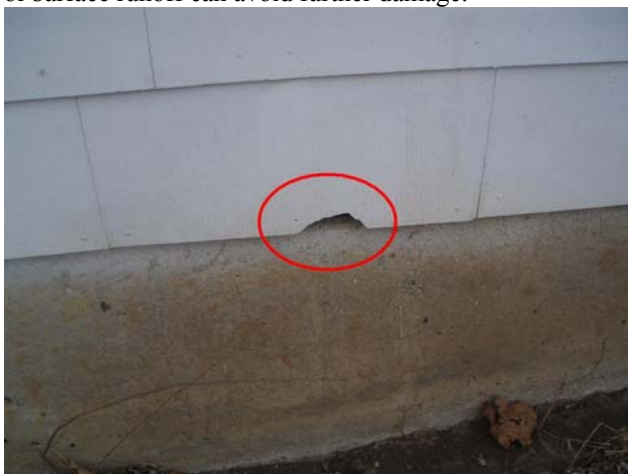
- **Monitor, Repair:** Localized minor damage was observed in the siding. Following repair of the damaged areas (which should be combined with exterior painting/maintenance) proper maintenance of the siding and control of water from roof or surface runoff can avoid further damage.

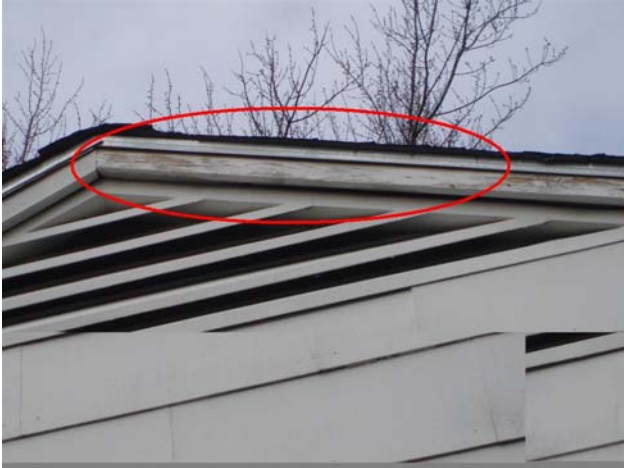
- **Repair:** The fascia and eaves are peeling and they should be painted to prevent water damage and rot.

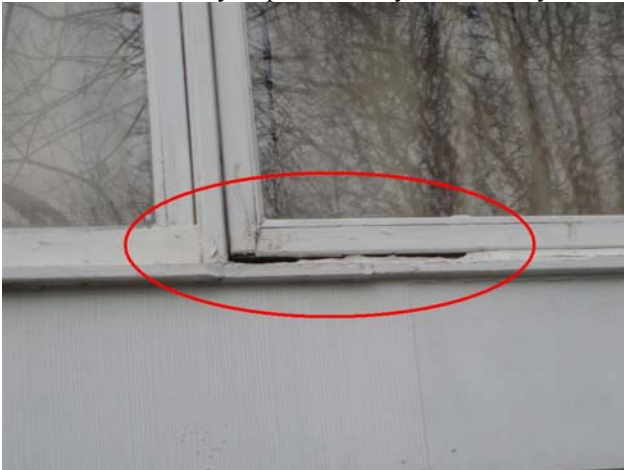
- **Repair:** Localized evidence of rot was visible on window trim/frame (example at south side of house). Repair to the window frame can usually be accomplished by a skilled carpenter. It's recommended that a thorough "inventory" be taken by a competent window repair technician to ascertain exactly how many areas will need to be repaired or replaced. Further evaluation by a specialist may well identify additional areas that require servicing.

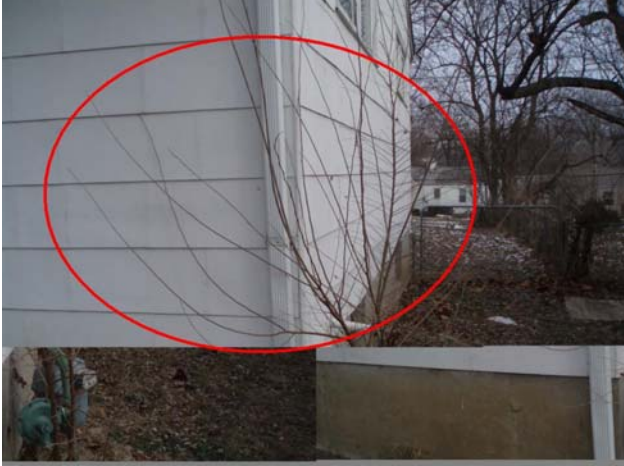
- **Repair:** Shrubs, bushes and/or vines growing on exterior walls need to be trimmed away from the structure to reduce the risk of water damage and insect infestation.

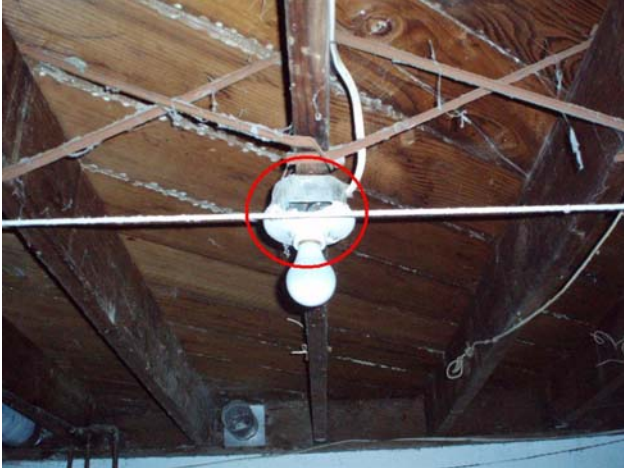
- **Repair:** The damaged light fixture in the basement should be repaired or replaced.

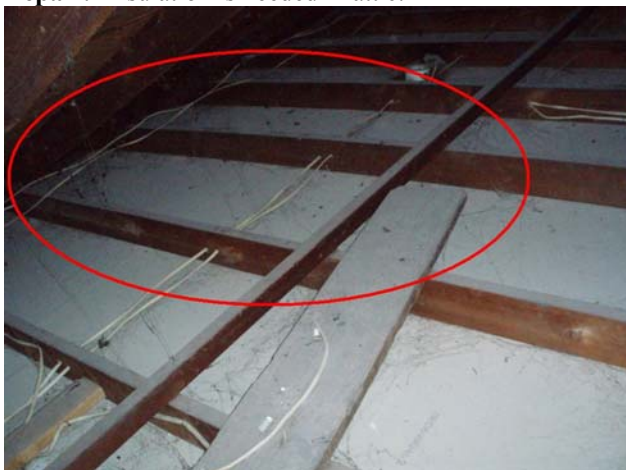
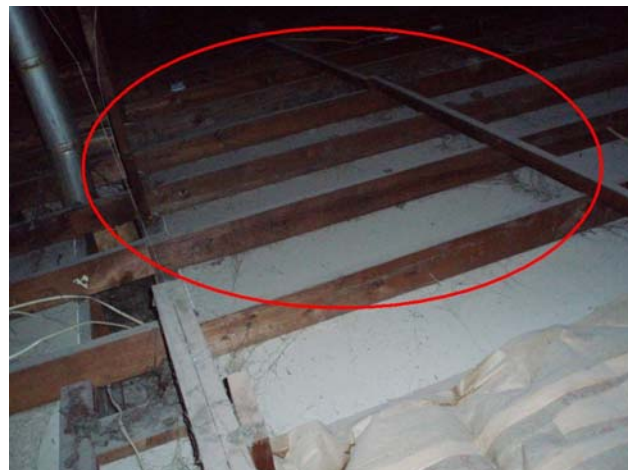
- **Repair:** Insulation is needed in attic.

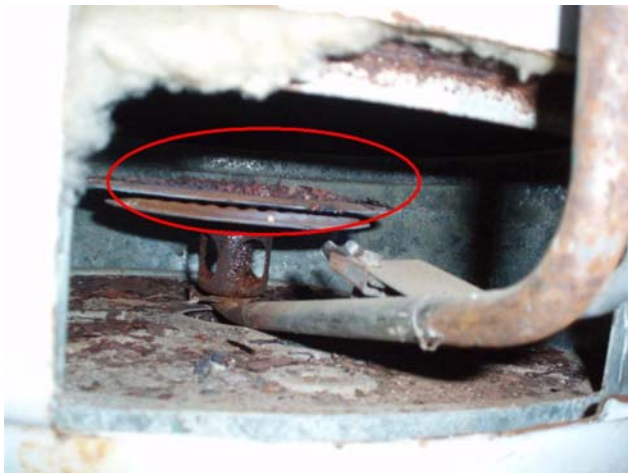
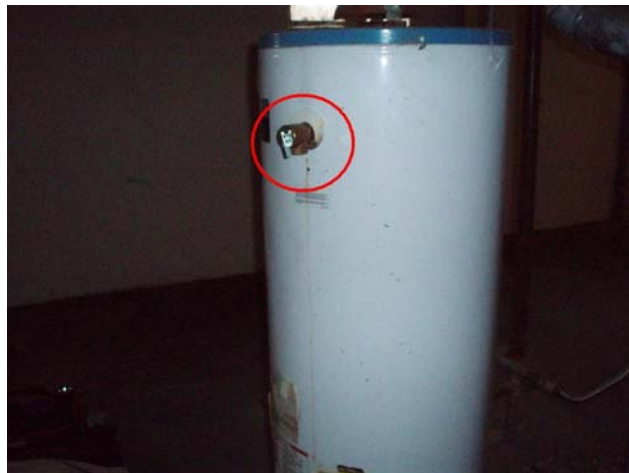
- **Monitor:** The water heater is an old unit that may be approaching the end of its useful life. It would be wise to budget for a new unit. One cannot predict with certainty when replacement will become necessary.
- **Repair:** The water heater burner is dirty. It should be cleaned and adjusted.
- **Repair:** The discharge piping serving the Temperature and Pressure Relief (TPR) Valve for the water heater should terminate not less than 6 inches or more than 24 inches above the floor.

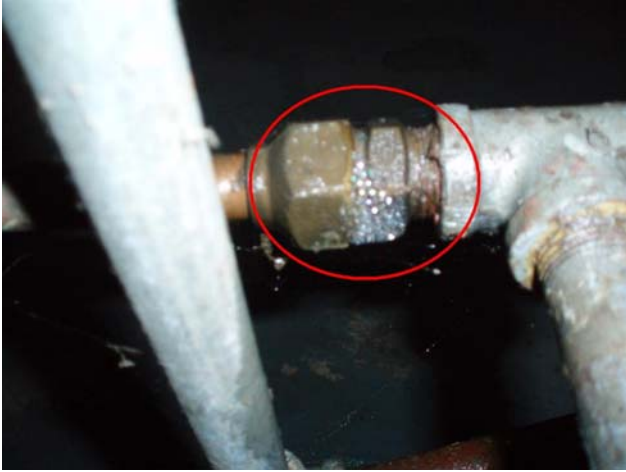
- **Repair, Safety Issue:** *A gas leak was detected (marked with blue tape) at the water heater gas pipe connection with a TIF 8800 gas/carbon monoxide detector and confirmed with soapy water. This is a serious safety concern. It is recommended that the gas utility, HVAC company or plumber be engaged as soon as possible to make the necessary repairs. The current occupants of the home should also be notified.*

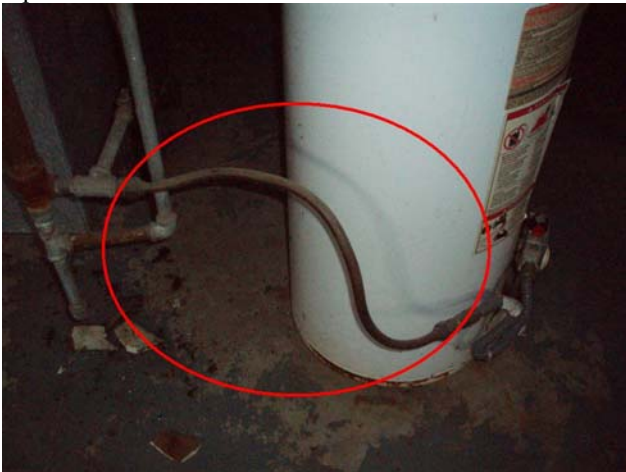
- **Repair:** Copper tubing is no longer suitable for gas piping. It's recommended this pipe servicing the water heater be replaced with one of suitable material.

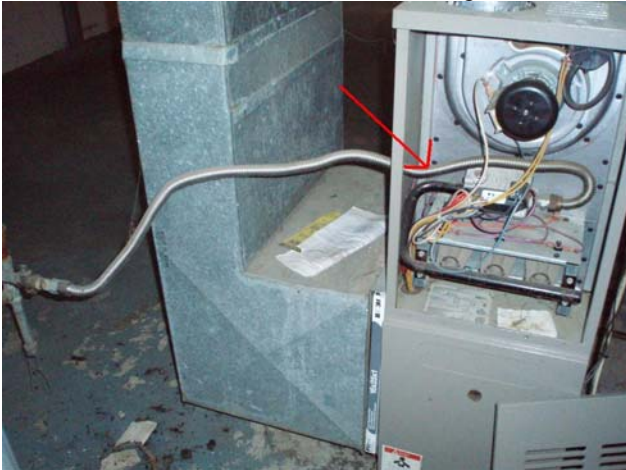
- **Repair:** Flexible gas appliance connections should not pass through walls, floors or the appliance housing as is the case of the furnace. This connector should be replaced with one of suitable solid gas piping.

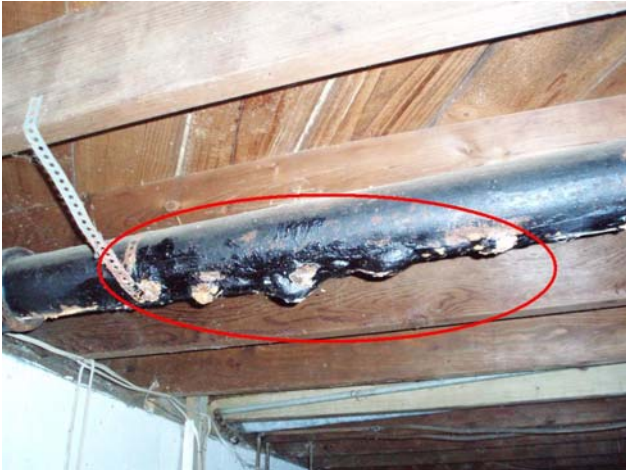
- **Monitor:** For the most part, the waste piping is old. It may be prone to unexpected problems. Improvement is recommended on an as needed basis.
