Star Home Inspection Services

Home Inspection Report

11409 W 67th Terr, Shawnee, KS 66203

Inspection Date: 12/18/2008

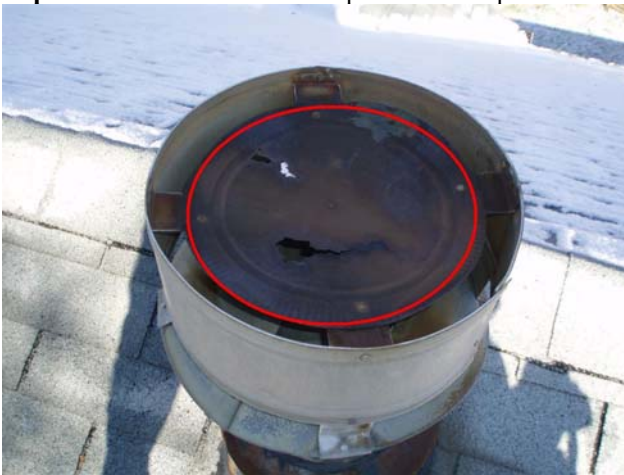
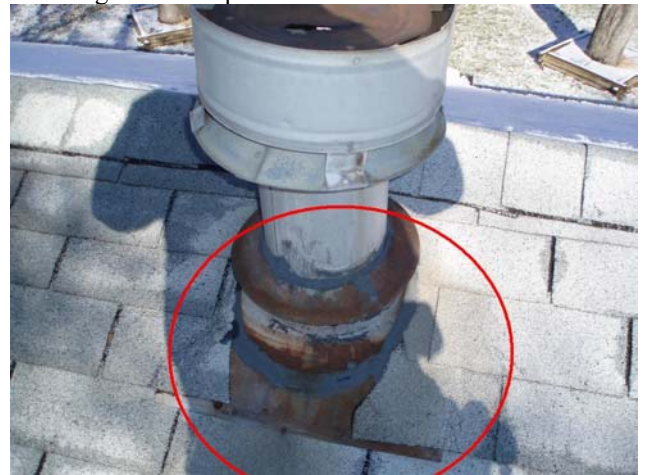
Sloped Roofing

- **Repair:** Exposed nail heads and guy wire eye hook at roof should be caulked (see pictures at last page of report).
- **Repair:** Rusted furnace vent cap should be replaced. Rusted flashing should be painted to extend its life.

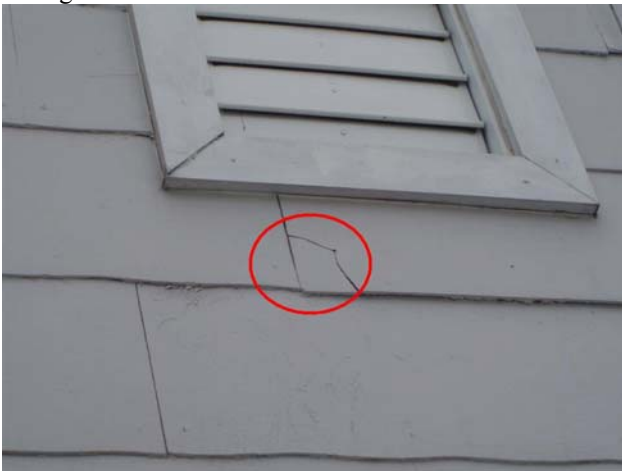
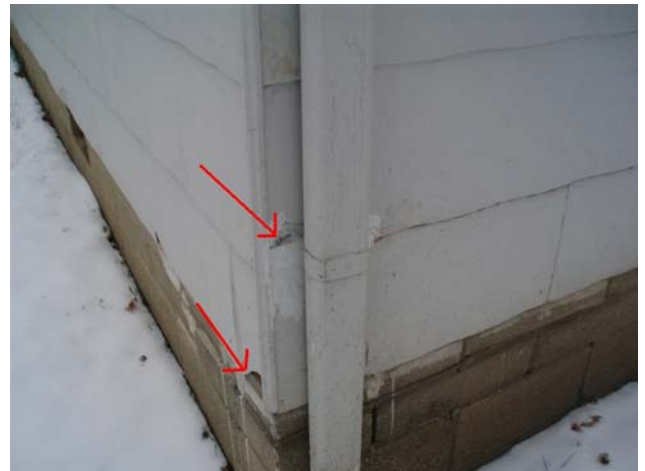
Exterior Walls

- **Repair:** The exterior siding paint is peeling and/or worn thin in localized areas (example above front northeast windows). These areas should be painted to prevent water damage or rot in the future.
- **Repair:** The paint on the trim around the siding is peeling in localized areas. These areas should be painted to prevent water damage and rot.
- **Monitor, Repair:** Localized minor damage of the exterior siding should be repaired. There is extra risk of hidden damage in such areas.

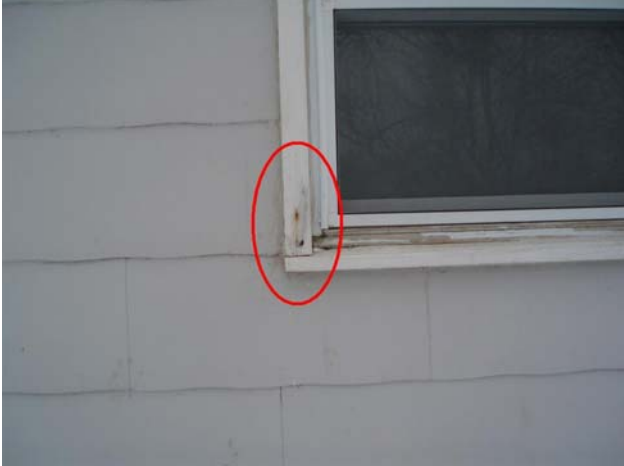
Windows

- **Repair:** The window frames trim require painting.
- **Repair:** Localized evidence of rot was visible on window trim/frame. Repair to the window frame can usually be accomplished by a skilled carpenter. It's recommended that a thorough "inventory" be taken by a competent window repair technician to ascertain exactly how many areas will need to be repaired or replaced. Further evaluation by a specialist may well identify additional areas that require servicing.

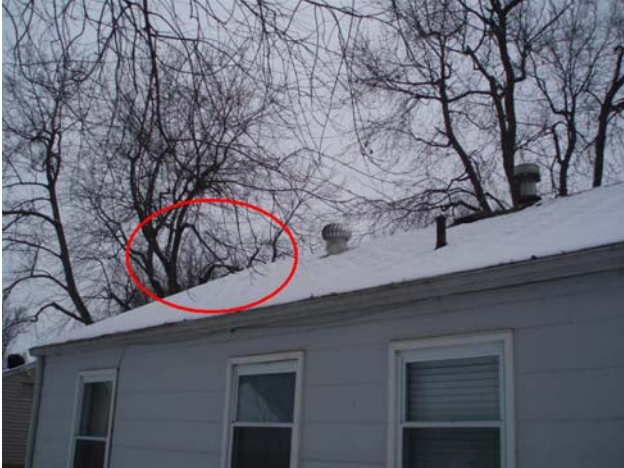
Landscaping

- **Repair:** Tree branches should be trimmed away from the house to avoid damage to the building.

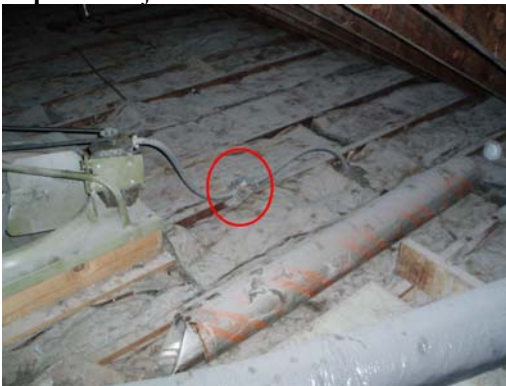
Distribution Wiring

- **Repair:** All junction boxes should be fitted with cover plates (example in attic), in order to protect the wire connections.

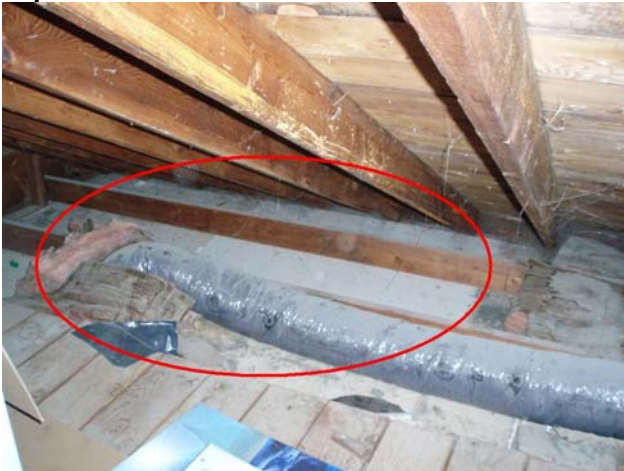
Attic / Roof

- **Repair:** Insulation should be evened out.

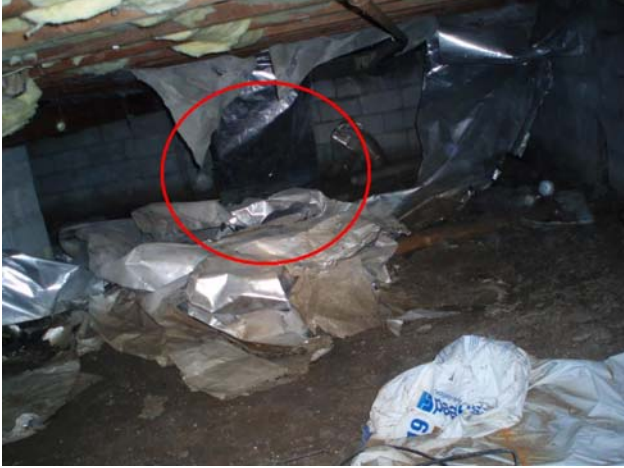
Crawl Space

- **Improve:** The moisture (vapor) barrier in the crawl space has come loose and it may be desirable to adjust or add to cover all areas of exposed soil.

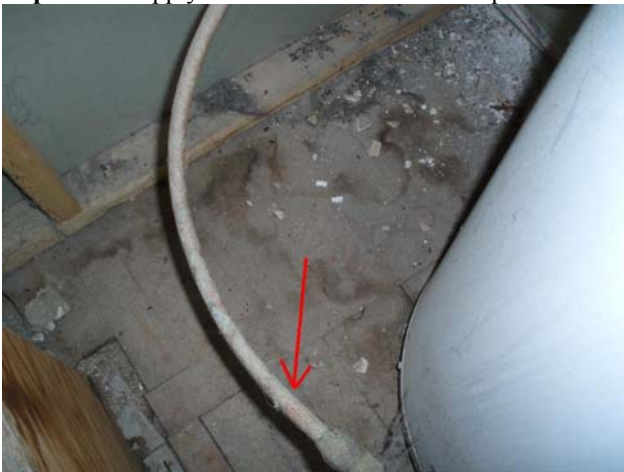
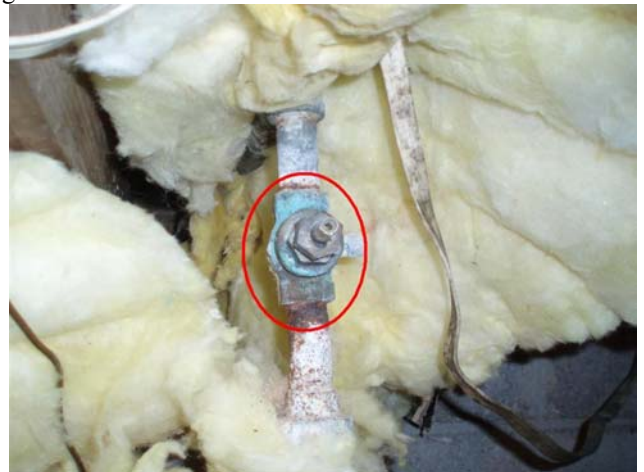
Supply Plumbing

- **Repair:** A supply valve handle in the crawl space is missing.

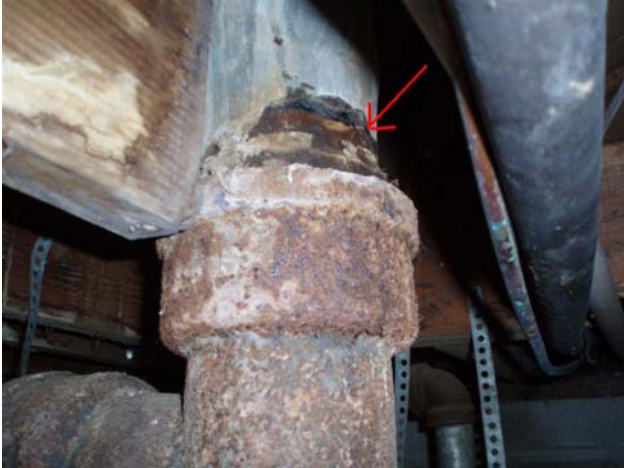
Waste / Vent

- **Monitor:** The lead waste piping is old and prone to leakage at the connections.
