**Star
Home
Inspection Services**

Home Inspection Report

11516 Flint St, Overland Park, KS 66210

Inspection Date: 3/21/2009

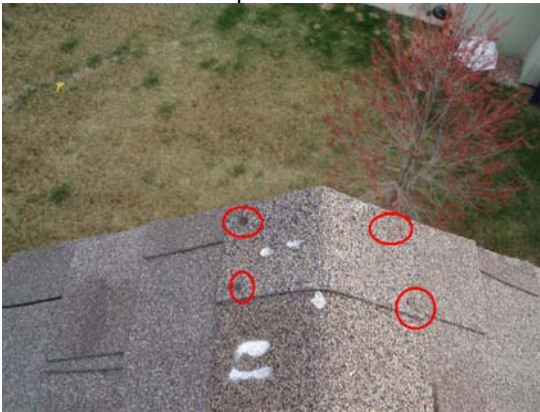
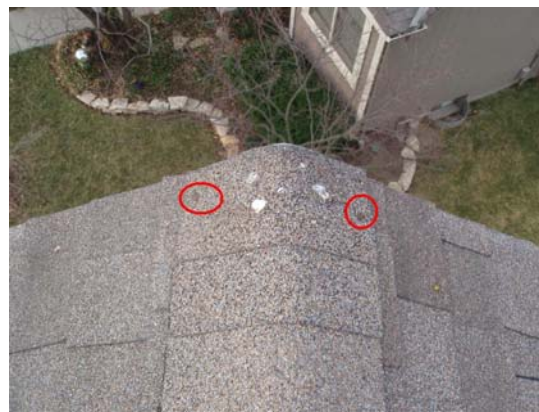
- **Repair:** Exposed nail heads were observed in the roofing shingles and/or ridge caps. All exposed nail heads should be caulked to reduce the potential of leaks.

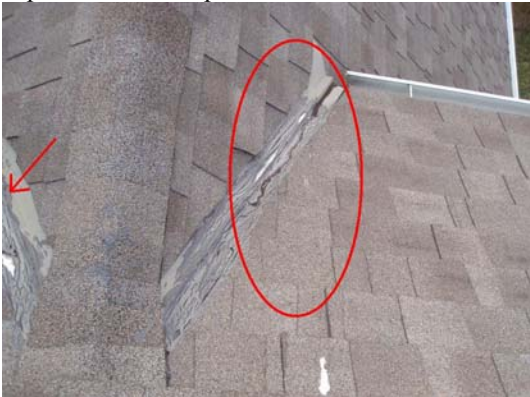
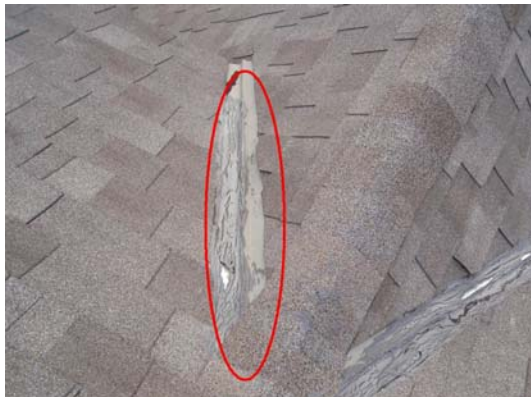
- **Monitor:** Prior repairs to the roofing are evident at the valley flashings. This would suggest that problems have been experienced in the past. This area should be monitored.

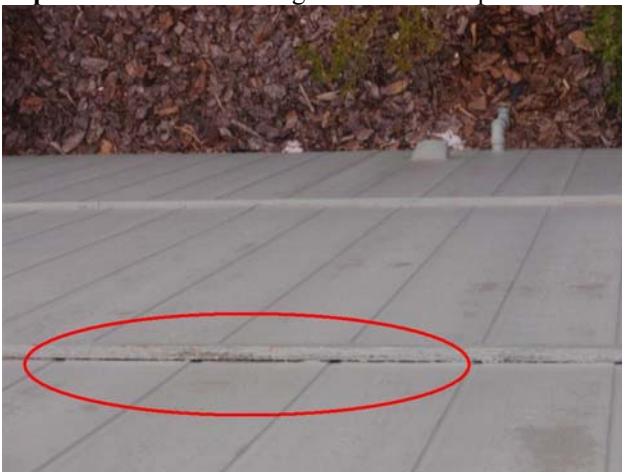
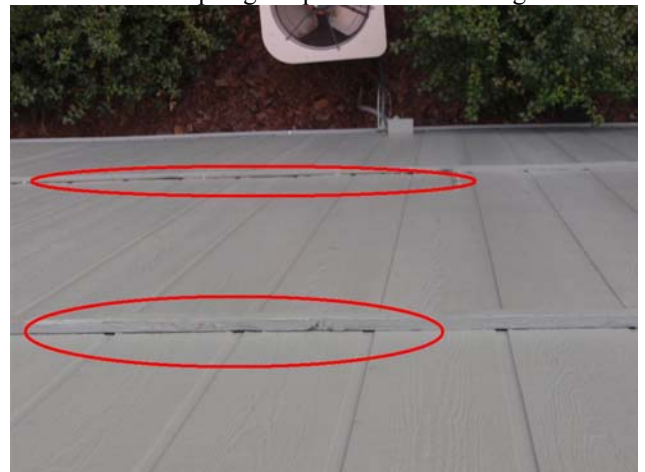
- **Repair:** The exterior siding horizontal trim pieces should be caulked at the top edge to prevent water damage.

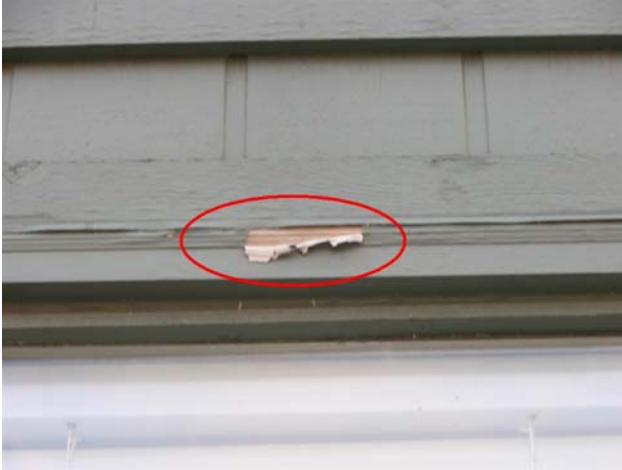
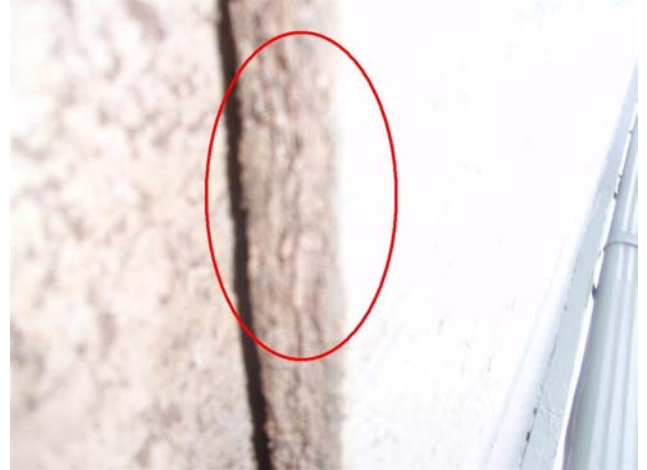
- **Monitor:** Siding of this type requires monitoring and maintenance. It has a tendency to pop out past nail heads creating a space where two panels join together. Re-securing and caulking these areas is standard maintenance for this type of siding.
- **Monitor:** Localized rot was observed in the siding (example at minor areas at back southwest corner lower edge and at fireplace siding near horizontal trim) . Following repair of the damaged areas (which should be combined with exterior painting/maintenance) proper maintenance of the siding and control of water from roof or surface runoff can avoid further damage.
- **Repair:** The paint on the trim around the siding is peeling. The bottom edge of the siding (example at back of house) is not painted. These areas should be painted to prevent water damage and rot.

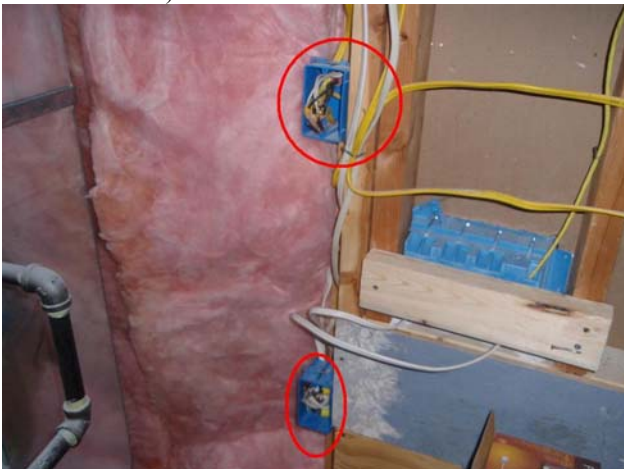
- **Repair:** All junction boxes should be fitted with cover plates, in order to protect the wire connections (examples under basement stairs).

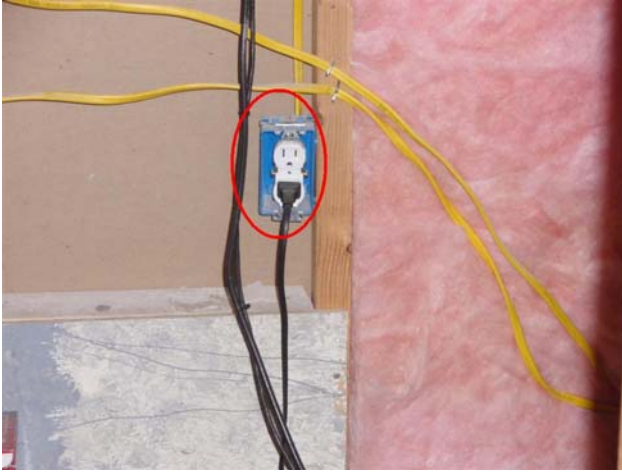
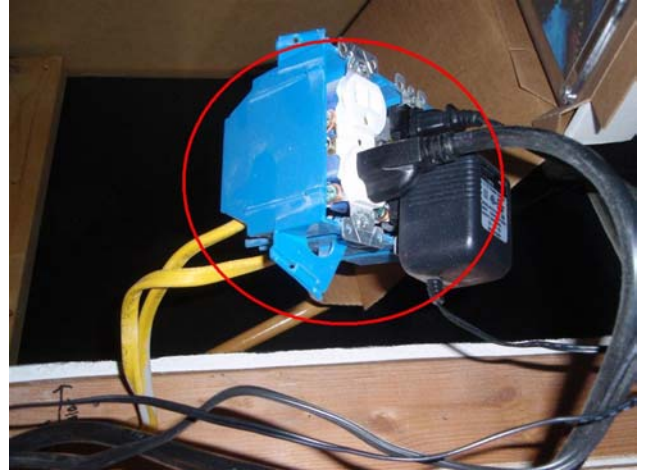
- **Repair:** Missing outlet cover plates should be replaced to avoid a shock hazard (examples in basement under stairs and in entertainment center wiring cabinet).

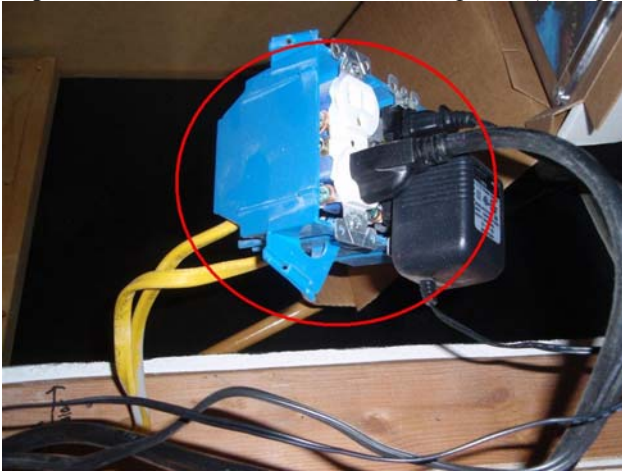
- **Repair:** An outlet is loose. It should be repaired (example in entertainment wiring cabinet).

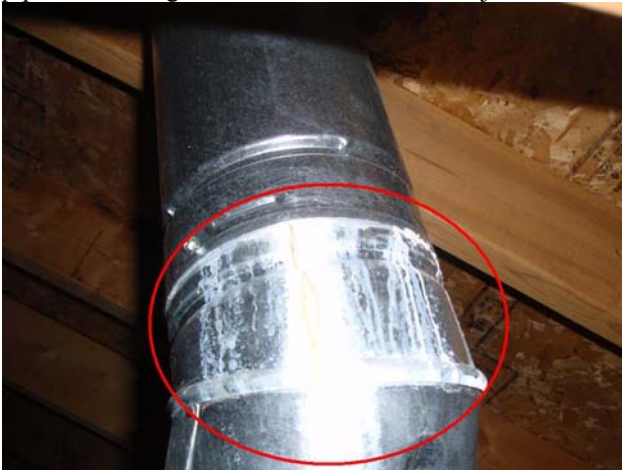
- **Monitor:** Water stains observed on furnace vent pipe in attic, suggesting previous leakage. Dampness in insulation below was noted. This is a fairly common condition normally caused by a blowing hard rain entering the furnace vent pipe and coming out at the first exhaust duct joint.
