**Star  
Home  
Inspection Services**

*Home Inspection Report*

**116 N Janell Dr, Olathe, KS 66061**

**Inspection Date: 10/6/2008**

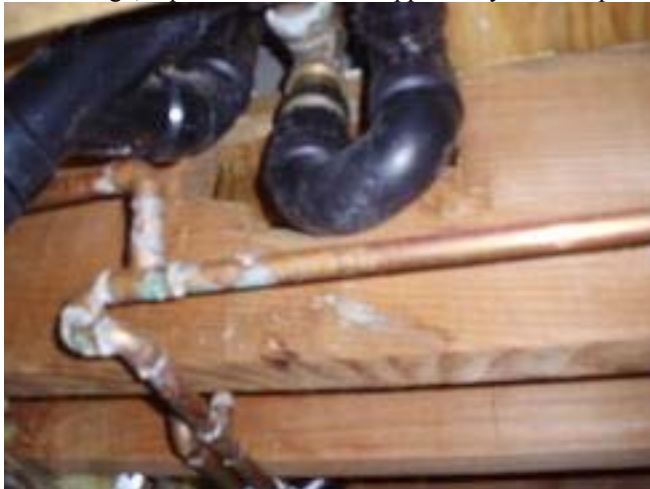
- **Monitor:** A floor joist was notched by the plumber when the home was built. This weakens the joist and risks structural damage; repairs or additional support may at some point be needed.

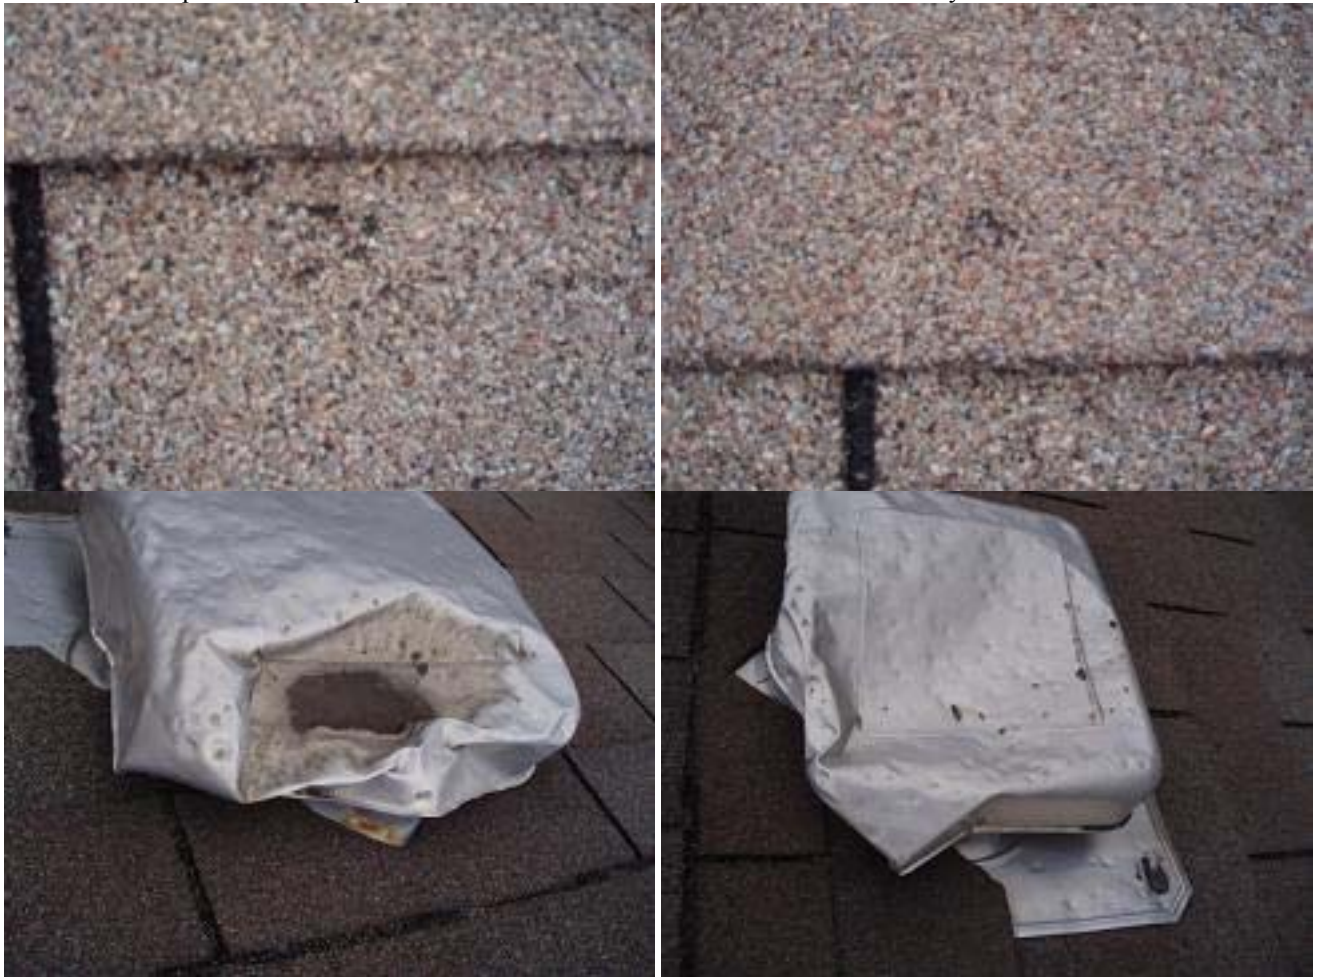
- **Repair:** Repairs to the roofing are needed – suspected storm damage was noted. Damaged or missing roofing material should be repaired. All roof penetrations should be examined and sealed as necessary.

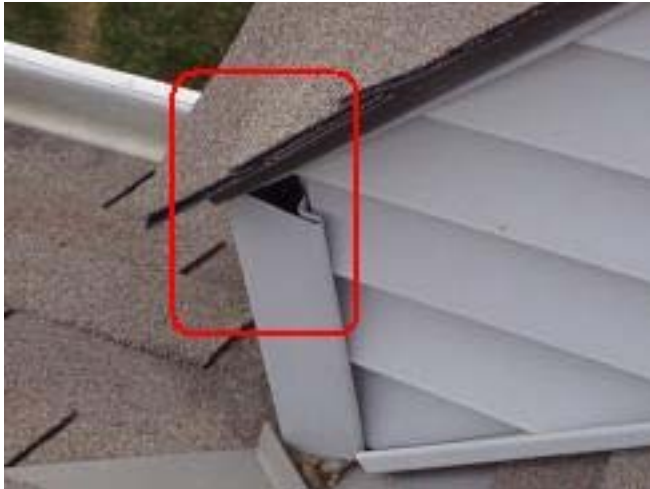
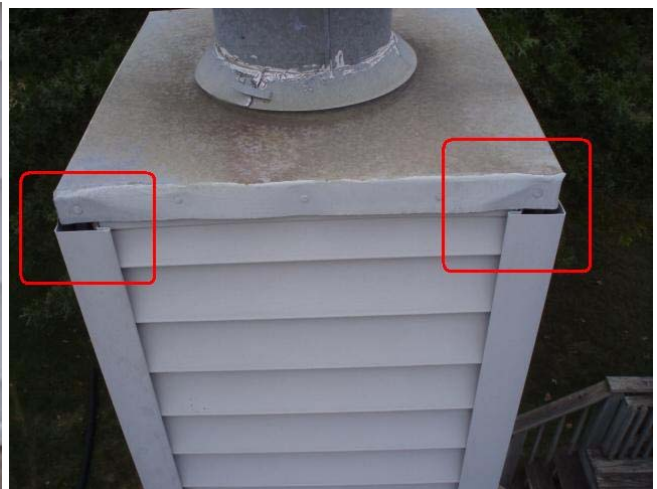
- **Repair:** The vertical trim work on the chimney chase needs to be better sealed at the top to avoid moisture entry and subsequent damage.

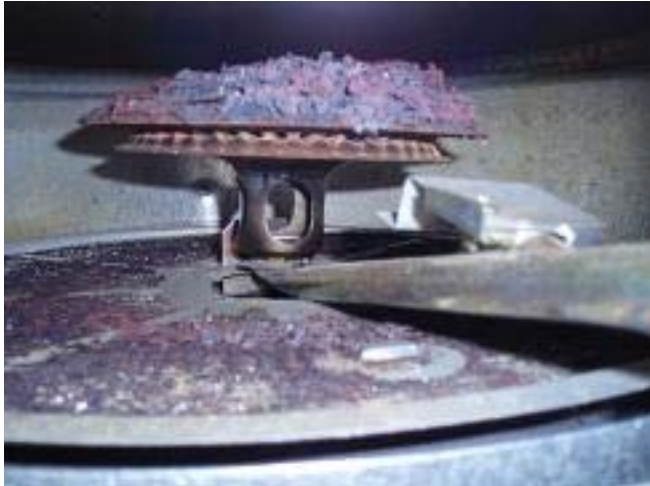
- **Repair:** The water heater burner is dirty. It should be cleaned and adjusted.

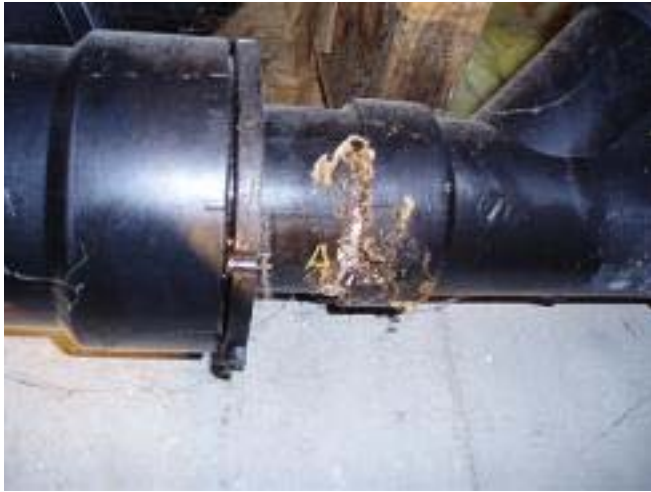
- **Repair:** The trap is leaking in the piping above the sump pump.
