**Star
Home
Inspection Services**

Home Inspection Report

119 SE Crestwood St, Lees Summit, MO 64063

Inspection Date: 08/03/2009

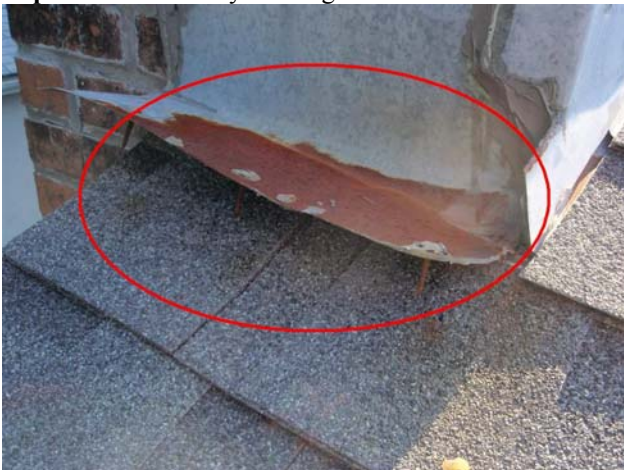
Flashings

- **Repair:** The chimney flashing is loose and should be re-secured to avoid leaks.

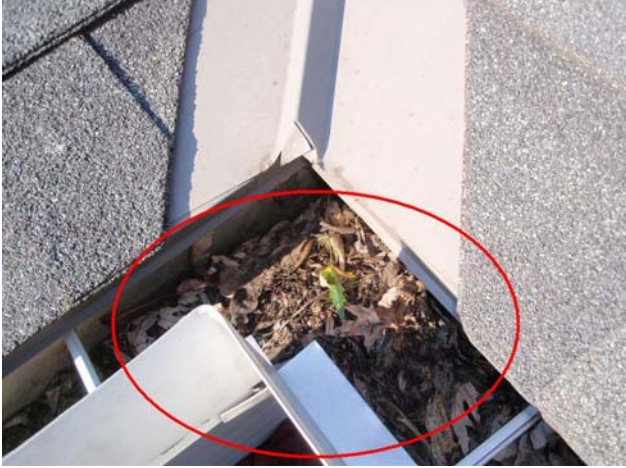
- **Repair:** The gutters require cleaning to avoid spilling roof runoff around the building – a potential source of water entry or water damage.
