Star Home Inspection Services

Home Inspection Report

11935 Charlotte St, Kansas City, MO 64146

Inspection Date: 05/15/2009

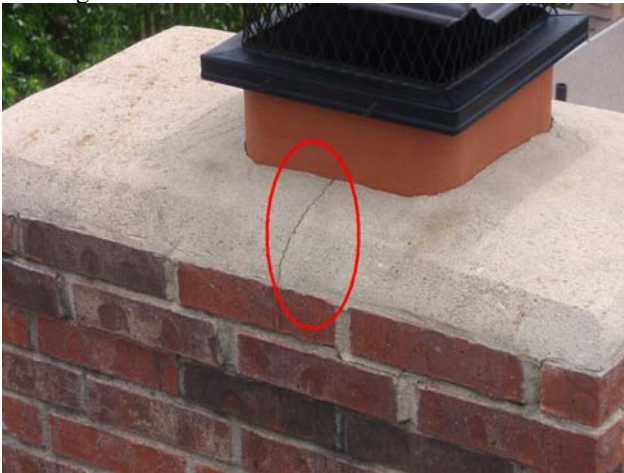
- **Repair:** The cap of the masonry chimney is cracked. These cracks should be sealed or caulked to prevent damage from freezing water.

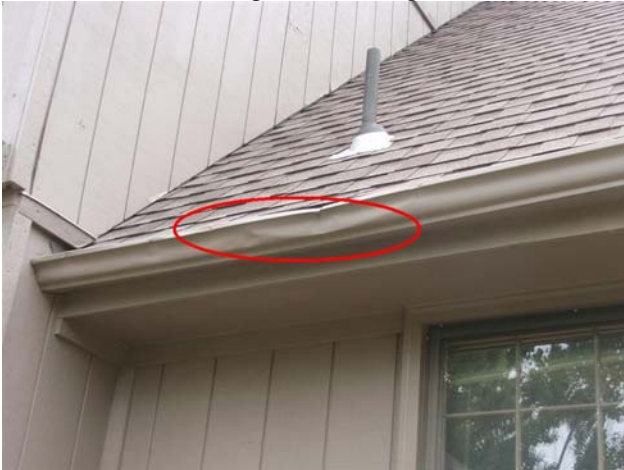
- **Monitor:** Minor damage to the back gutter was noted.

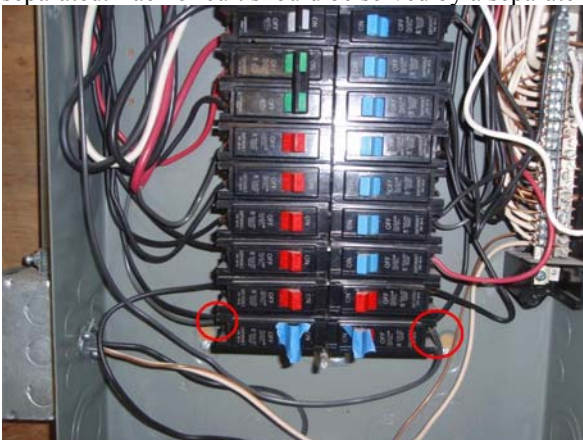
- **Repair:** Circuits within the main distribution panel that are doubled up (referred to as "double taps") should be separated. Each circuit should be served by a separate fuse or breaker.
