**Star
Home
Inspection Services**

Home Inspection Report

12081 S Troost St Olathe, KS 66061

Inspection Date: 02/12/2010

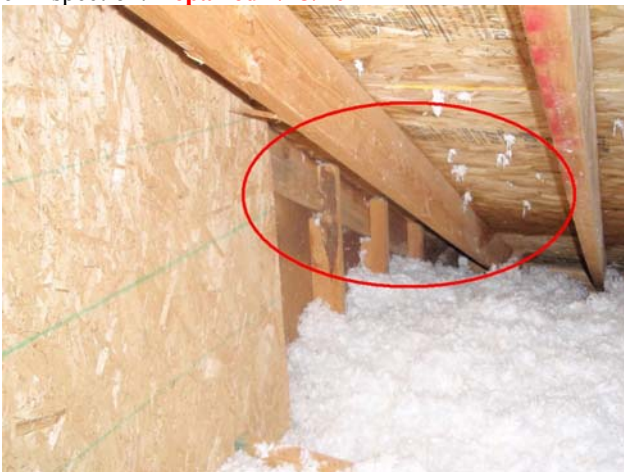
- **Monitor:** No roof sheathing clips were observed between the sheathing panels. This condition is fairly common and not unusual, although it is recommend this be investigated further when re-roofing
- **Repair:** Evidence of moisture was observed on the underside of the roof sheathing near the chimney siding. This can weaken the sheathing and ultimately necessitate replacement. Roof/Chimney flashing repairs were in progress at the time of inspection. **Repaired 2/13/10**

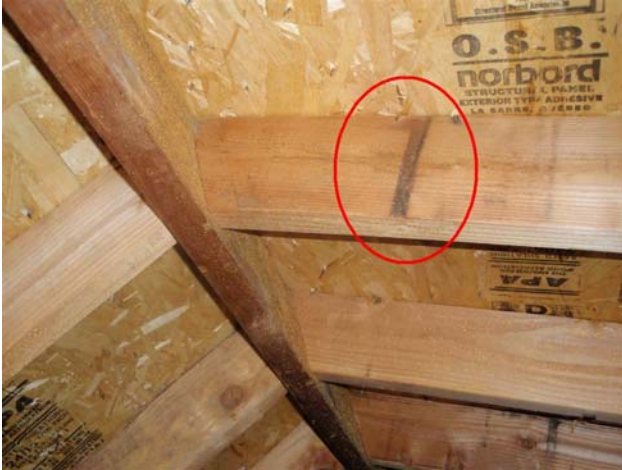
- **Monitor:** Construction mold was visible on some roof rafters. This is mold that grows on the lumber while lying in the weather during construction as evidenced by the strap marks. Most homes have some level of this mold and it goes dormant once removed from the elements and normally does not present any problems.

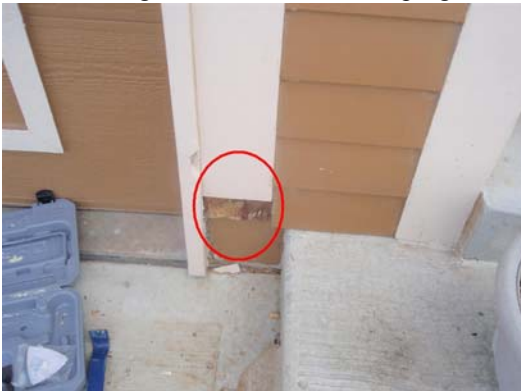
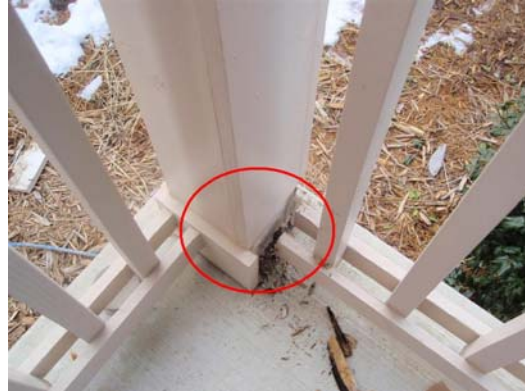
- **Repair:** The siding trim needs caulking improvements in localized areas to prevent water damage and rot. **Repaired 2/13/10**
- **Repair:** Localized rot/damage was observed in the trim around the siding (i.e. at southeast corner, near overhead door and at front porch rail trim). Following repair of the damaged areas (which should be combined with exterior painting/maintenance) proper maintenance of the siding and control of water from roof or surface runoff can avoid further damage. Renovations were in progress at the time of inspection. **Repaired 2/13/10**

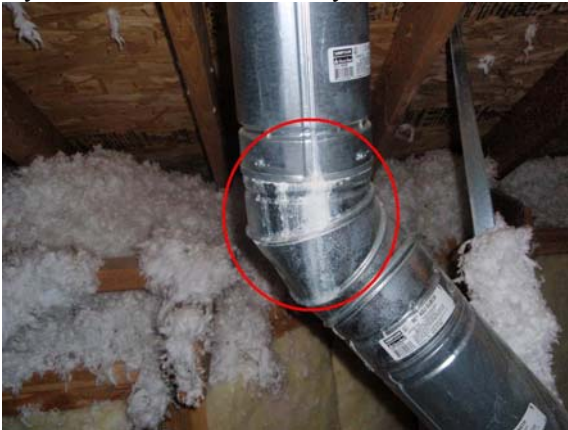
- **Monitor:** While in the attic water stains were observed on the lower sections of the furnace flue. The insulation below the elbow also showed signs of past moisture. It appears that rain blew in under the rain cap and came down the interior of the flue until it got to the first joint where it then transferred to the outside surface and dripped off the elbow. This is a common condition in 80% of homes but very seldom is enough to penetrate completely through the insulation to the drywall below. Monitor for any additional wetness after rains.
