**Star
Home
Inspection Services**

Home Inspection Report

12125 Hardy St, Overland Park, KS 66213

Inspection Date: 3/13/2009

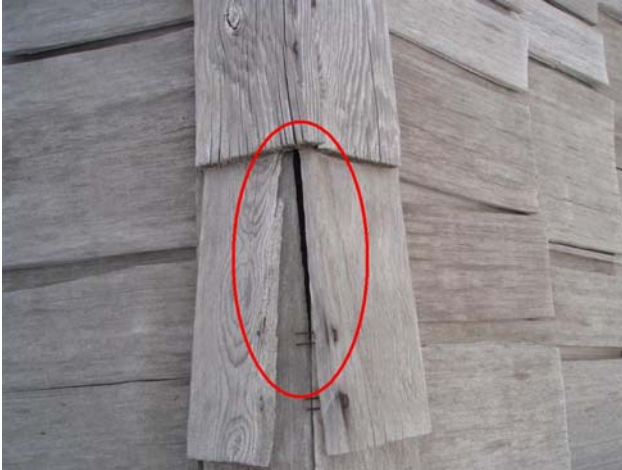
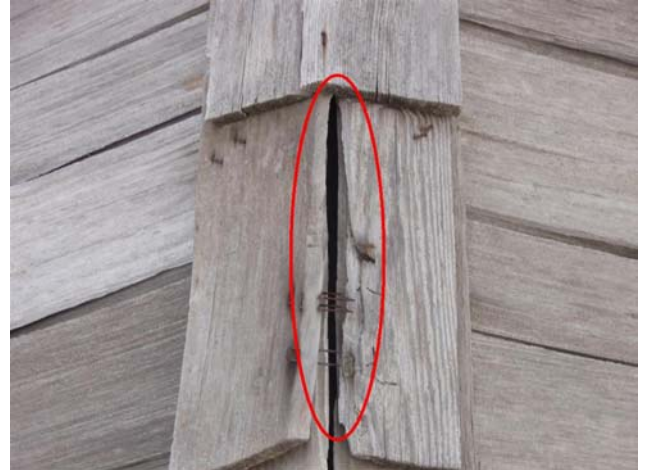
- **Repair:** Split, loose or damaged ridge caps of the roofing require repair. **Repaired**

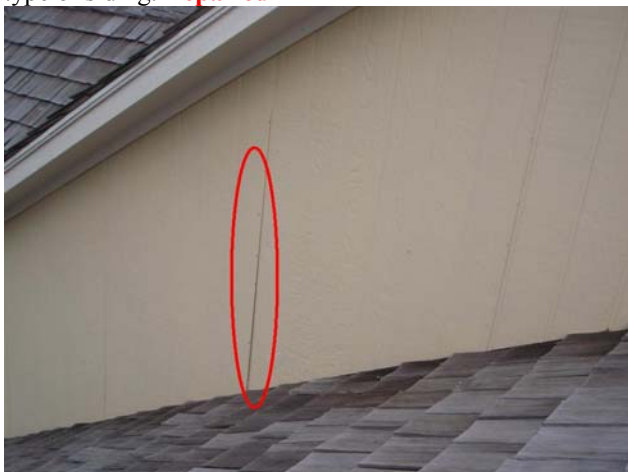
- **Repair:** The loose siding where the roof steps up over the front porch area should be re-secured to avoid water damage. Siding of this type requires considerable monitoring and maintenance. It has a tendency to pop out past nail heads creating a space where two panels join together. Re-securing and caulking these areas is standard maintenance for this type of siding. **Repaired**

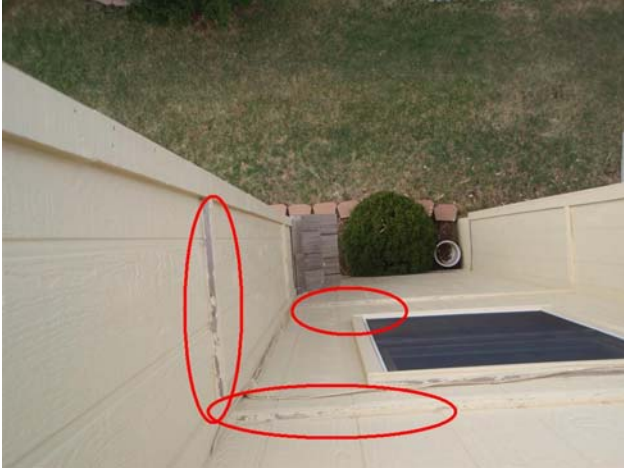
- **Repair:** The paint on the trim around the siding is peeling (examples at garage overhead door and top of siding trim). These areas should be painted to prevent water damage and rot. **Repaired**

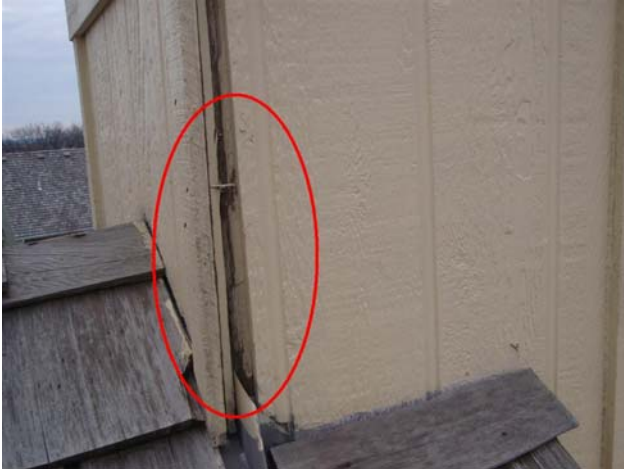
- **Repair:** The trim on the northwest corner of the chimney siding at the roof is missing. **Repaired**
