Star Home Inspection Services

Home Inspection Report

12263 Rosewood, Overland Park, KS 66209

Inspection Date: 11/17/2008

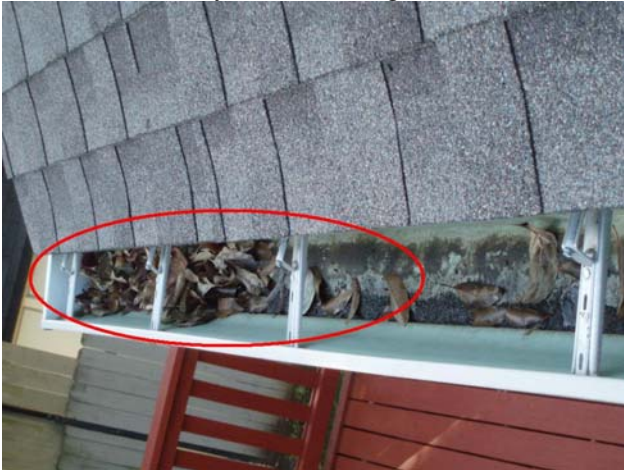
- **Repair:** The gutters (back south gutter) require cleaning to avoid spilling roof runoff around the building – a potential source of water entry or water damage.

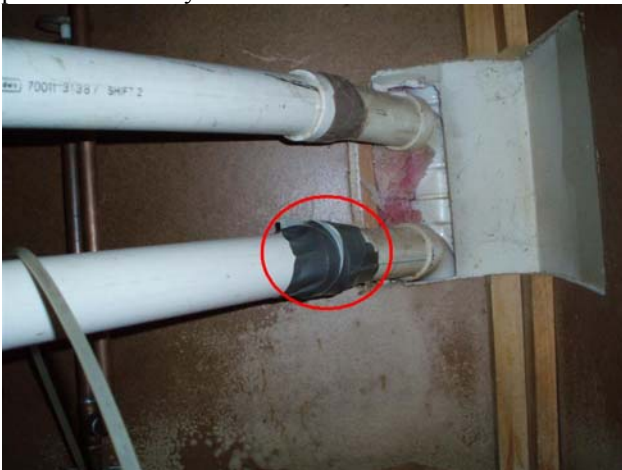
- **Repair:** The upstairs north right hand bathroom sink drain plug is inoperative and needs repair.
- **Monitor:** The kitchen sink drain pipe below sink was observed to have duct tape at piping connection, suggesting that a previous leak may have occurred.
