**Star
Home
Inspection Services**

Home Inspection Report

12532 Nieman Rd Overland Park, KS 66213

Inspection Date: 03/09/2010

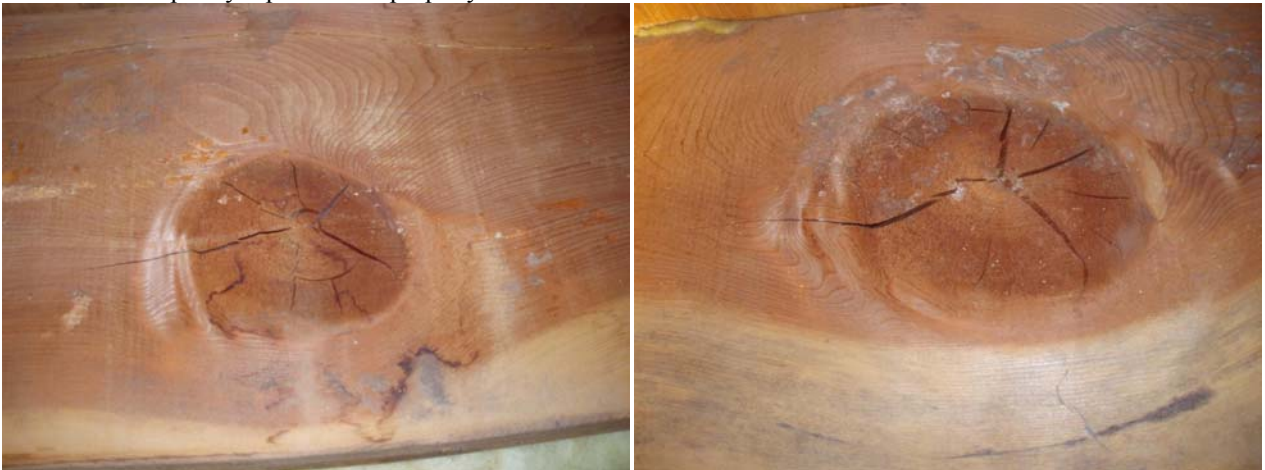
- **Monitor:** Floor joists are cracked. Cracked joists are repaired by replacement, “sister” joists along side, or additional support. Where one or very few damaged joists are found, this work is not high priority and can be combined with other structural or carpentry repairs at the property.

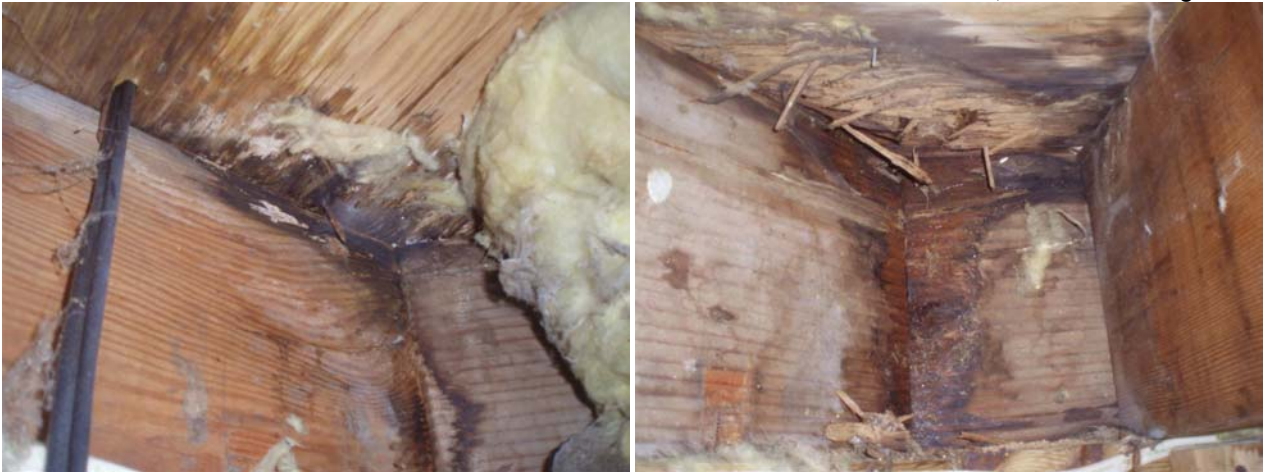
- **Monitor, Repair:** The floor structure shows evidence of minor rot at the front under the dining area windows. Rot weakens the structure and causes distress to the building. Damaged wood should be repaired or replaced and the conditions that have promoted the rot (such as wet conditions and/or poor ventilation) should be remedied.

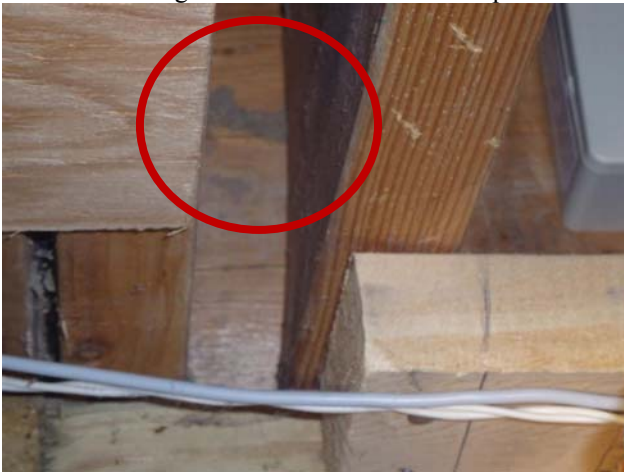
- **Monitor, Repair:** Evidence of termite activity was observed and there is risk of additional hidden damage. If the property has not already been treated, a licensed pest control specialist should be engaged. Termites can do a substantial amount of damage to the wood structural components of a home.

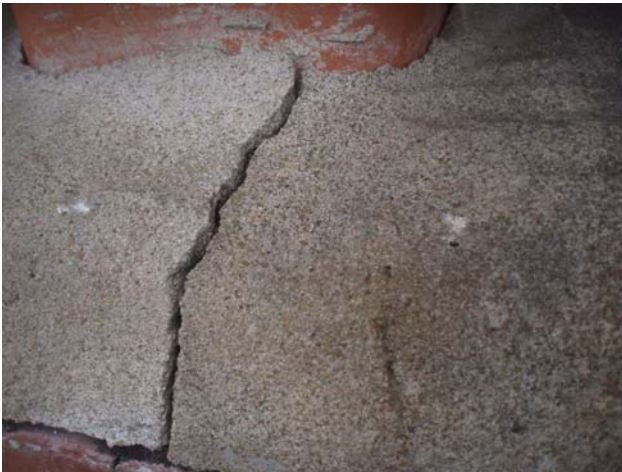
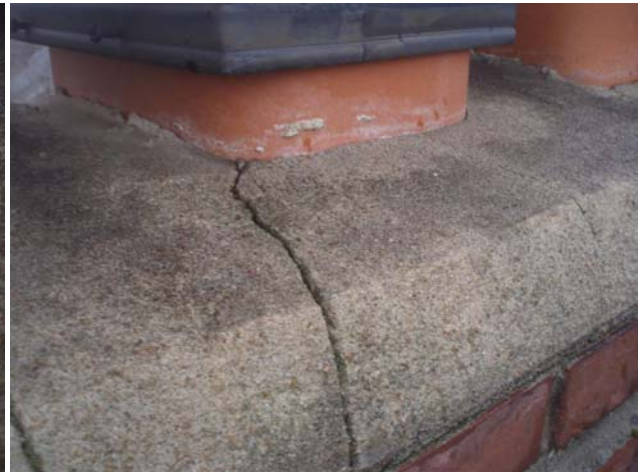
- **Repair:** The cap of the masonry chimney is cracked. These cracks should be sealed or caulked to prevent damage from freezing water.

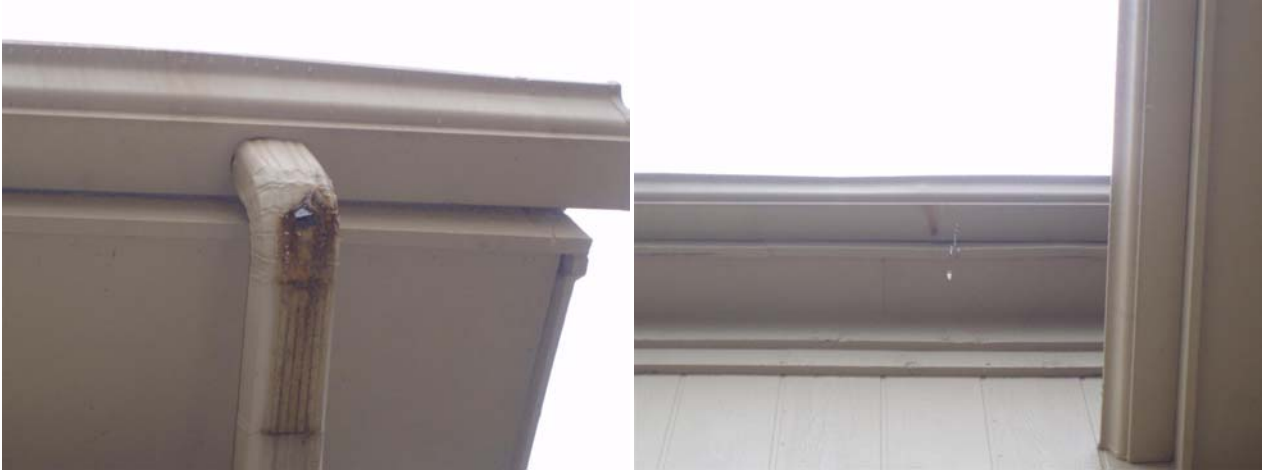
- **Repair:** The old galvanized gutters and downspouts are rusting noticeably. Replacement should be anticipated over the next few years. In the interim, leaks that develop should be repaired.

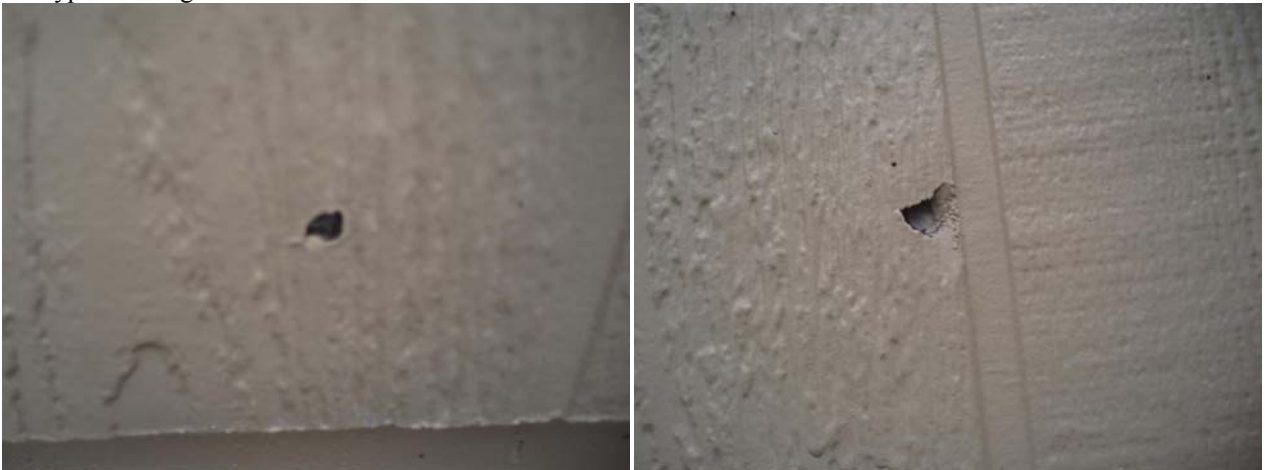
- **Monitor:** Siding of this type requires monitoring and maintenance. It has a tendency to pop out past nail heads creating a space where two panels join together. Re-securing and caulking the seams and nail holes is standard maintenance for this type of siding.

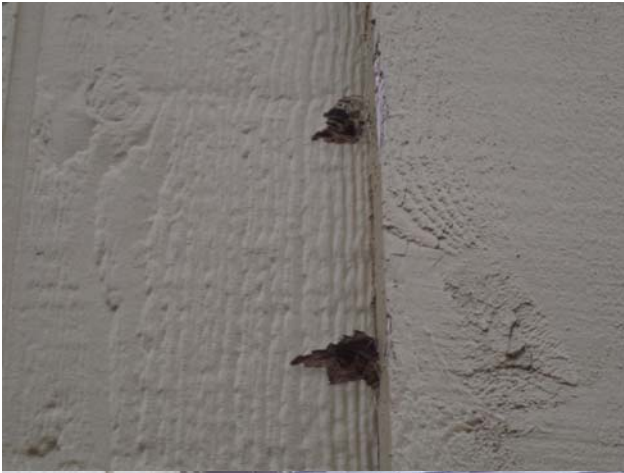
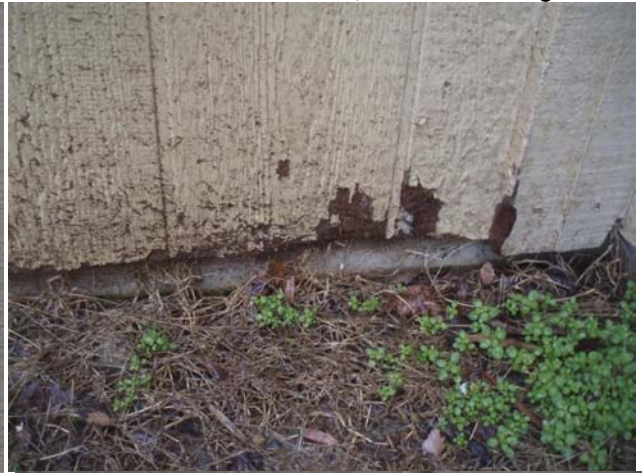
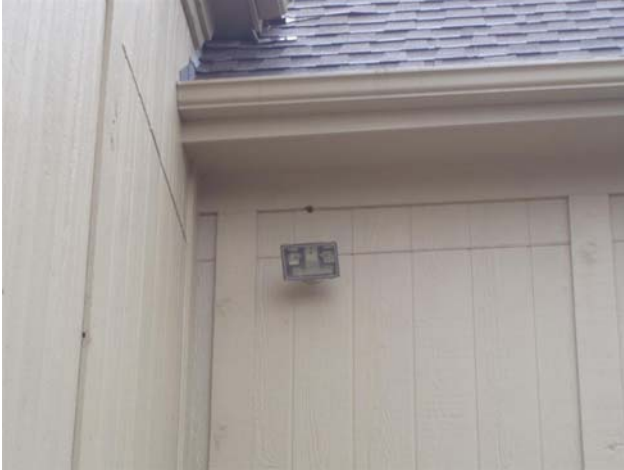
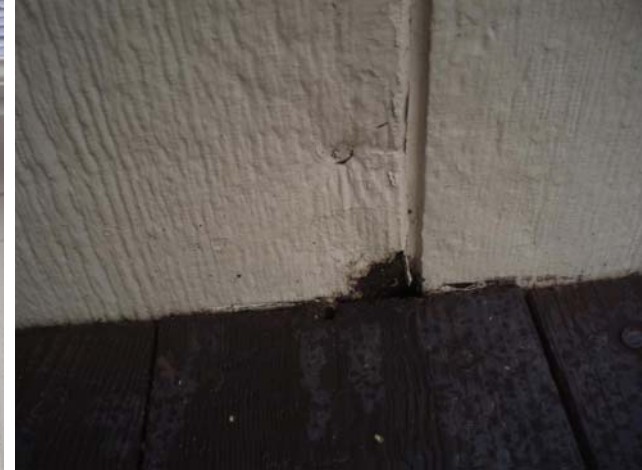
- **Repair:** Localized rot and damage was observed in the siding. Following repair of the damaged areas (which should be combined with exterior painting/maintenance) proper maintenance of the siding and control of water from roof or surface runoff can avoid further damage.

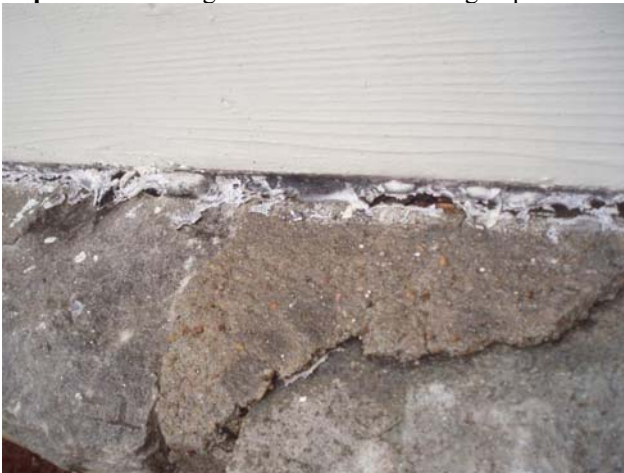
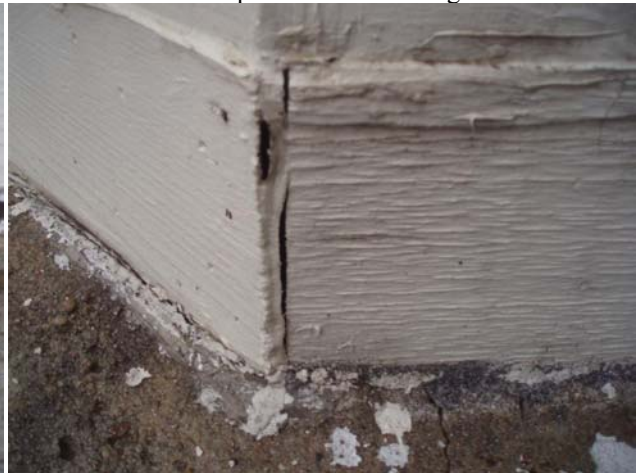
- **Repair:** The siding and trim needs caulking improvements in localized areas to prevent water damage and rot.

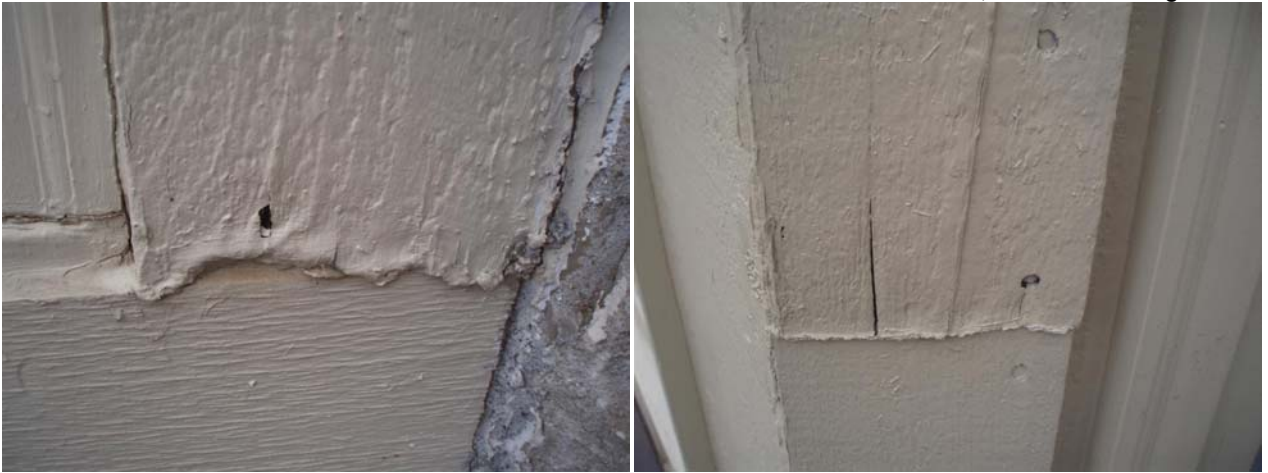
- **Repair:** The paint on the trim around the siding is peeling. These areas should be painted to prevent water damage and rot.
- **Repair:** Localized rot was observed in the trim around the siding. Following repair of the damaged areas (which should be combined with exterior painting/maintenance) proper maintenance of the siding and control of water from roof or surface runoff can avoid further damage.

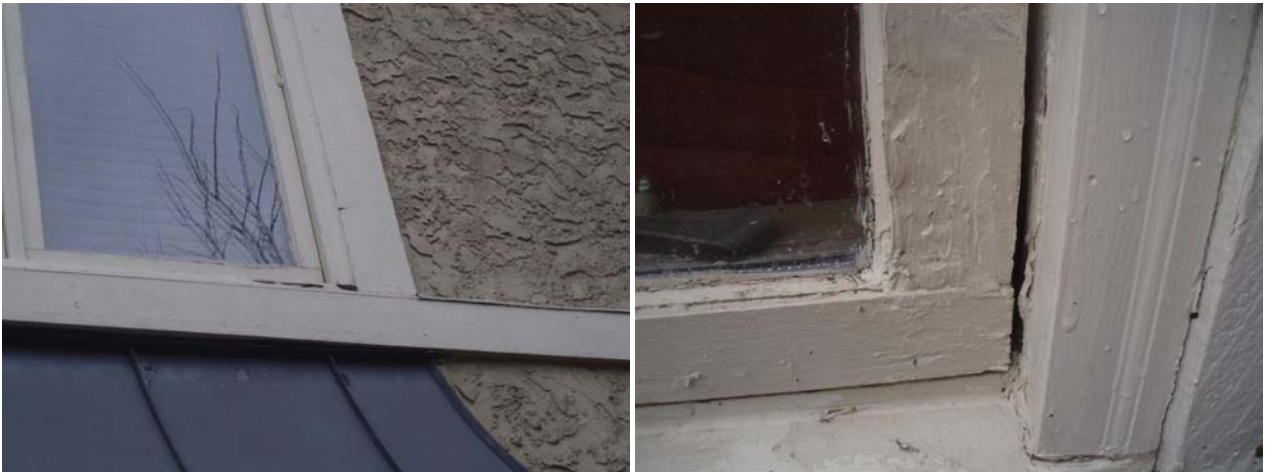
- **Repair:** Localized evidence of rot was visible on window trim/frame. Repair to the window frame can usually be accomplished by a skilled carpenter. It's recommended that a thorough "inventory" be taken by a competent window repair technician to ascertain exactly how many areas will need to be repaired or replaced. Further evaluation by a specialist may well identify additional areas that require servicing.

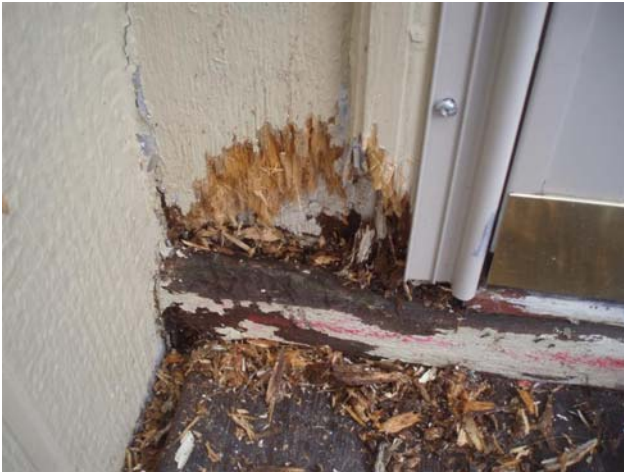
- **Repair:** Localized rot and damage was visible on the deck and basement walk out door trim/frames. Repair to the door trim and frame can usually be accomplished by a skilled carpenter. It's recommended that a thorough "inventory" be taken by a competent window/door repair technician to ascertain exactly how many areas will need to be repaired or replaced. Further evaluation by a specialist may well identify additional areas that require servicing.

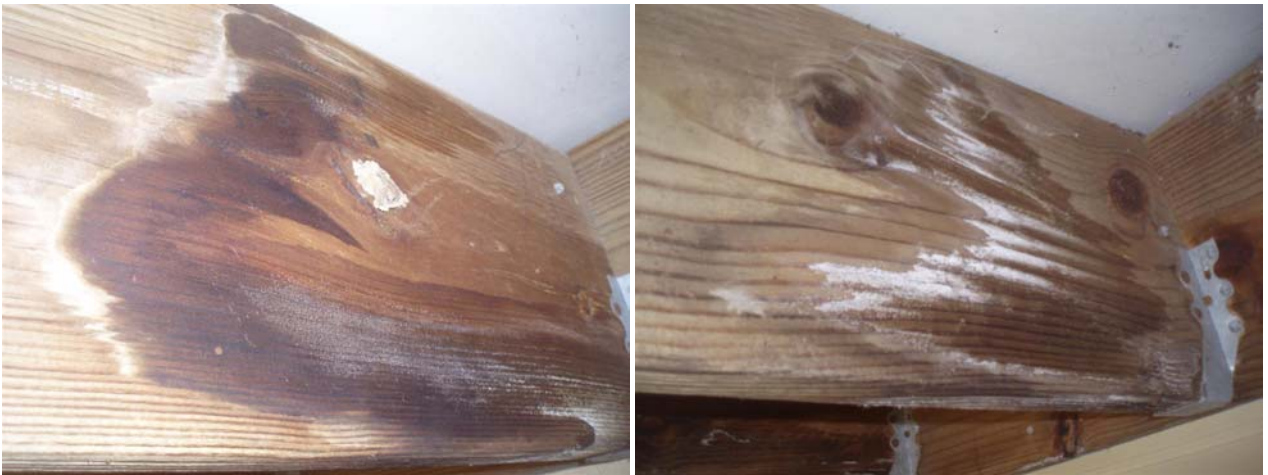
- **Monitor:** The deck shows evidence of rot. Replacement may eventually be desired. In the interim, localized repairs could be undertaken.

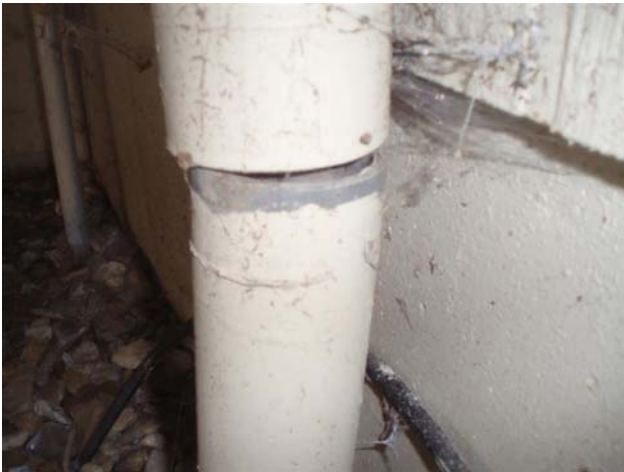
- **Repair:** The service conduit has pulled loose from the meter box due to soil settlement. Repair is needed.

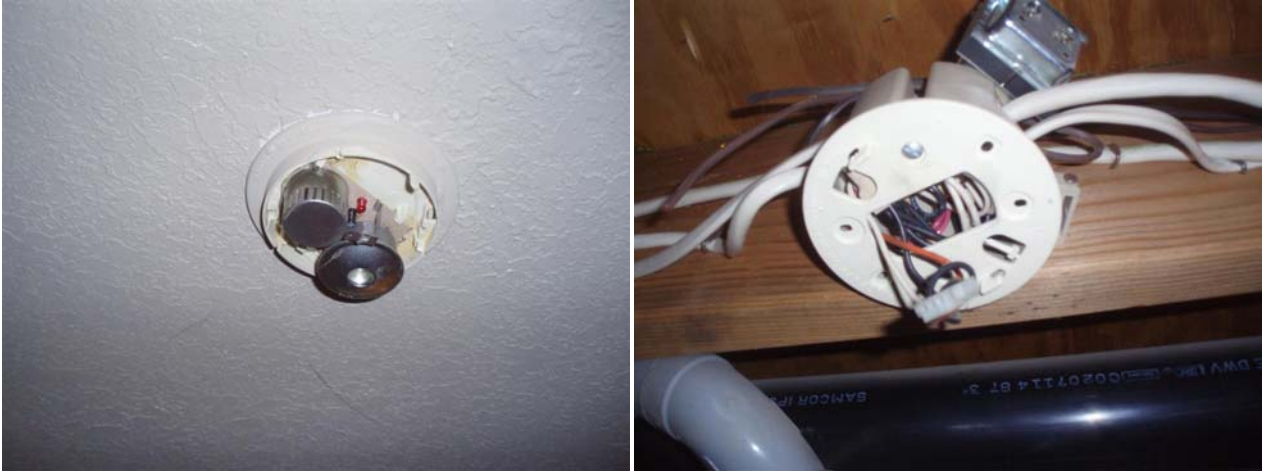
- **Repair, Safety Issue:** Missing smoke detector was observed in the basement unfinished area and the cover is missing in the upstairs hall.

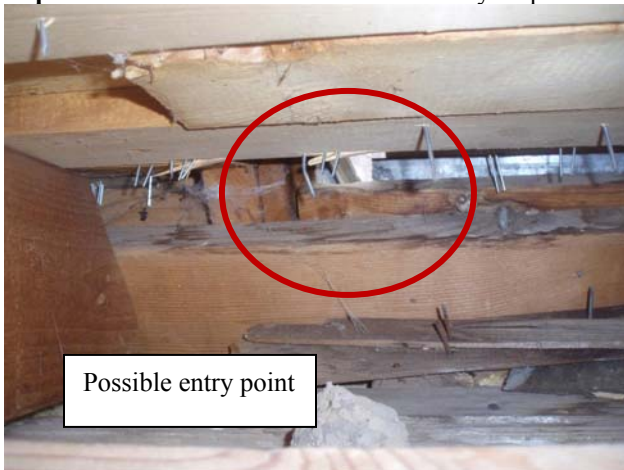
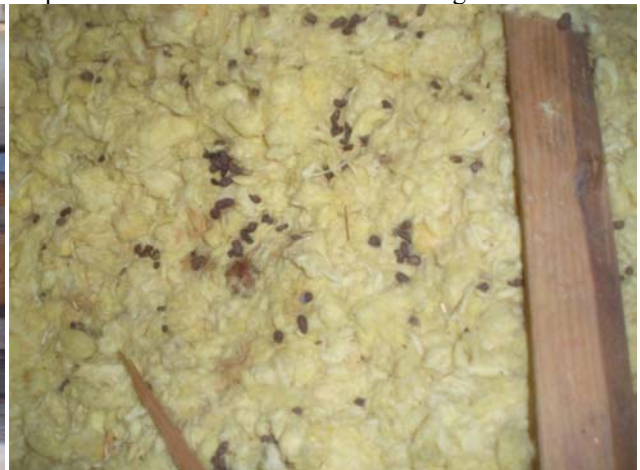
- **Repair:** There is evidence of vermin activity. A pest control specialist should be consulted in this regard.

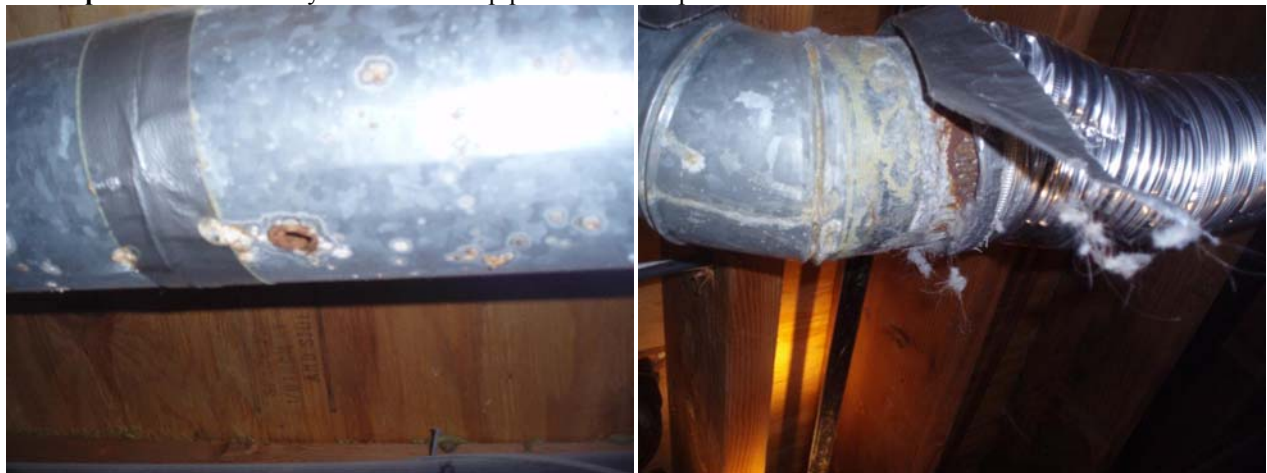
- **Repair:** The clothes dryer exhaust vent pipe should be improved.
