**Star
Home
Inspection Services**

Home Inspection Report

12605 Bradshaw St Overland Park, KS 66213

Inspection Date: 08/11/2010

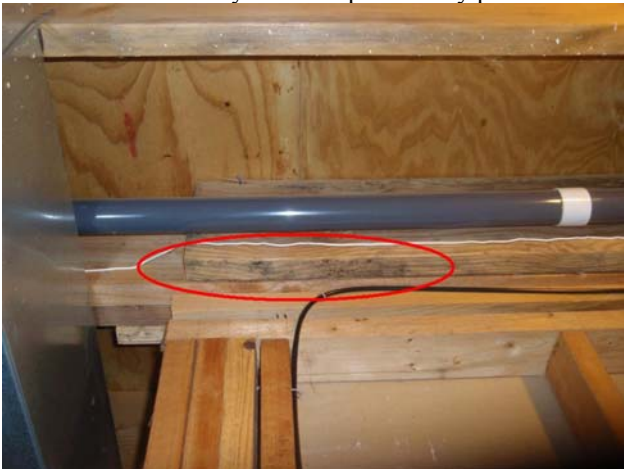
- **Monitor:** Construction mold was visible on some floor joists. This is mold that grows on the lumber while lying in the weather during construction. Most homes have some level of this mold and it goes dormant once removed from the elements and normally does not present any problems.

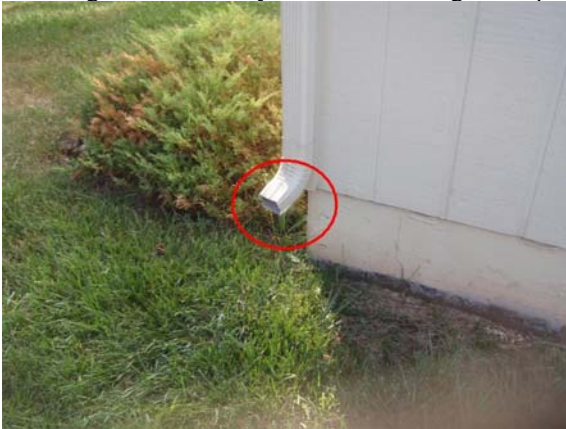
- **Repair:** The downspout(s) should discharge water at least five (5) feet from the house. Storm water should be encouraged to flow away from the building at the point of discharge.

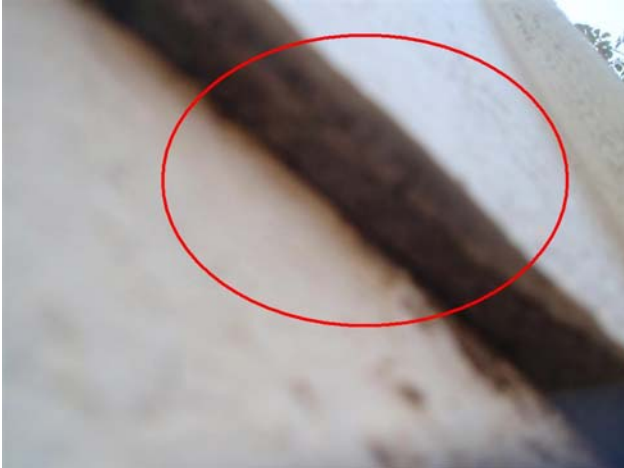
- **Repair:** The exterior siding paint is peeling and/or worn thin in localized areas (i.e. bottom edge of siding.) These areas should be painted to prevent water damage or rot in the future.

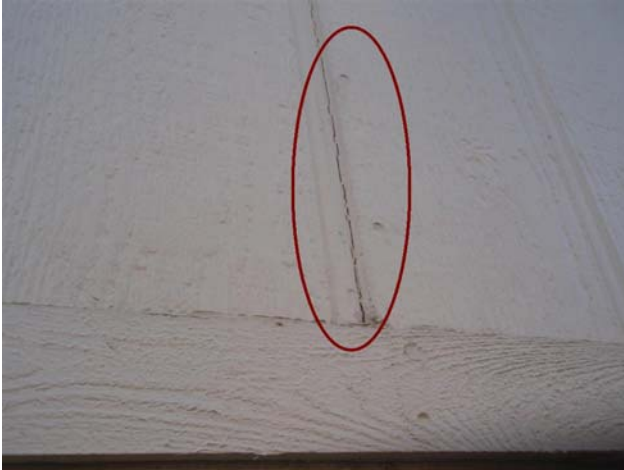
- **Repair:** Siding of this type requires considerable monitoring and maintenance. It has a tendency to pop out past nail heads creating a space where two panels join together. Re-securing and caulking the seams and nail holes is standard maintenance for this type of siding (i.e. west side.)

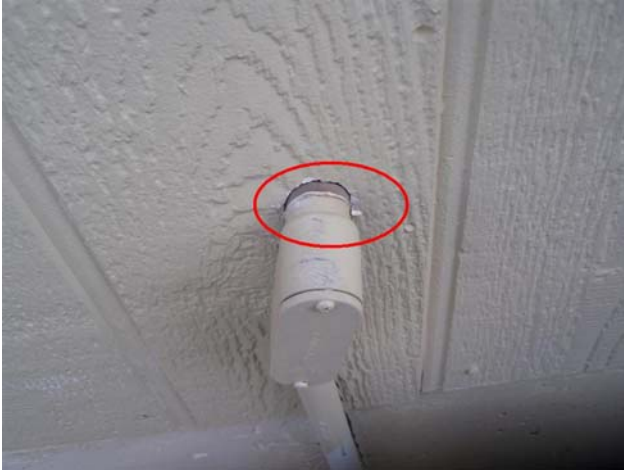
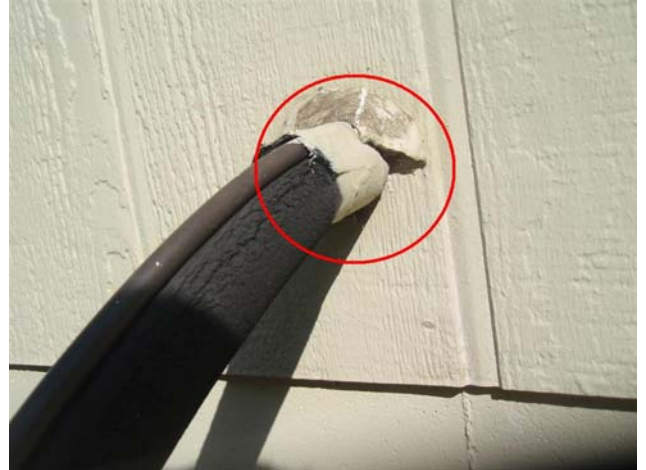
- **Repair:** Any openings in the exterior siding should be sealed. An example is where the air conditioner refrigerant lines and sprinkler system conduit enter the house. Caulking is needed.

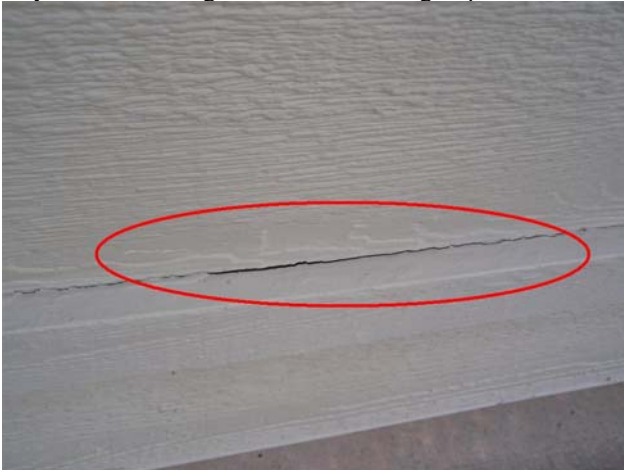
- **Repair:** The siding trim needs caulking improvements in localized areas to prevent water damage and rot.

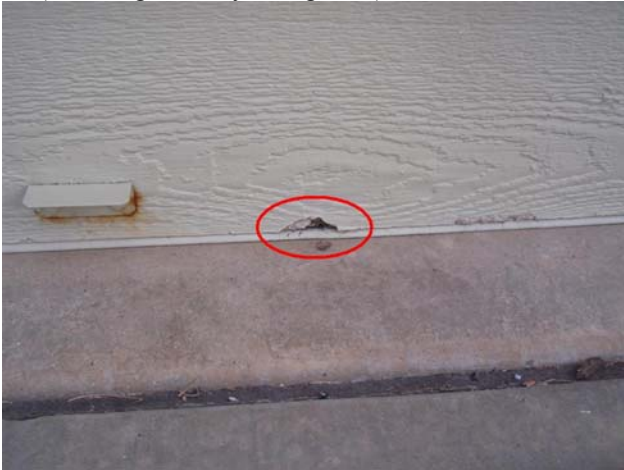
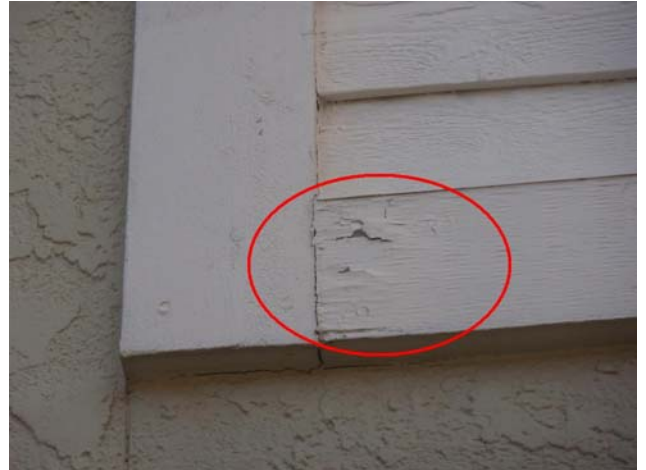
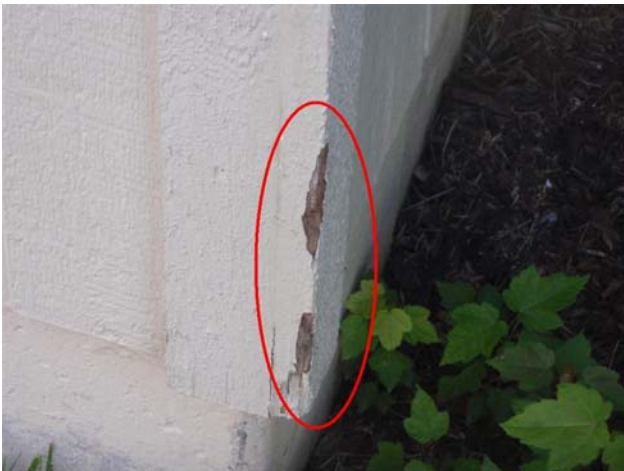
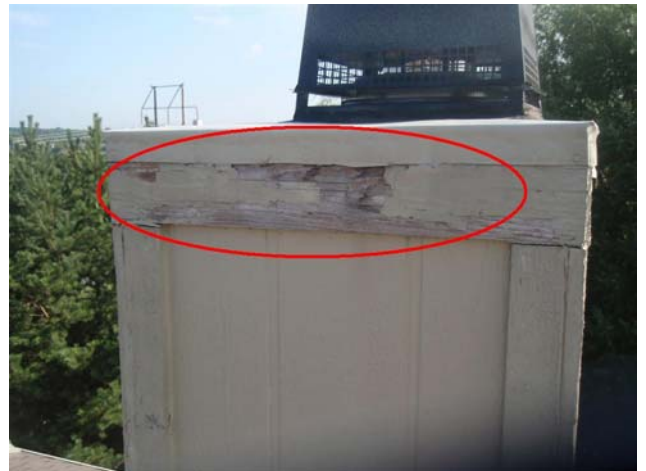
- **Repair:** The paint on the trim around the siding is peeling. These areas should be painted to prevent water damage and rot (including chimney siding trim.)

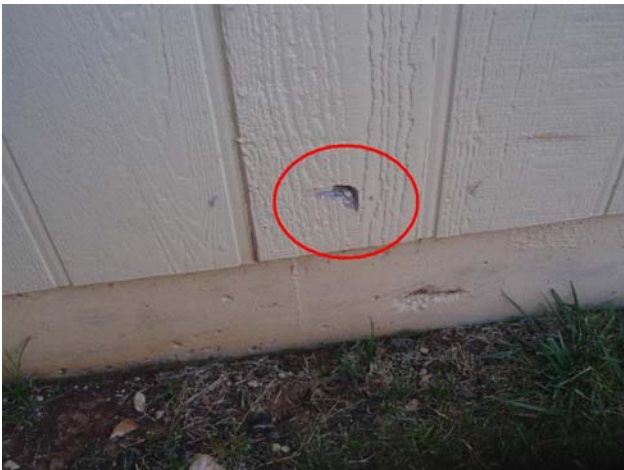
- **Repair:** Localized rot was observed in the trim around the siding (i.e. under front southwest window.) Following repair of the damaged areas (which should be combined with exterior painting/maintenance) proper maintenance of the siding and control of water from roof or surface runoff can avoid further damage.
- **Repair:** Localized damage of the siding should be repaired (i.e. west side.) There is extra risk of hidden damage in such areas.

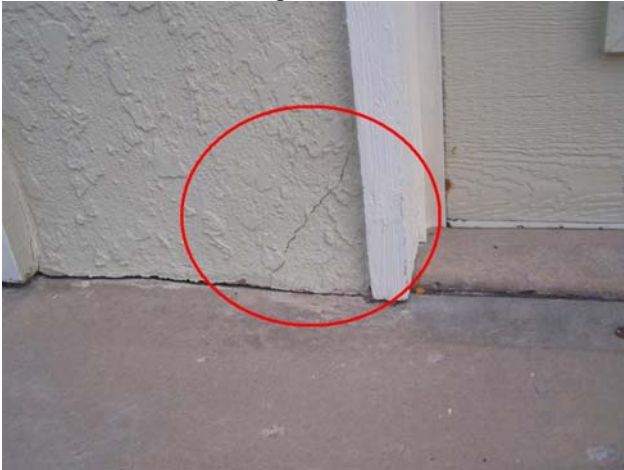
- **Repair:** Cracks were observed in the exterior walls. These areas should be repaired to prevent water intrusion. There is extra risk of hidden damage in such areas.

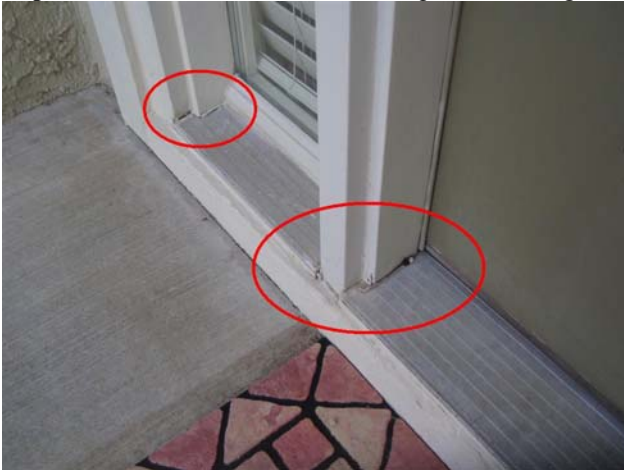
- **Repair:** The front door frame/ trim requires caulking.

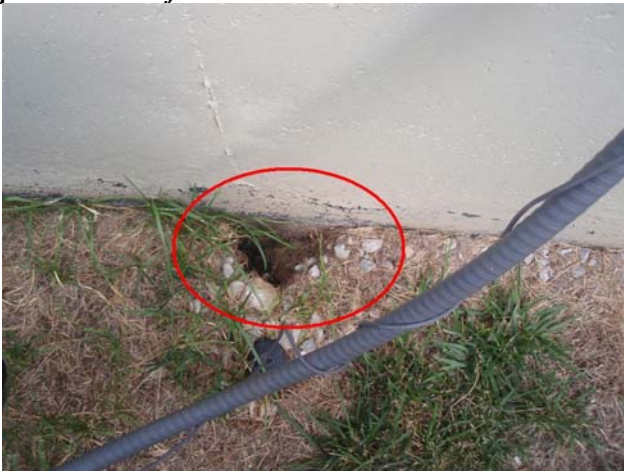
- **Repair:** The grading should be improved to promote the flow of storm water away from the house. This can often be accomplished by the addition of top soil. The ground should slope away from the house at a rate of one inch per foot for at least the first five feet. At least eight (8) inches of clearance should be maintained between soil level and the bottom of exterior wall siding. *It should be understood that it is impossible to predict whether moisture penetration will pose a problem in the future.*

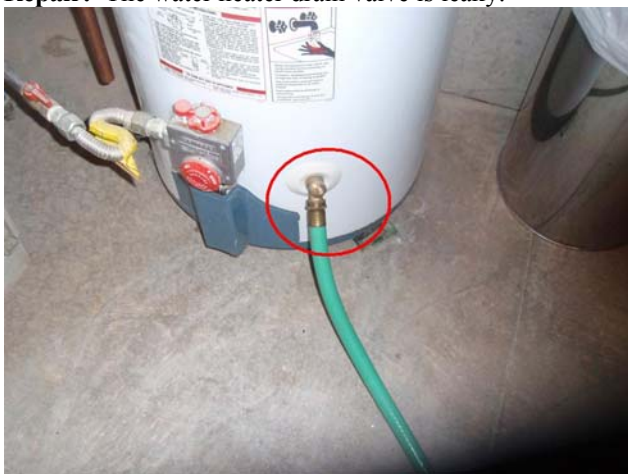
- **Monitor:** Water heaters have a typical life expectancy of 7 to 12 years. The existing unit is approaching or has exceeded this age range. One cannot predict with certainty when replacement will become necessary.
- **Repair:** The water heater drain valve is leaky.

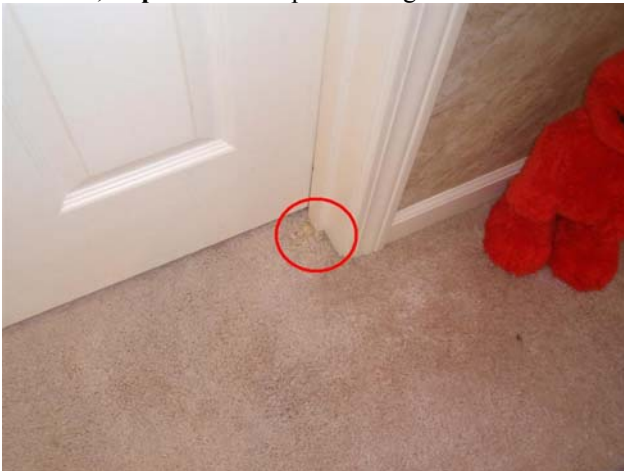
- **Monitor:** The carpet shows typical wear and/or minor soiled spots and stains.
- **Monitor, Repair:** The carpet flooring was observed to have damage at the corner of the closet door in the master bath.
