Star Home Inspection Services

Home Inspection Report

127 W 69th St, Kansas City, MO 64113

Report Number: 10312008-1A

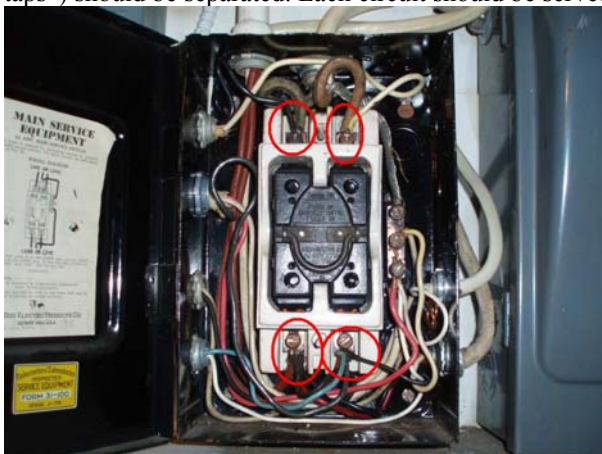
Main Panel

- **Repair:** The main distribution panel does not contain enough circuits to properly serve the home. A larger panel or an auxiliary would be desirable. Circuits within the main distribution panel that are doubled up (referred to as "double taps") should be separated. Each circuit should be served by a separate fuse or breaker.

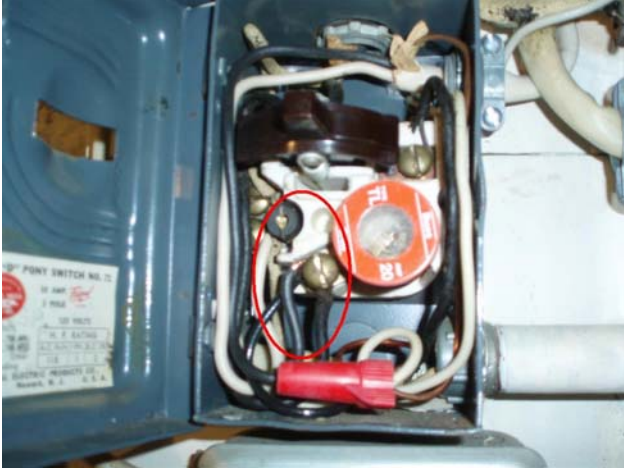
Auxiliary Panel(s)

- **Repair:** Circuits within the auxiliary panel that are doubled up (referred to as “double taps”) should be separated. Each circuit should be served by a separate fuse or breaker.

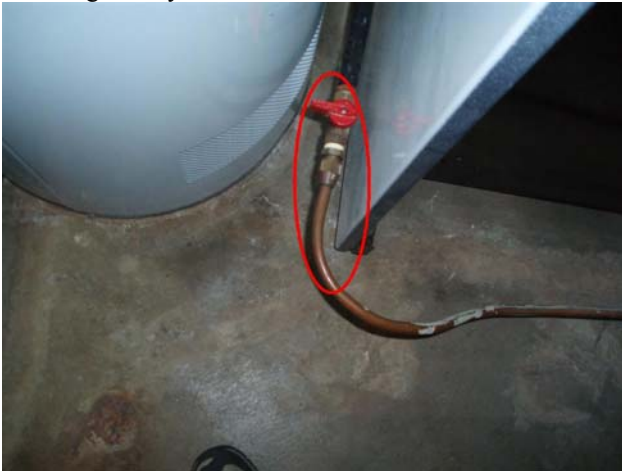
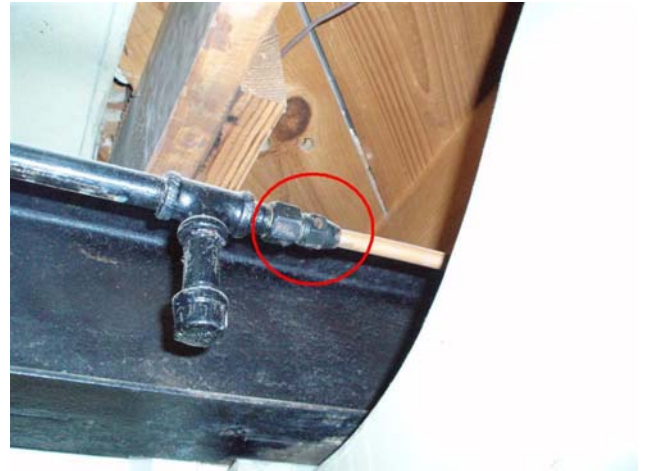
Gas Piping

- **Repair:** Copper tubing servicing the basement appliance and the main floor fireplace is no longer suitable for gas piping. It's recommended this pipe be replaced with one of suitable material. Aluminum tubing is normally unsuitable material also. It's recommended to check with the local utility company regarding the suitability of this material servicing the dryer.
