**Star  
Home  
Inspection Services**

*Home Inspection Report*

**12718 Maple St Overland Park, KS 66209**

**Inspection Date: 09/23/2010**

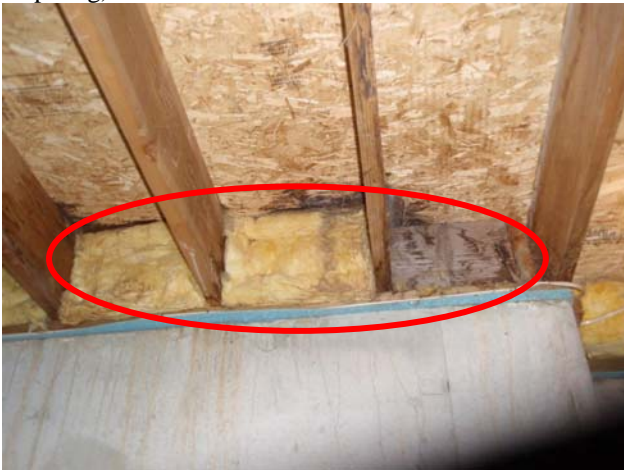
- **Monitor:** Water staining of the subflooring (supporting layer of flooring atop floor joists and below finish flooring or carpeting) was found at the northeast corner of the unfinished basement.

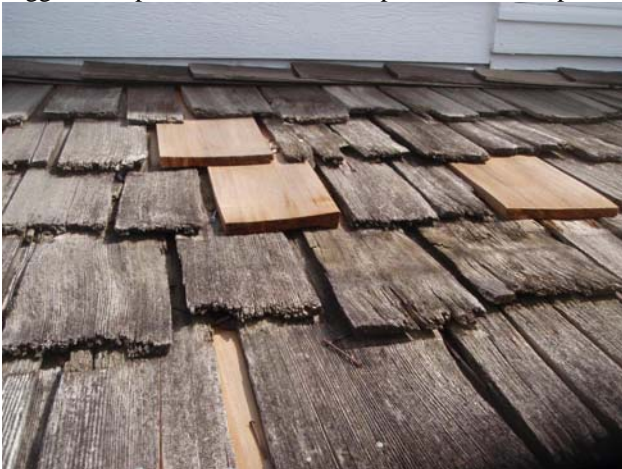
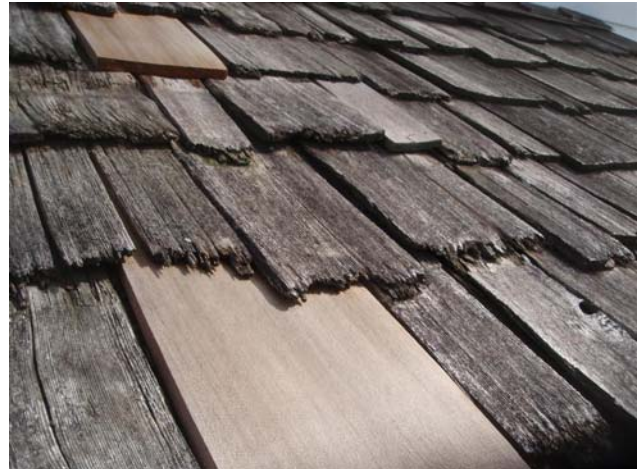
- Monitor:** The roofing is near the end of its life. Older roofs are, by their nature, a high maintenance roof. Annual inspection and repair should be anticipated. In addition, the older flashings should be monitored. In some cases, a deteriorated flashing can result in expensive repairs, because sections of the roofing have to be removed. As a rule of thumb, replacement of the entire roof covering may be logical if more than ten percent of the roof requires repair. The life expectancy of wood roofs is generally 15 to 20 years with tune-ups normally needed around the 10<sup>th</sup> year. This will depend on several factors such as the quality of shingle or shake, the slope of the roof (steeper is better), the amount of exposed shingle, and the amount of sun or shade. As with all roofs, annual maintenance is needed. Cracked, curled, or displaced shingles or shakes should be repaired. As a rule of thumb, replacement of the entire roof covering may be logical if more than ten percent of the wood roof requires repair. Prior repairs to the roofing are evident. This would suggest that problems have been experienced in the past. This area should be monitored.

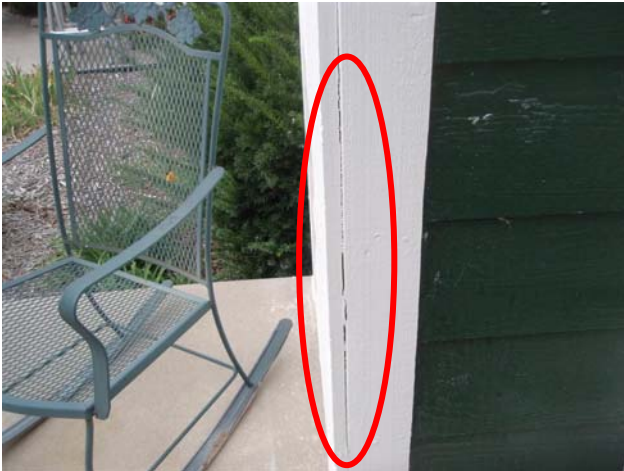
- **Repair:** The siding trim needs caulking improvements near the front porch siding to prevent water damage and rot.

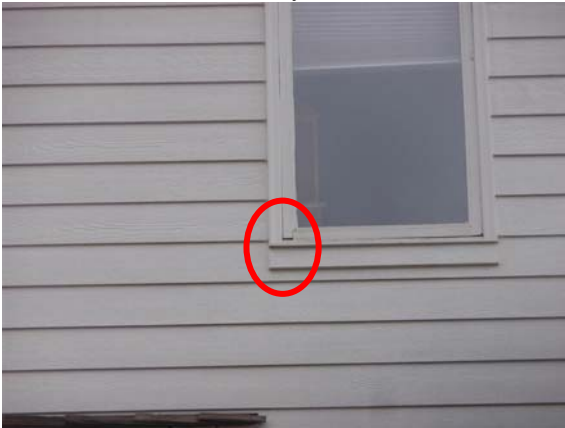
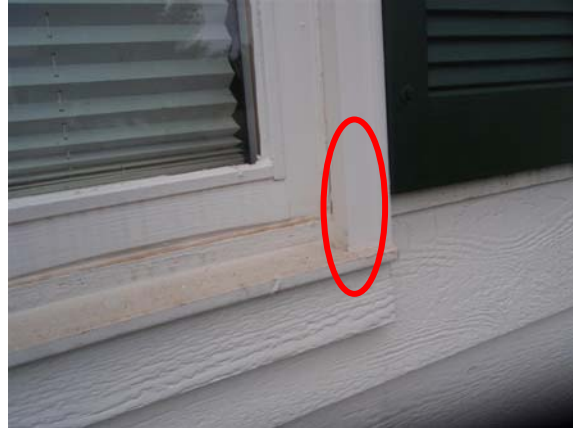
- **Improve:** Some of the windows require caulking improvement (i.e. second story front southeast, garage. northeast and northwest back second story windows.)

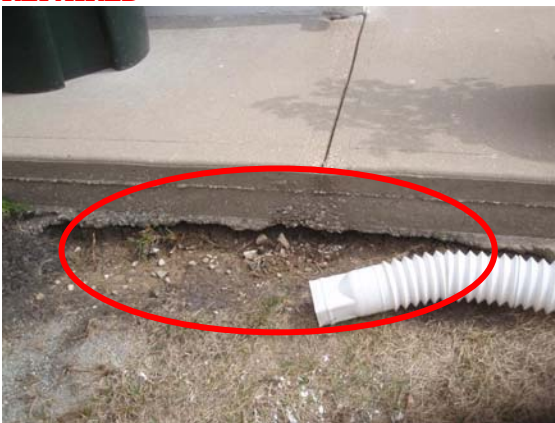
- **Recommend:** The grading should be improved to promote the flow of storm water away from the house (i.e. the void under the laundry room entry and garage side door patio should be filled.) This can often be accomplished by the addition of top soil. The ground should slope away from the house at a rate of one inch per foot for at least the first five feet. At least eight (8) inches of clearance should be maintained between soil level and the bottom of exterior wall siding. *It should be understood that it is impossible to predict whether moisture penetration will pose a problem in the future.* **REPAIRED**

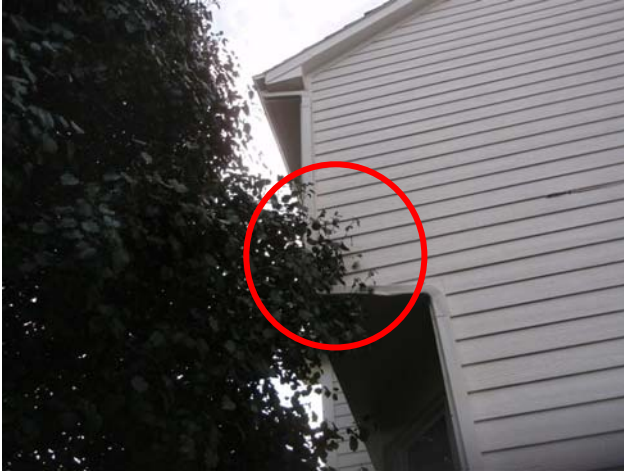
- **Repair:** Tree branches should be trimmed away from the house to avoid damage to the building. **REPAIRED**

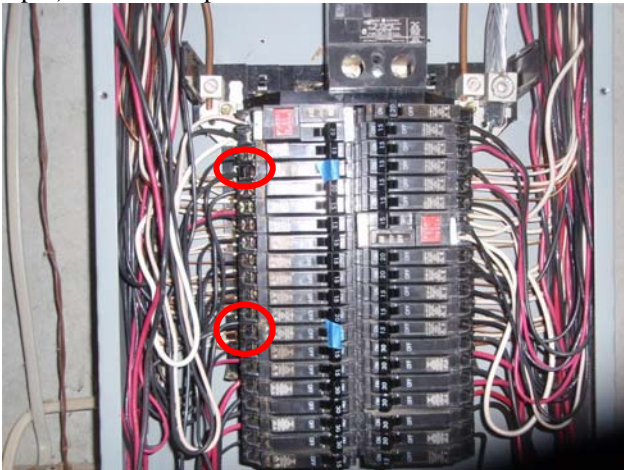
- **Repair:** Circuits within the main distribution panel (marked with blue tape) that are doubled up (referred to as "double taps") should be separated. Each circuit should be served by a separate fuse or breaker. **REPAIRED**

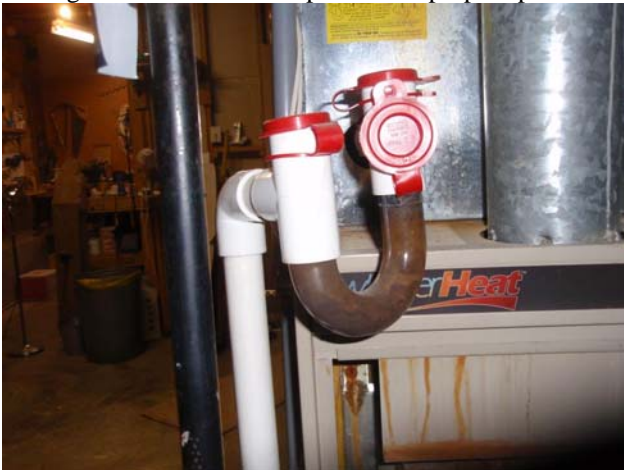
- **Repair:** The west heating system is inoperative and requires service. **REPAIRED**
- **Repair:** The condensate line leading from the west furnace appears dirty and needs to be cleaned to avoid blockage, leaking into the furnace and possible improper operation of the equipment. **REPAIRED**

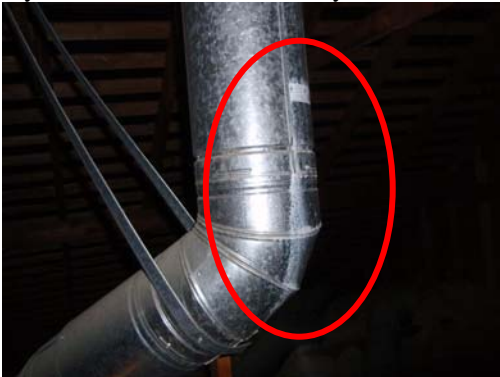
- **Monitor:** While in the attic water stains were observed on the lower sections of the furnace flue. The insulation below the elbow also showed signs of past moisture. It appears that rain blew in under the rain cap and came down the interior of the flue until it got to the first joint where it then transferred to the outside surface and dripped off the elbow. This is a common condition in 80% of homes but very seldom is enough to penetrate completely through the insulation to the drywall below. Monitor for any additional wetness after rains. **RAIN CAP RECENTLY REPLACED**

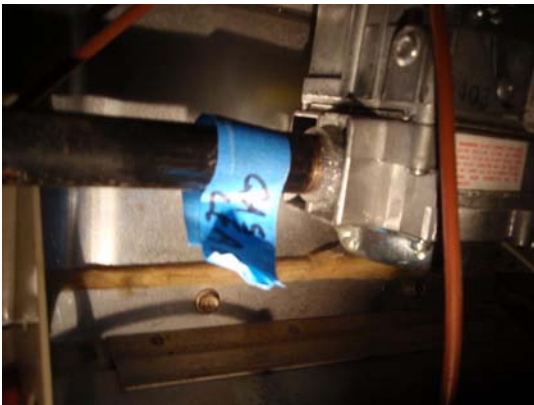
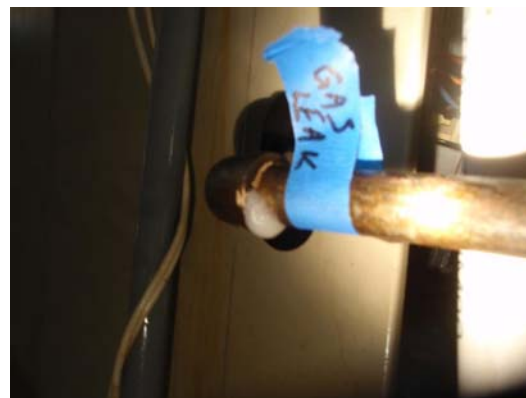
- **Repair, Safety Issue:** *Gas leaks were detected with a TIF 8800 gas/carbon monoxide detector and confirmed with soapy water (near the west furnace and inside the housing of the east furnace, marked "GAS LEAK" with blue tape.) This is a serious safety concern. It is recommended that the gas utility, HVAC company or plumber be engaged as soon as possible to make the necessary repairs. The current occupants of the home should also be notified.*

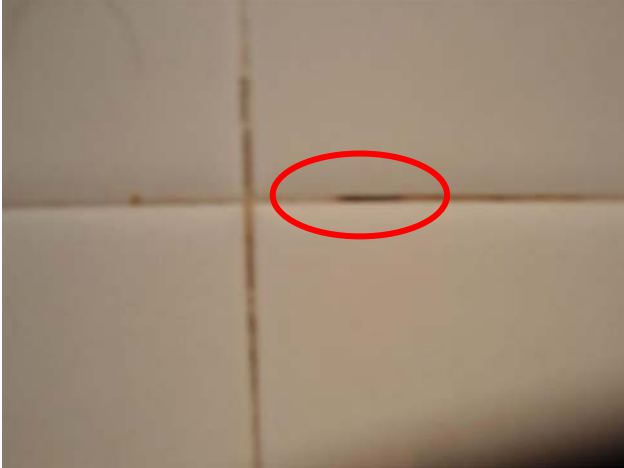
- **Monitor:** The family room bar counter and sink were observed to have surface wear.
- **Repair:** The sink drain plug is inoperative and needs repair (i.e. basement bath, northeast bedroom bath and southeast bedroom bath.) **REPAIRED**
- **Monitor:** The northeast bedroom bath sink was observed to drain slowly, suggesting that an obstruction may exist.
- **Repair:** The southeast bedroom bath shower head is leaky.
- **Improve:** Cracked, deteriorated and/or missing master bath shower stall grout should be replaced.

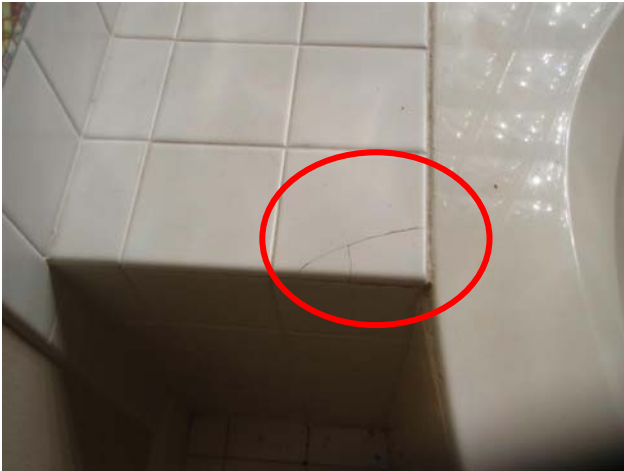
- **Improve:** Cracked, deteriorated and/or missing basement bath sink side splash and basement bath tile floor caulk at the cabinets should be replaced.
- **Improve:** Cracked, deteriorated and/or missing southeast bedroom bath shower enclosure caulk could be improved.
- **Monitor:** Cracked tile was observed near the master bath whirlpool tub.

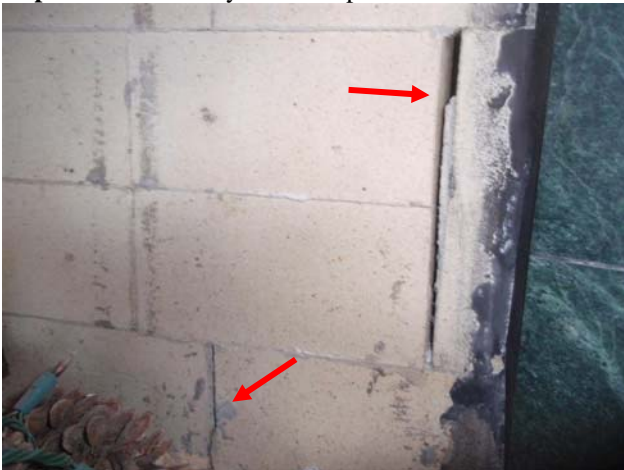
- **Improve:** The family room fireplace firebox side wall mortar should be improved. **REPAIRED**
