Star Home Inspection Services

Home Inspection Report

12919 W 100th St, Lenexa, KS 66213

Inspection Date: 3/27/2009

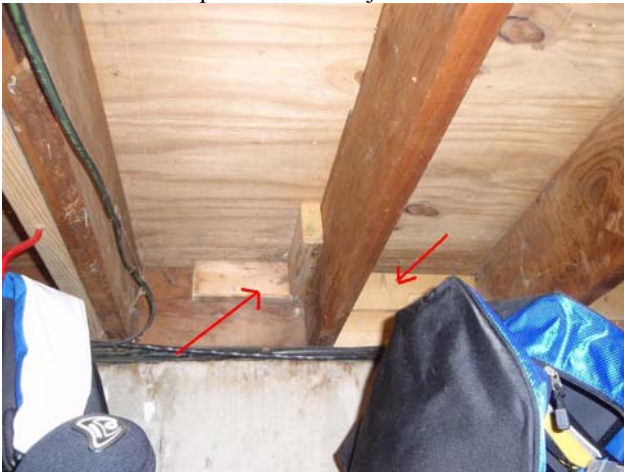
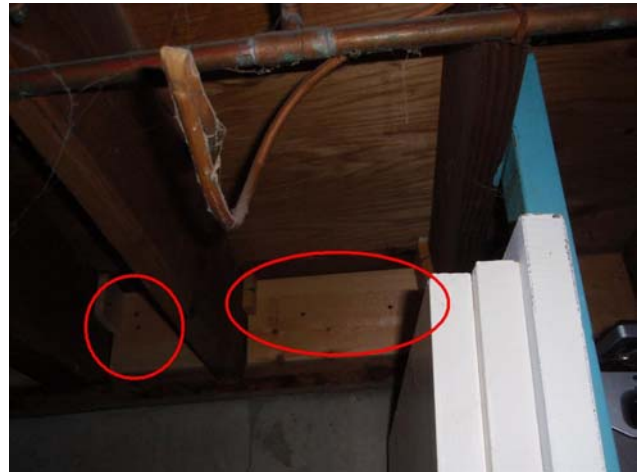
- **Monitor:** Prior repairs to the rim joists at the back and front of the basement were noted.

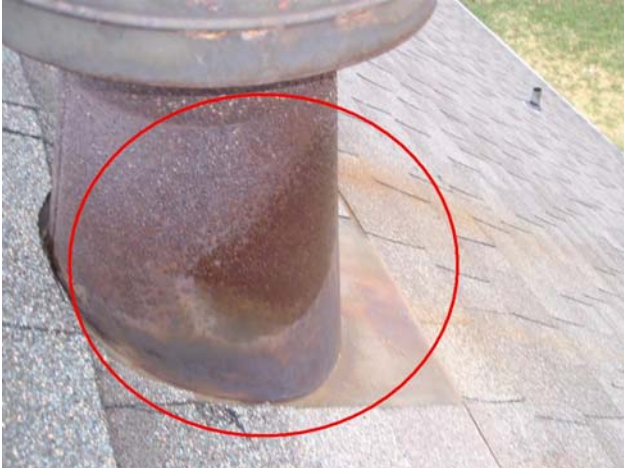
- **Improve:** The furnace vent flashing is rusting. It should be painted to extend its life.

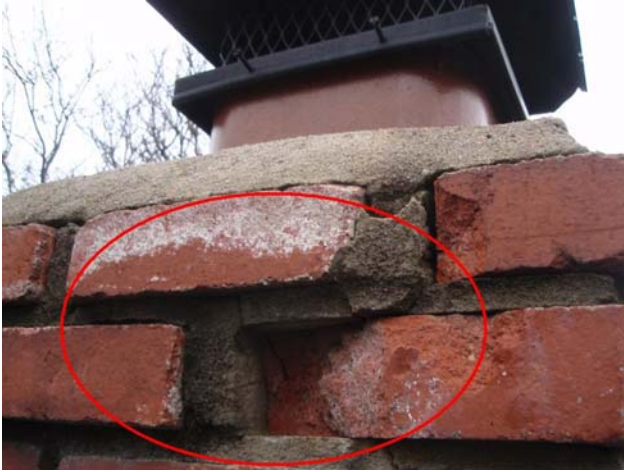
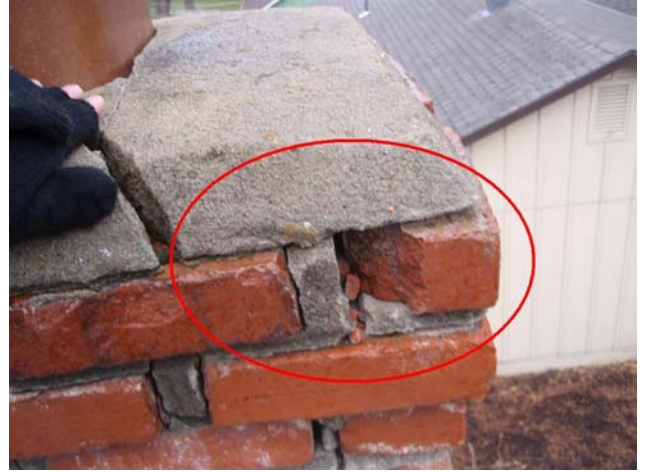
- **Repair:** The masonry chimney shows evidence of substantial spalling (surface deterioration of the masonry). Rebuilding of this chimney is needed.

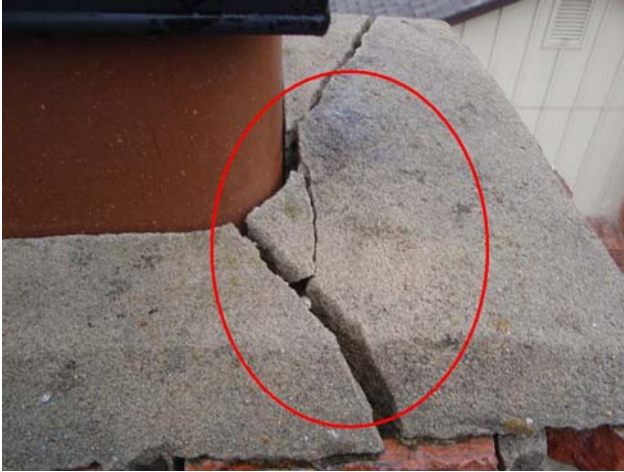
- **Repair:** The cap of the masonry chimney should be repaired/replaced and the chimney flue should be checked for damage. Damaged flues can be unsafe.

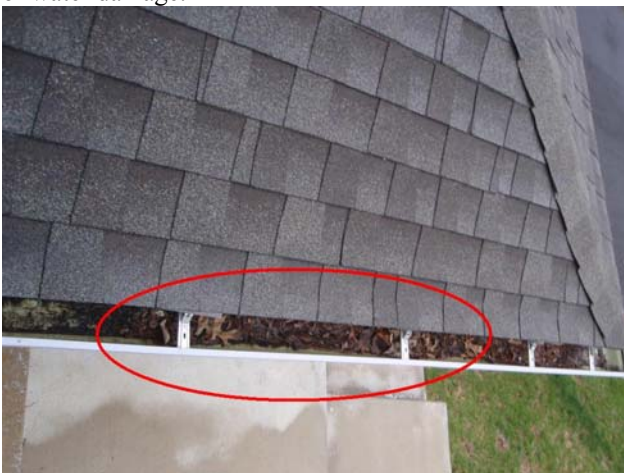
- **Repair:** The gutters require cleaning to avoid spilling roof runoff around the building – a potential source of water entry or water damage.

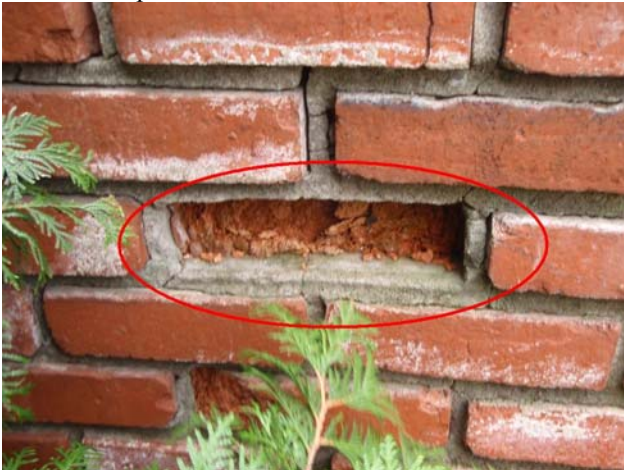
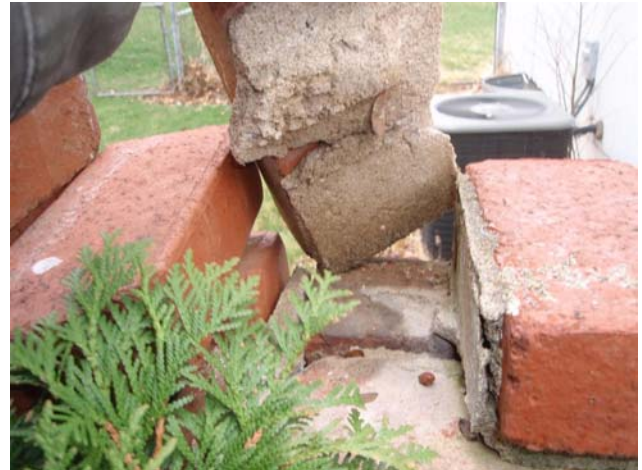
- **Repair:** The masonry exterior wall shows evidence of spalling (surface deterioration of the masonry). Repairs are needed at the east and west sides. Localized pointing of deteriorated mortar between the bricks of the exterior walls is advisable to prevent further deterioration.

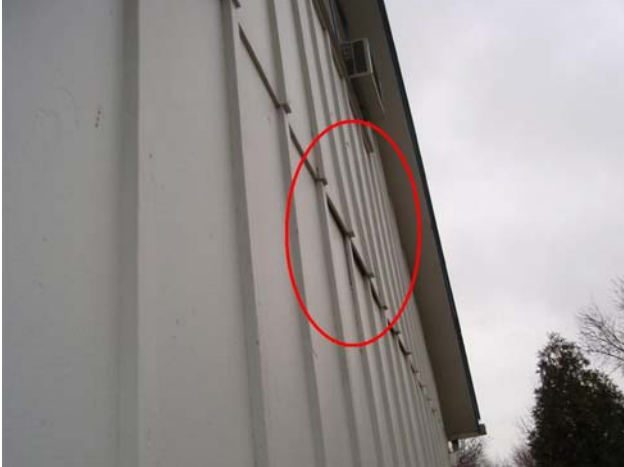
- **Repair:** The loose siding at the east side of the home should be re-secured to avoid more damage.

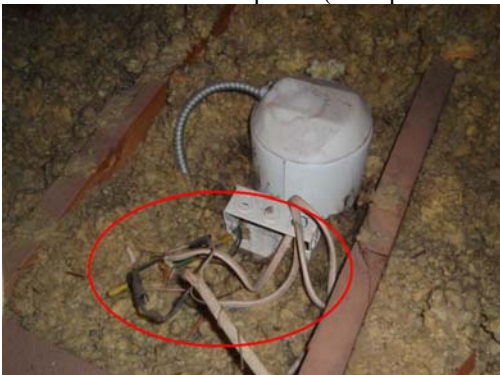
- **Repair:** Extension cords should not be used as permanent wiring. This wiring for the garage door openers should be removed and replaced with permanent wiring and an outlet(s).
- **Repair:** Improper electrical connections should be repaired. All electrical connections should be made inside junction boxes fitted with cover plates (example in attic).
