**Star
Home
Inspection Services**

Home Inspection Report

13004 Corrington Ave Grandview, MO 64030

Inspection Date: 10/14/2010

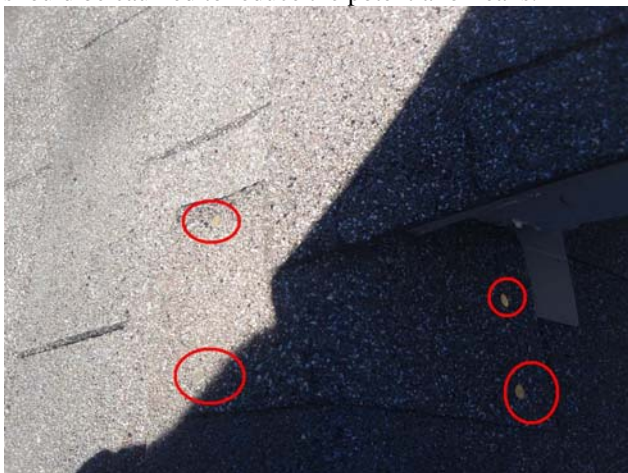
- **Recommend:** Exposed nail heads were observed in the roofing shingles and/or ridge caps. All exposed nail heads should be caulked to reduce the potential of leaks.

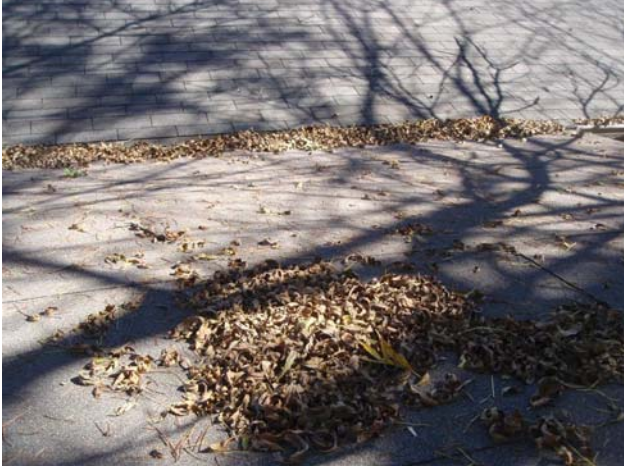
- **Improve:** Debris should be removed from the back patio cover rolled roofing to reduce risk of leaks and early roof wear.

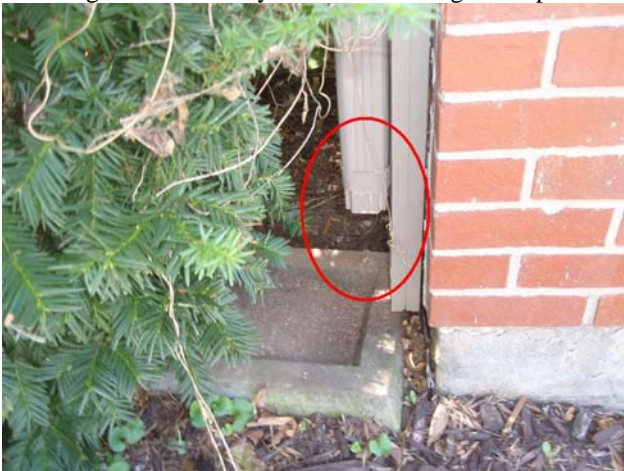
- **Repair:** The gutters require cleaning to avoid spilling roof runoff around the building – a potential source of water entry or water damage.
- **Repair:** The downspout(s) should discharge water at least five (5) feet from the house. Storm water should be encouraged to flow away from the building at the point of discharge.

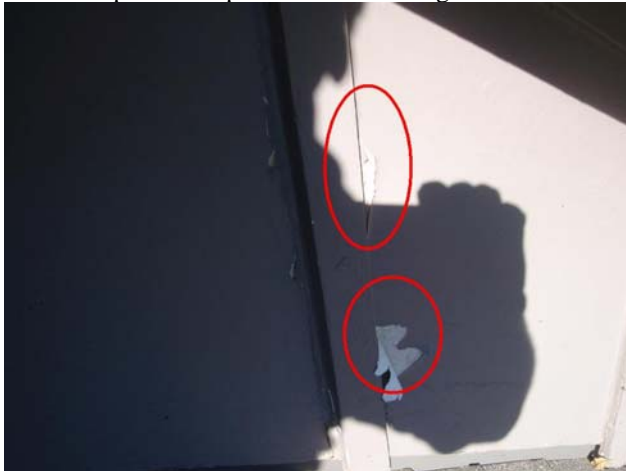
- **Repair:** The exterior siding paint is peeling and/or worn thin in localized areas (i.e. at roof step up siding.) These areas should be painted to prevent water damage or rot in the future.

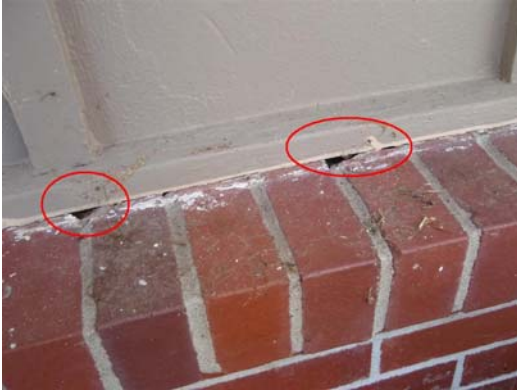
- **Repair:** Localized rot was observed in the siding (i.e. south side.) Following repair of the damaged areas (which should be combined with exterior painting/maintenance) proper maintenance of the siding and control of water from roof or surface runoff can avoid further damage.
- **Repair:** The siding trim needs caulking improvements in localized areas to prevent water damage and rot. An example is where the siding trim meets the brick veneer at the front of the house. .

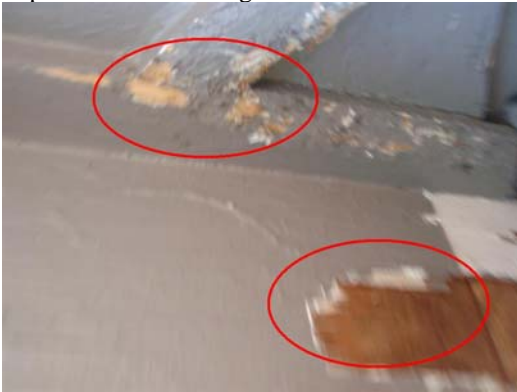
- **Repair:** The paint on the trim around the siding is peeling (i.e. roof step up siding trim.) These areas should be painted to prevent water damage and rot.

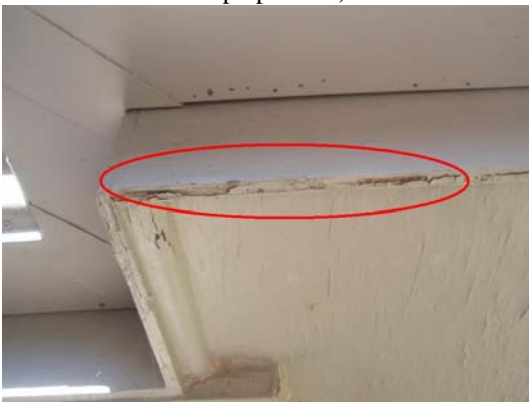
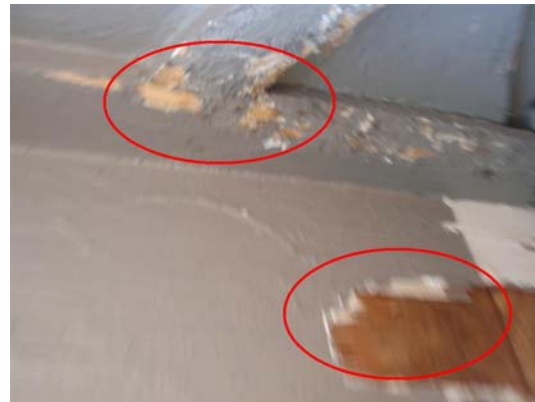
- **Repair:** The soffit and fascia should be painted in localized areas to prevent water damage and rot (i.e. at front porch fascia and at roof step up soffit.)

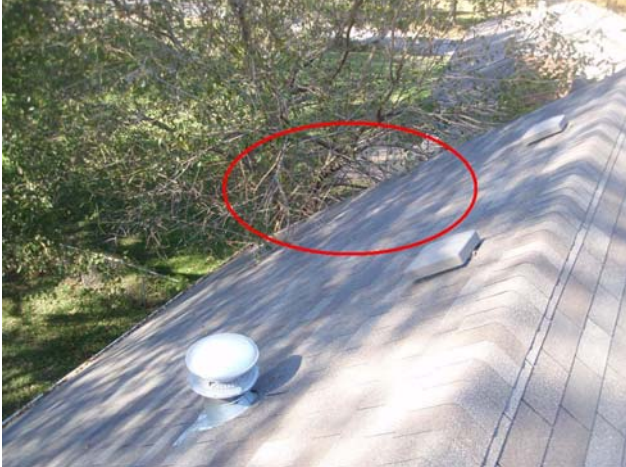
- **Repair:** Tree branches should be trimmed away from the house to avoid damage to the building.

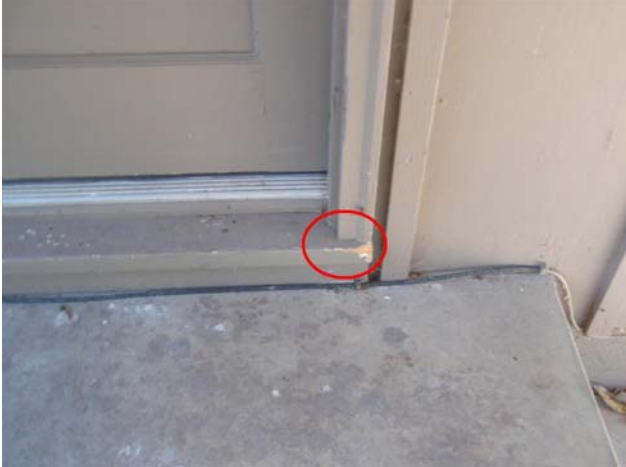
- **Improve:** The paint on the back door frame/ trim is peeling and requires painting.

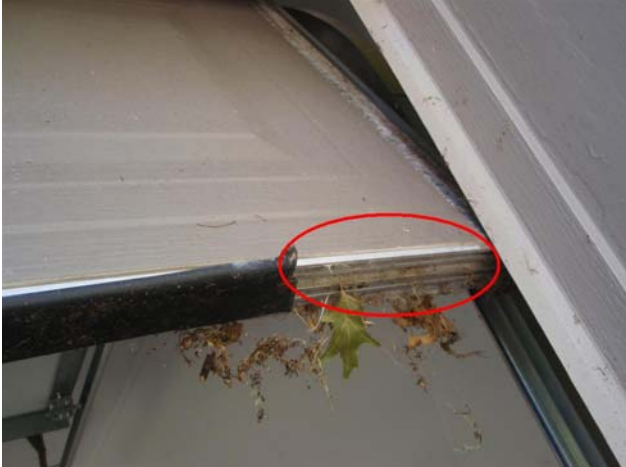
- **Repair:** The overhead garage door weather strip is damaged and needs repair.

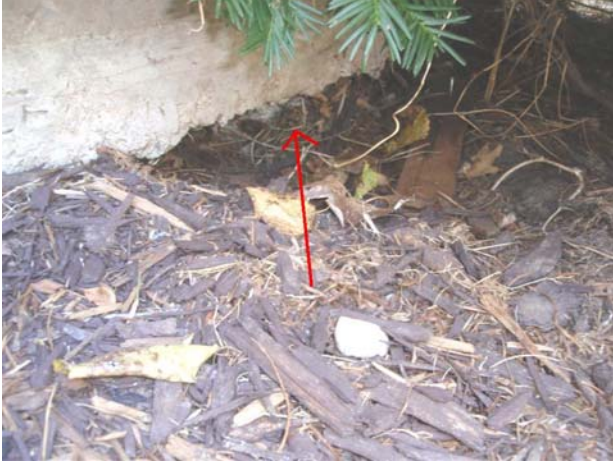
- **Repair:** The grading should be improved to promote the flow of storm water away from the house. The void under the front porch should be filled. This can often be accomplished by the addition of top soil. The ground should slope away from the house at a rate of one inch per foot for at least the first five feet. At least eight (8) inches of clearance should be maintained between soil level and the bottom of exterior wall siding. *It should be understood that it is impossible to predict whether moisture penetration will pose a problem in the future.*

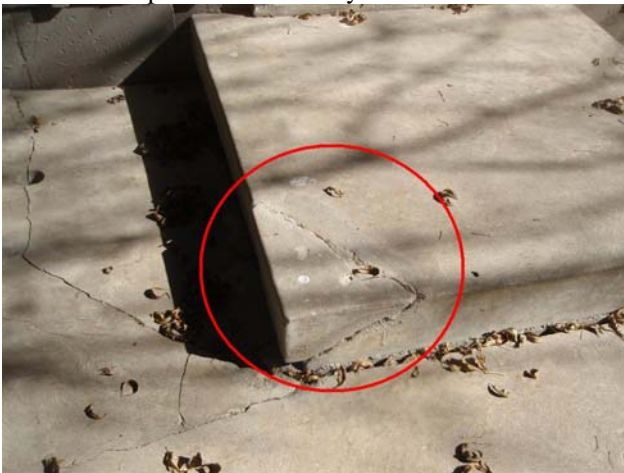
- **Monitor, Repair, Safety Issue:** The steps serving the back porch have settled and cracked, previous repairs were observed. Repair is discretionary at this time but if additional movement is observed repairs may be needed.

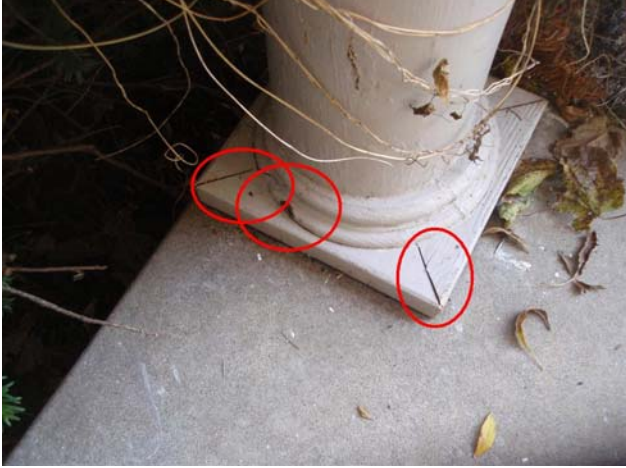
- **Repair:** The trim around the base of the support posts for the porch and patio cover need localized paint and caulk. If rot is uncovered the proper repairs should be made prior to painting.

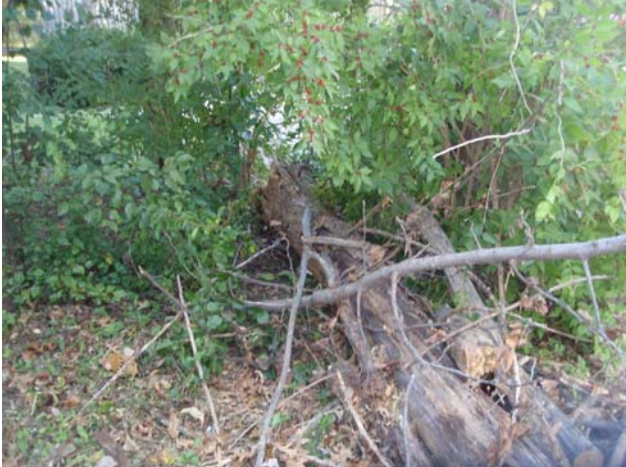
- **Repair:** The dead trees remnants at the front yard near the driveway should be removed.

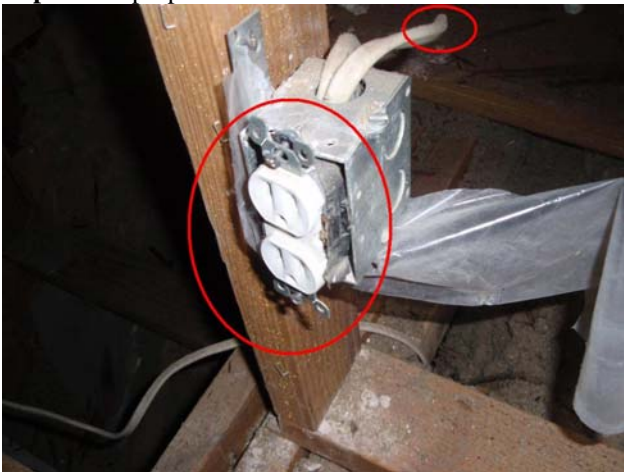
- **Repair:** Improper electrical connections at the outlet in the attic with improperly terminated wires should be repaired.

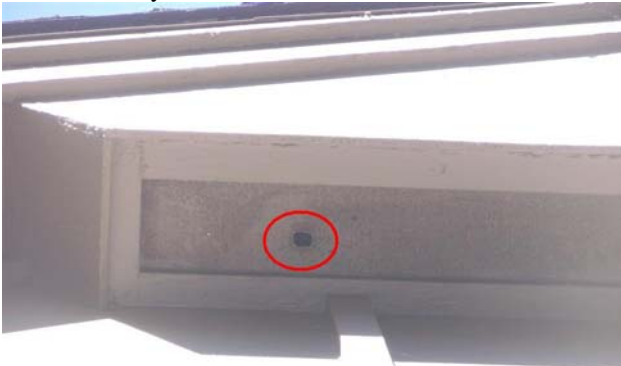
- **Repair:** Gable soffit vent screen at the south side appears to be damaged. This should be repaired or replaced to prevent vermin activity.

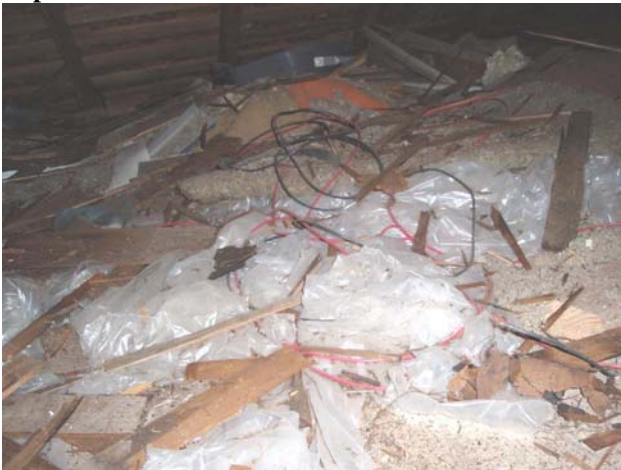
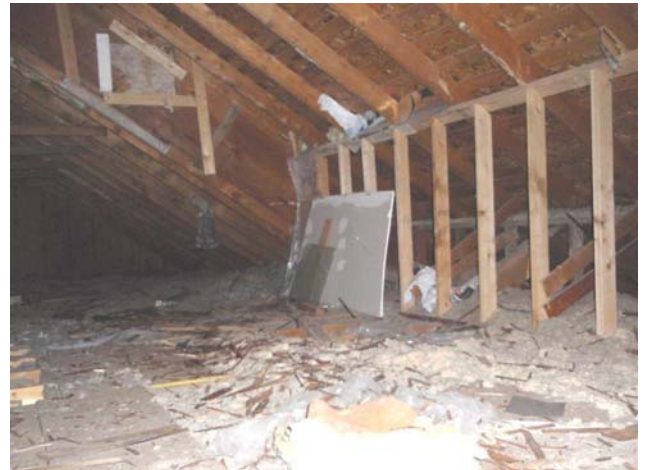
- **Repair:** Debris in attic should be removed.

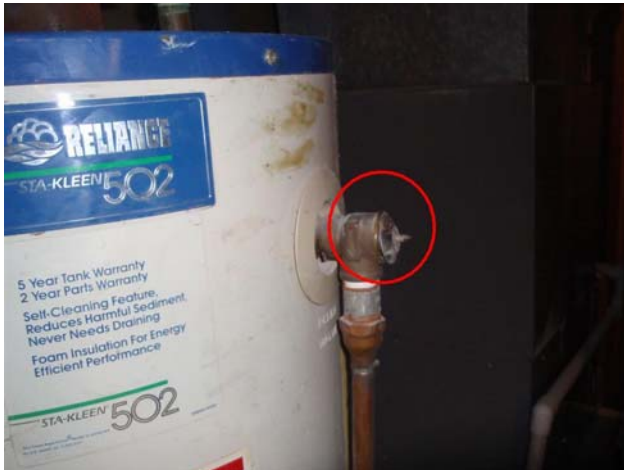
- **Monitor:** The water heater is an old unit that may be approaching the end of its useful life. It would be wise to budget for a new unit. One cannot predict with certainty when replacement will become necessary.
- **Monitor:** The supply piping shows evidence of corrosion where it meets the water heater. This is a common condition.
- **Repair, Safety Issue:** For safety reasons, it is recommended that the missing Temperature and Pressure Relief (TPR) Valve lever be installed for the water heater.

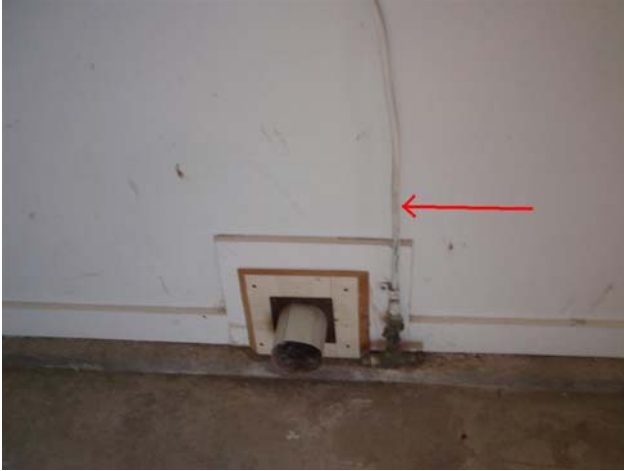
- **Monitor, Repair:** Copper tubing and galvanized steel is no longer suitable for gas piping by most gas utility companies. This should be confirmed or verified with the local gas company and if confirmed it's recommended any copper or galvanized steel pipe be replaced with one of suitable material.

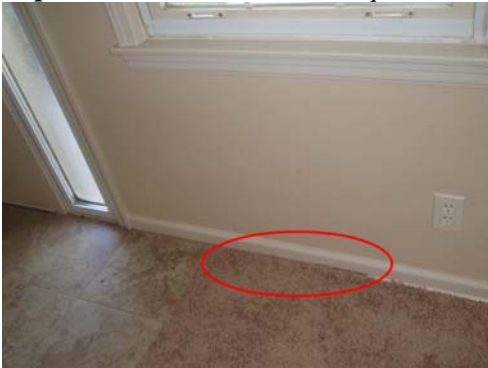
- **Improve:** The installation of the quarter round trim in the family room is incomplete. Repair is discretionary.

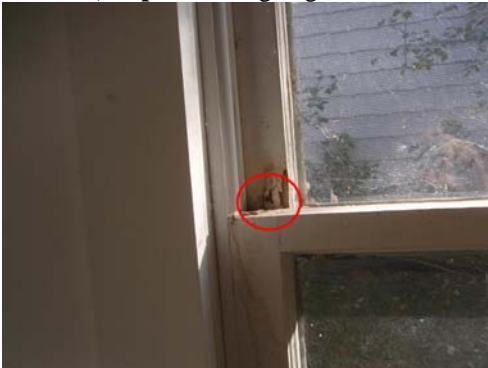
- **Monitor, Repair:** The garage interior window trim is peeling. Repair is discretionary.
