**Star
Home
Inspection Services**

Home Inspection Report

1302 Ann Ave Harrisonville, MO 64701

Inspection Date: 02/26/2010

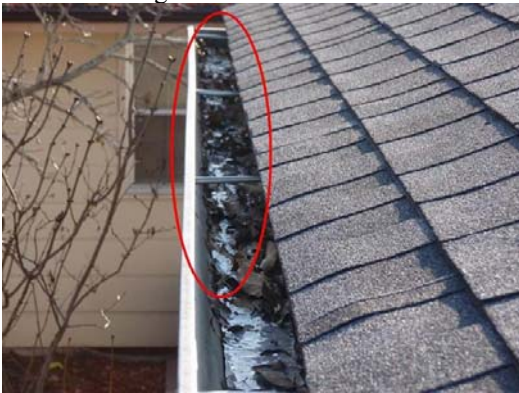
- **Repair:** The gutters require cleaning to avoid spilling roof runoff around the building – a potential source of water entry or water damage.

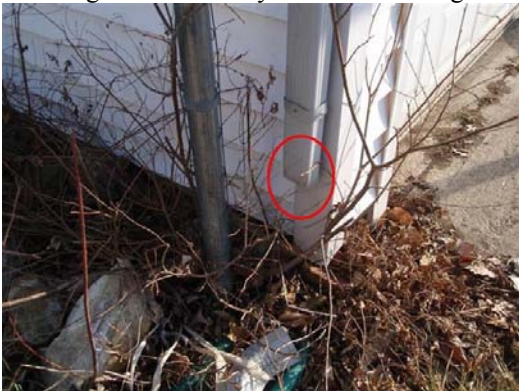
- **Repair:** The downspout(s) should discharge water at least five (5) feet from the house. Storm water should be encouraged to flow away from the building at the point of discharge.

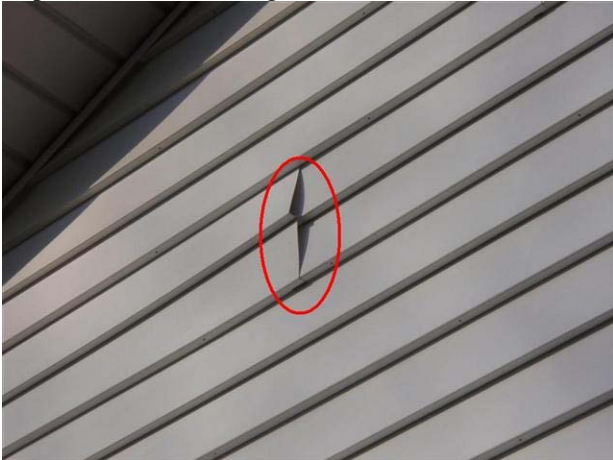
- **Repair:** The loose siding should be re-secured to avoid water and/or wind damage (i.e. east side.)

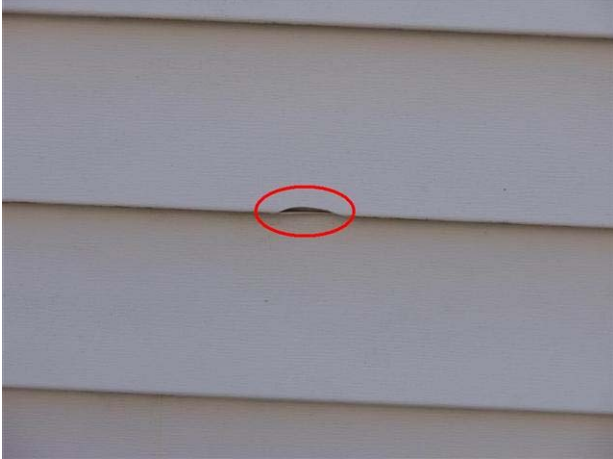
- **Monitor, Repair:** Localized minor damage of the vinyl siding at the west side of the home was observed.

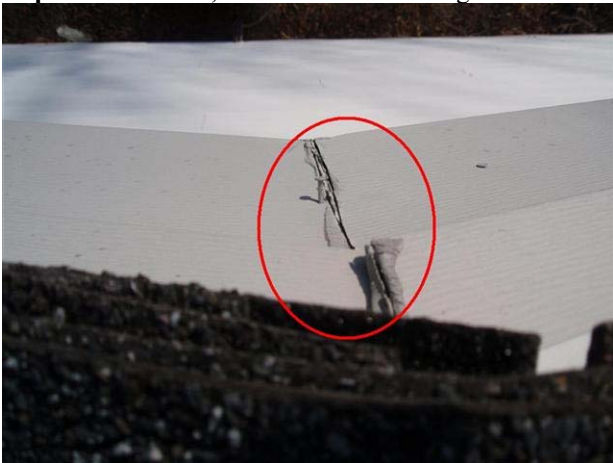
View from east roof ridge

- **Improve:** Cracked, deteriorated or missing caulk at the east side top eave aluminum covering should be improved.

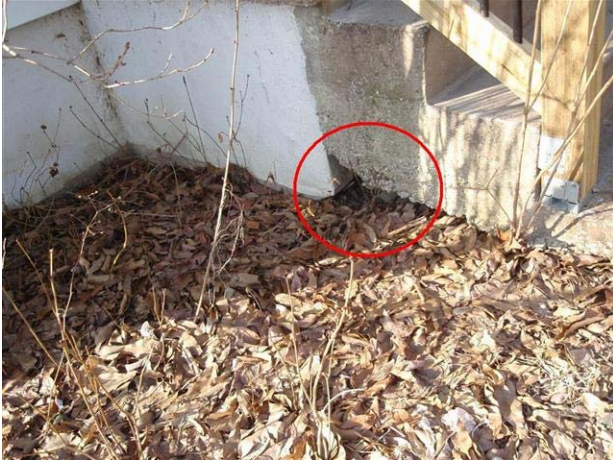
- **Repair:** The grading should be improved to promote the flow of storm water away from the house. This can often be accomplished by the addition of top soil. The ground should slope away from the house at a rate of one inch per foot for at least the first five feet. At least eight (8) inches of clearance should be maintained between soil level and the bottom of exterior wall siding. The void under the back steps should be filled. *It should be understood that it is impossible to predict whether moisture penetration will pose a problem in the future.*

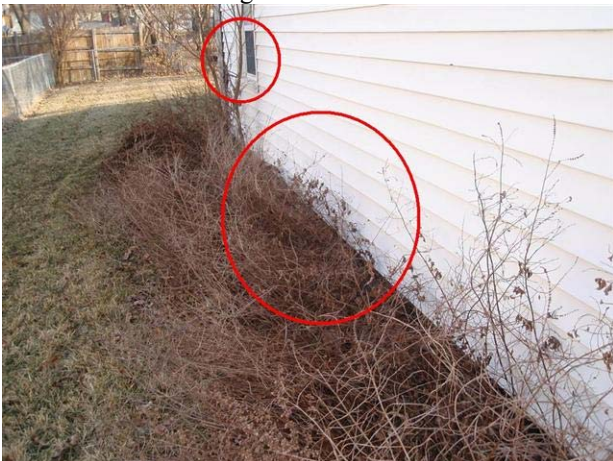
- **Repair:** Tree branches should be trimmed away from the house to avoid damage to the building.
- **Repair:** Shrubs, bushes and/or vines growing on exterior walls need to be trimmed away from the structure to reduce the risk of water damage and insect infestation.

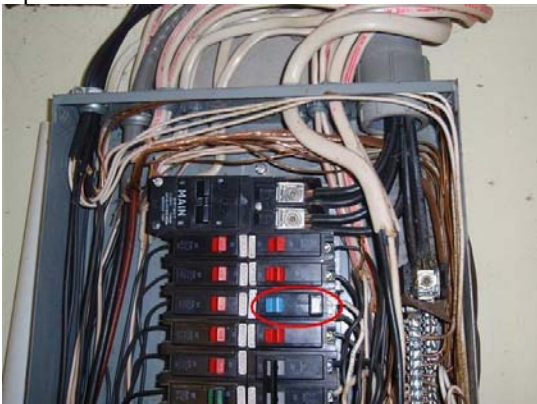
- **Repair:** The ground fault circuit interrupter (GFCI) at the main panel did not respond properly to testing. It should be replaced.

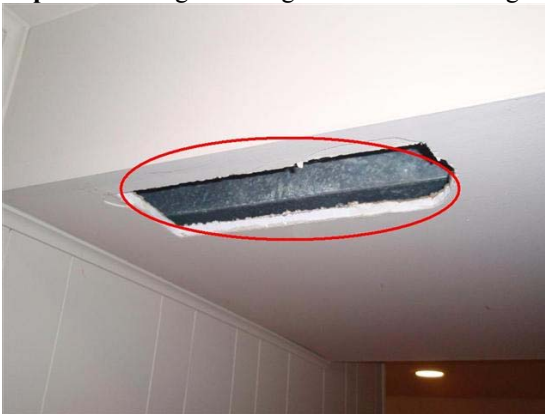
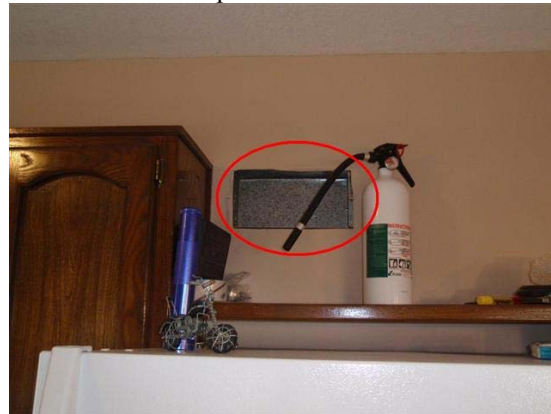
- **Repair:** Missing or damaged vent/return air register covers should be replaced.
