# Star Home Inspection Services

## *Home Inspection Report*

**1308 E 98th Terr, Kansas City, MO 64131**

**Inspection Date: 2/18/2008**

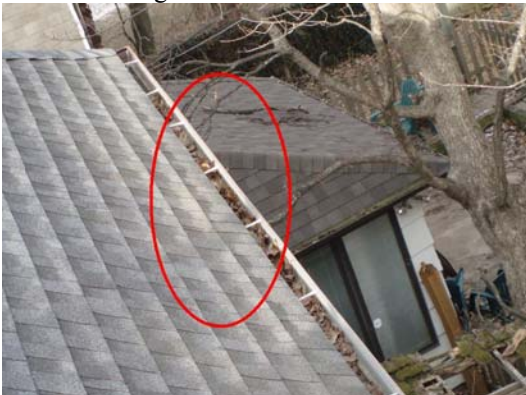
- **Repair:** The gutters require cleaning to avoid spilling roof runoff around the building – a potential source of water entry or water damage.

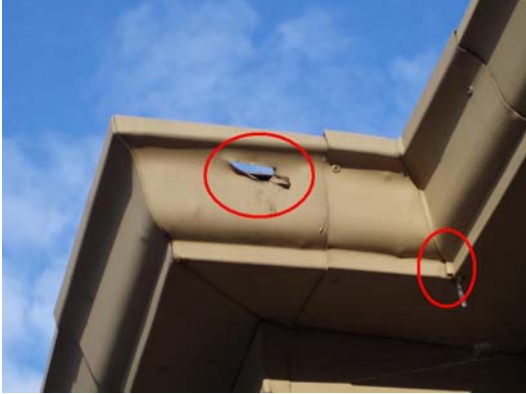
- **Repair:** Minor leaks in the gutters should be repaired.
- **Repair:** Damaged and/or missing gutters should be repaired or replaced as necessary to avoid spilling roof runoff around the building – a potential source of water entry or water damage.

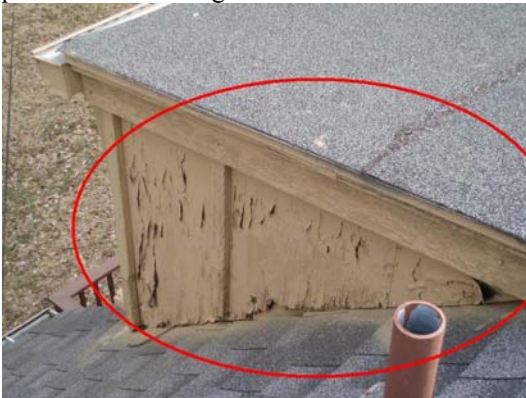
- **Monitor:** The masonry exterior (right lower corner near garage door) wall shows evidence of minor spalling (surface deterioration of the masonry). Repair is not necessary at this time but this condition should be monitored..
- **Repair:** The exterior siding paint is peeling and/or worn thin in localized areas. These areas should be painted to prevent water damage or rot in the future.

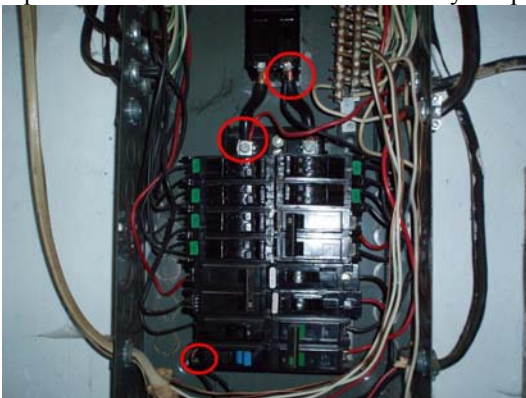
- **Repair:** The 60 amp fuse box servicing the air conditioner is oversized. The manufacturer plate on air conditioning unit calls for a maximum breaker (fuse) size of 40 amps. This should be repaired.
- **Repair:** Circuits within the main distribution panel that are doubled up (referred to as "double taps") should be separated. Each circuit should be served by a separate fuse or breaker.

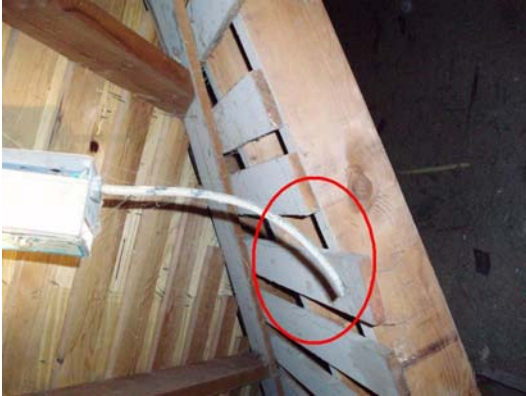
- **Repair:** Abandoned wiring should be replaced or appropriately terminated. (Abandoned wiring pictured below is live in attic).

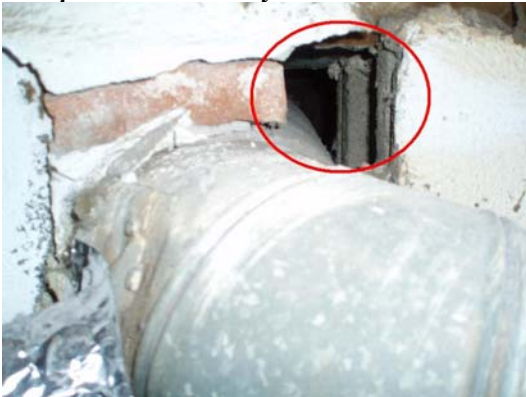
- **Repair, Safety Issue:** *Poor exhaust flue connections (example at furnace/water heater exhaust at chimney) should be improved immediately.* Poor connections risk flue gas and carbon monoxide leakage or other unsafe conditions.

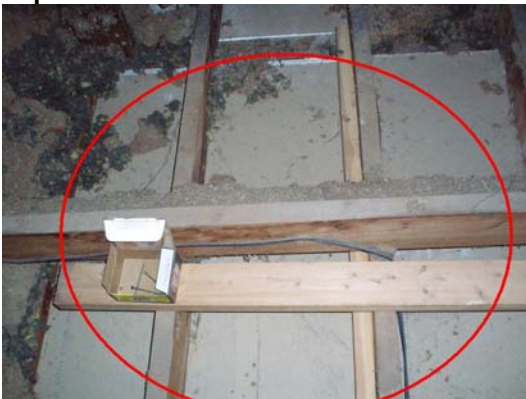
- **Repair:** Insulation should be evened out.
