**Star
Home
Inspection Services**

Home Inspection Report

1308 NW Deer Run Tr Blue Springs, MO 64015

Inspection Date: 09/11/2010

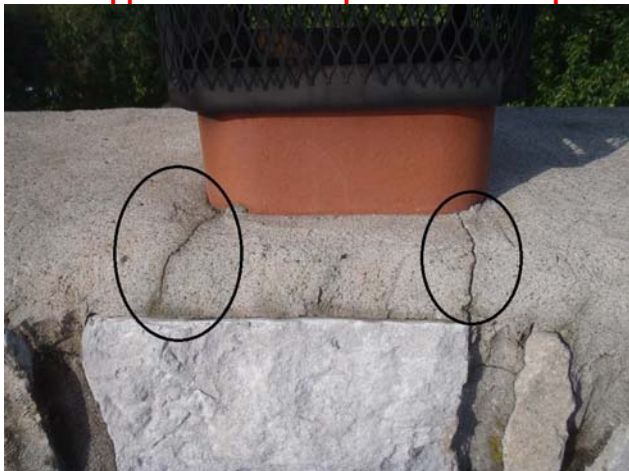
- **Monitor, Repair:** The cap of the masonry chimney is cracked. These cracks should be sealed or caulked before winter to prevent damage from freezing water. **Repaired cracks in cap as shown in photo. Also repaired crack on opposite side of cap. Performed repair on 11 September 2010**

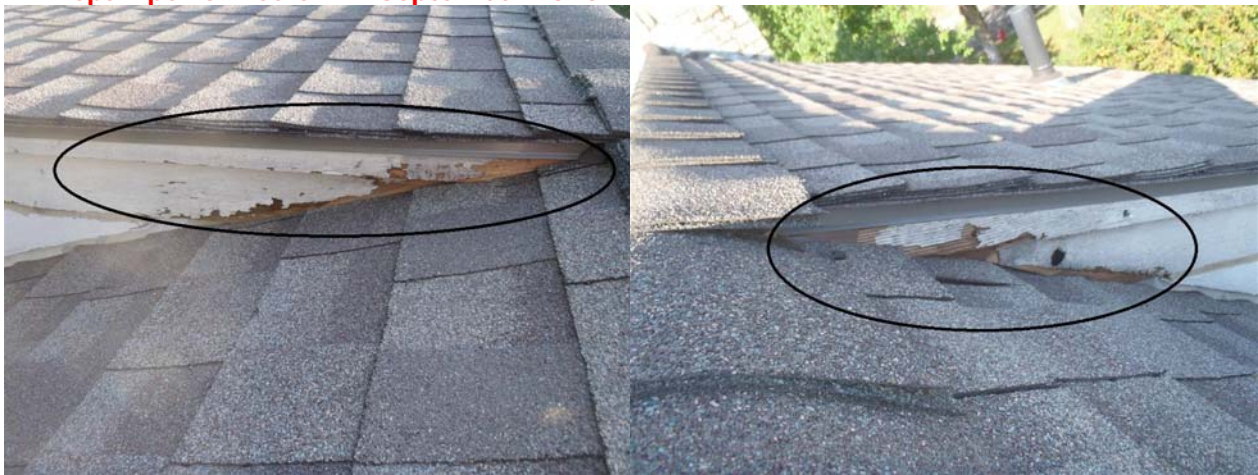
- **Repair:** The eaves are peeling and they should be painted to prevent water damage and rot. Any rot discovered in the process should be repaired. **Scraped and painted eaves on both sides of dormer as shown in photo. Repair performed on 11 September 2010.**

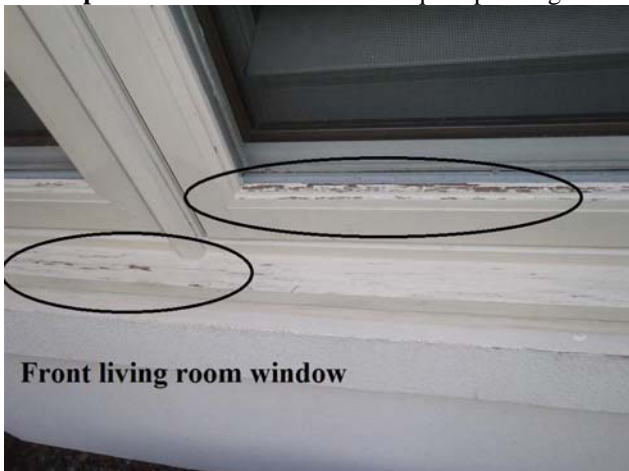
Front living room window

- **Repair:** Some window frames require painting and caulking.

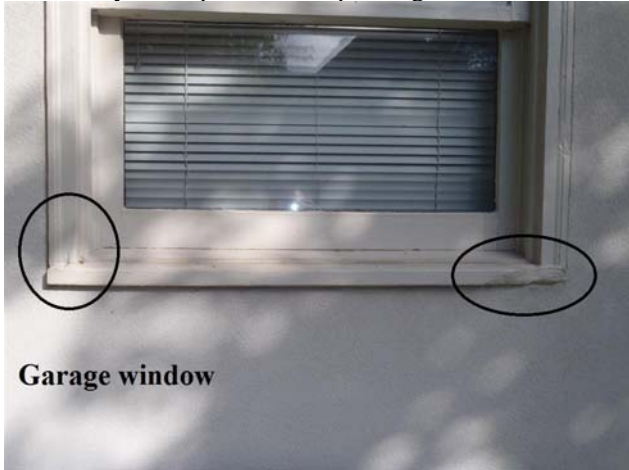
Garage window

- **Monitor:** Localized evidence of repaired rot was visible on the garage window trim/frame. These areas are currently protected with paint and do not need immediate attention. It is recommended, however, that these areas be monitored closely and repaired when painting is done in the future.

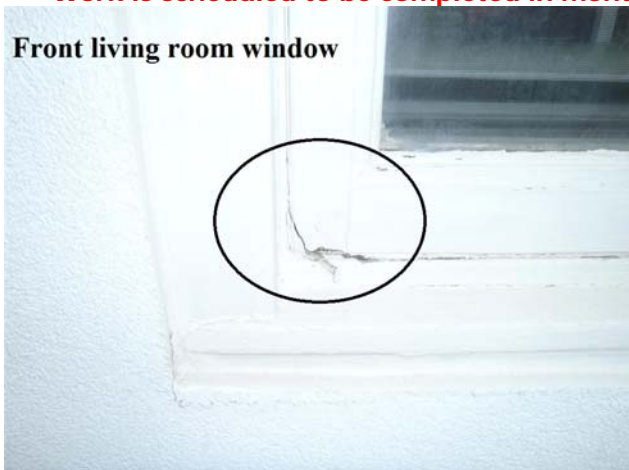
Front living room window

- **Repair:** Localized evidence of rot was visible on the east, north and west window trim/frames. Repair to the window frame can usually be accomplished by a skilled carpenter. It's recommended that a thorough "inventory" be taken by a competent window repair technician to ascertain exactly how many areas will need to be repaired or replaced. Further evaluation by a specialist may well identify additional areas that require servicing. **Received quotation for the repair of North and West windows of front room and East bedroom window at rear of house. Work is scheduled to be completed in month of October.**

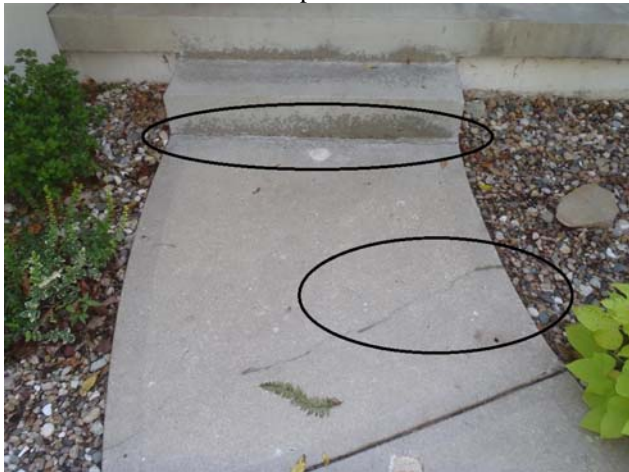
- **Monitor:** The walkway has settled and cracked and has been mud jacked to raise the slab. Persisting movement may result in the need for repairs.

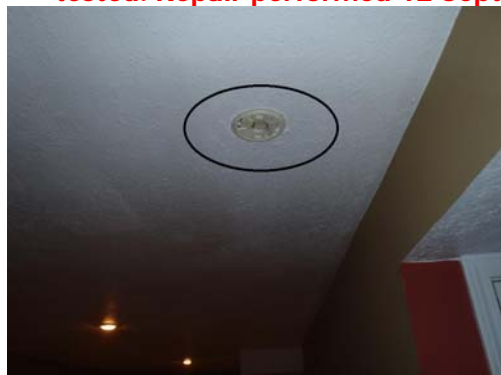
- **Repair, Safety Issue:** Missing smoke detector was observed in the basement **New smoke detector installed and tested. Repair performed 12 September 2010.**

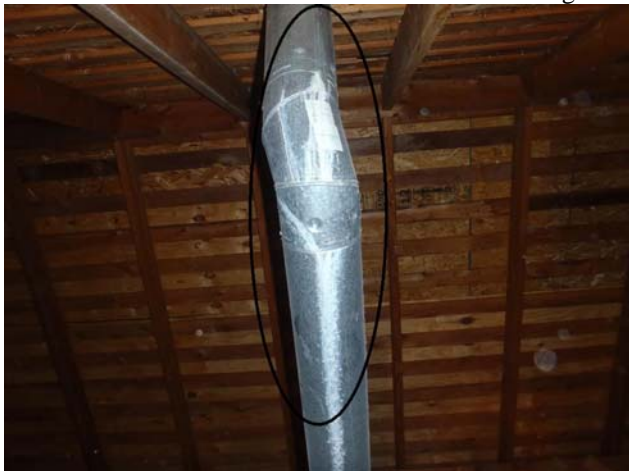
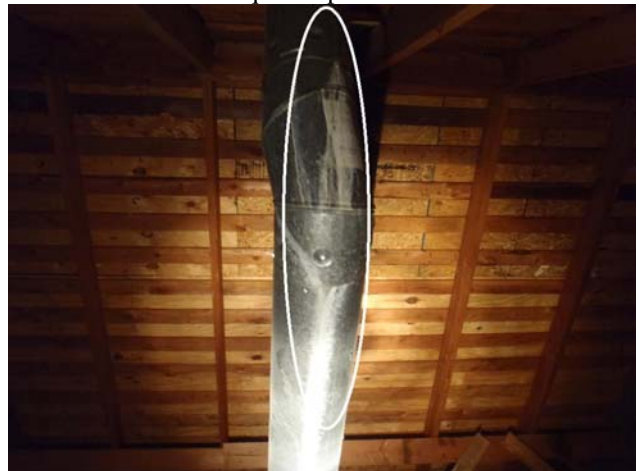
- **Monitor:** While in the attic water stains were observed on the lower sections of the furnace flue. The insulation below the elbow also showed signs of past moisture. This can be caused from several things. The most common is just condensation in the flue above the roof. Another would be the storm collar around the flue could be leaking. The wind can also blow just right that rain blows in under the rain cap and runs down the interior of the flue until it gets to the first joint where it then transferred to the outside surface and dripped off the elbow. This is a common condition in 80% of homes but very seldom is enough to penetrate completely through the insulation to the drywall below. Monitor for any additional wetness after rains. There were no signs above the roof that would require repairs.

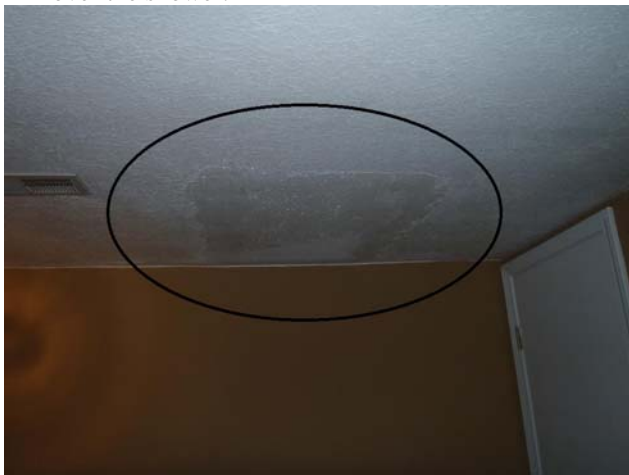
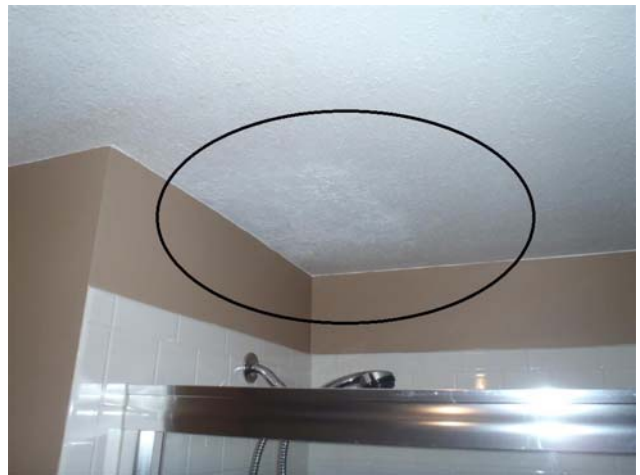
- **Monitor:** Repaired water damage was noted on the basement ceiling under the kitchen and in the basement bathroom over the shower.

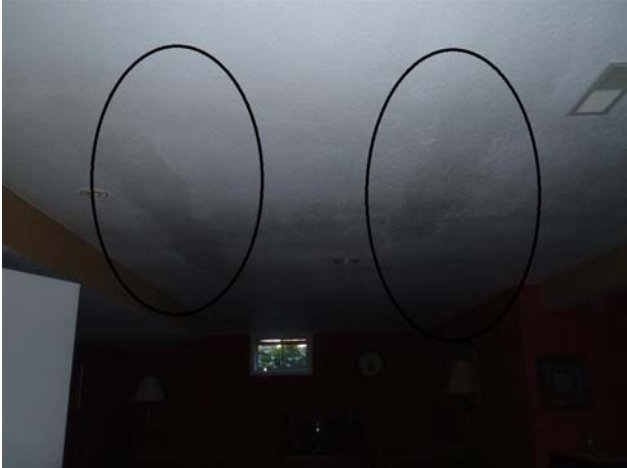
- **Monitor:** Evidence of patching was detected on the center of the basement ceiling.

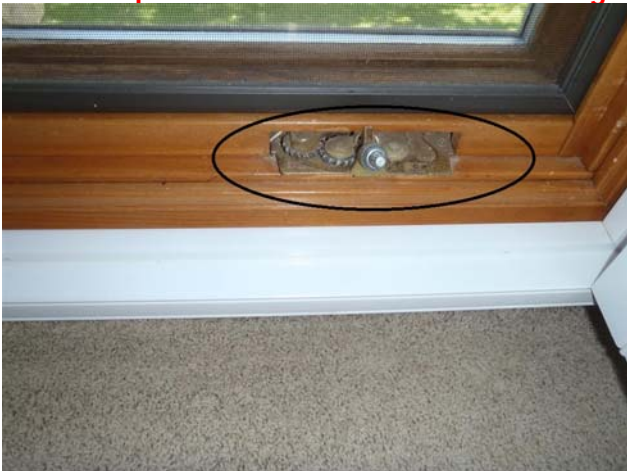
- **Repair:** Window cranking hardware is damaged on one living room window and one northwest bedroom window. **Broken cranks are being replaced with new hardware by the same contractor that is performing the other window repairs as stated on page 4. Hardware has been ordered from manufacturer and repairs are scheduled to occur during the month of October 2010.**
