Star Home Inspection Services

Home Inspection Report

13203 S 15th St, Grandview, MO 64030

Inspection Date: 11/3/2008

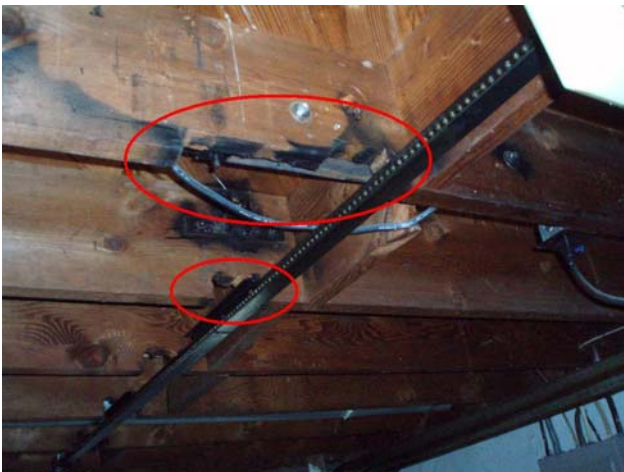
- **Monitor:** Floor joists are notched and or cut in the garage area for garage door opener operation. This weakens the joist and risks structural damage; if any further movement is or cracking is observed repairs or additional support will be needed.

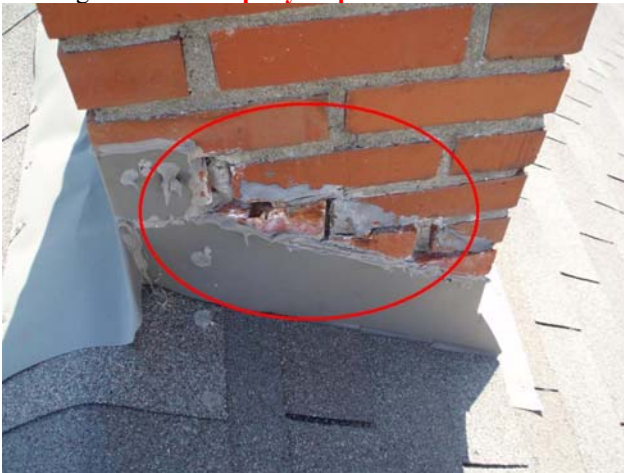
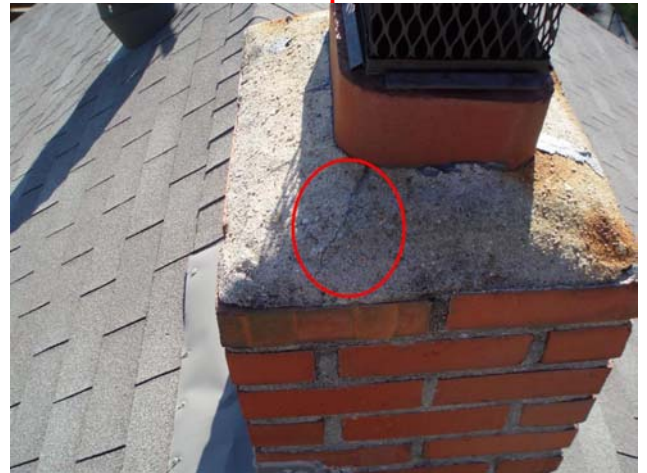
- **Repair:** The masonry chimney needs re-pointing (replacing the mortar between the bricks) to avoid water damage.
- **Repair:** The cap of the masonry chimney is cracked. These cracks should be sealed or caulked to prevent damage from freezing water. **A company re-pointed the bricks and allied a crown coat to seal the cap.**

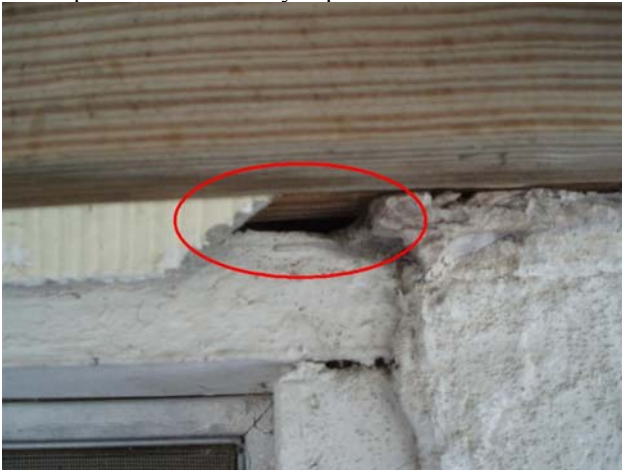
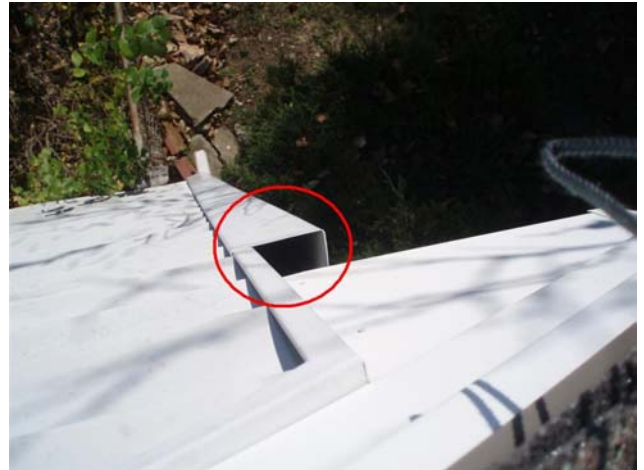
- **Repair:** The exterior siding should be sealed at opening below deck where potential insect entry may occur. **Repaired**
- **Repair:** Seal openings at top of siding at corners of house to prevent water entry. Possible hidden damage in areas where potential water entry is present.

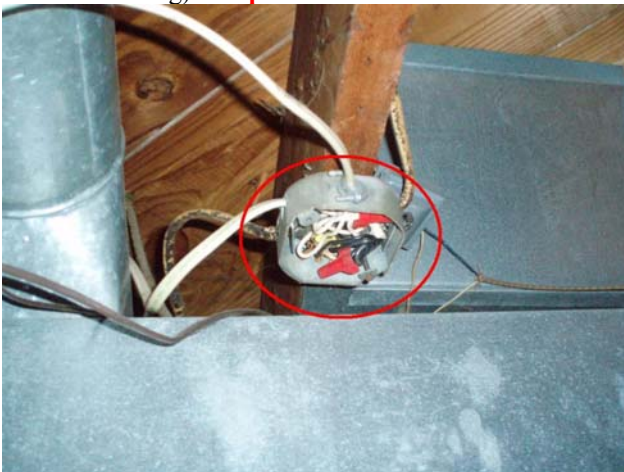
- **Repair:** All junction boxes should be fitted with cover plates, in order to protect the wire connections (example at basement ceiling). **Repaired**

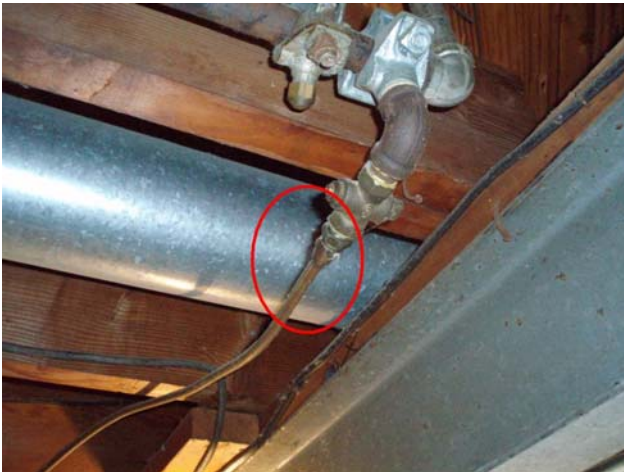
- **Repair:** Copper tubing is no longer suitable for gas piping. It's recommended this pipe be replaced with one of suitable material.

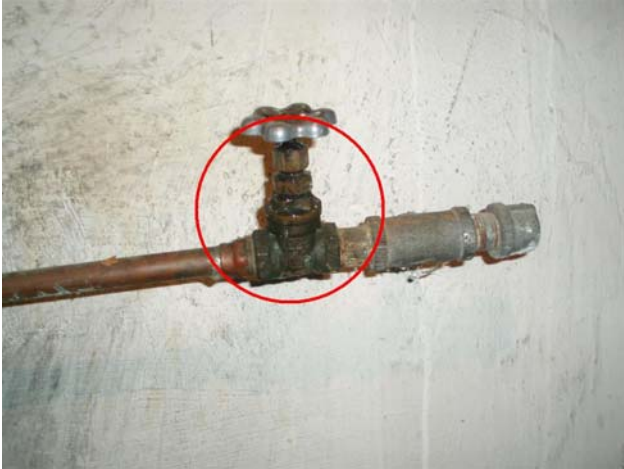
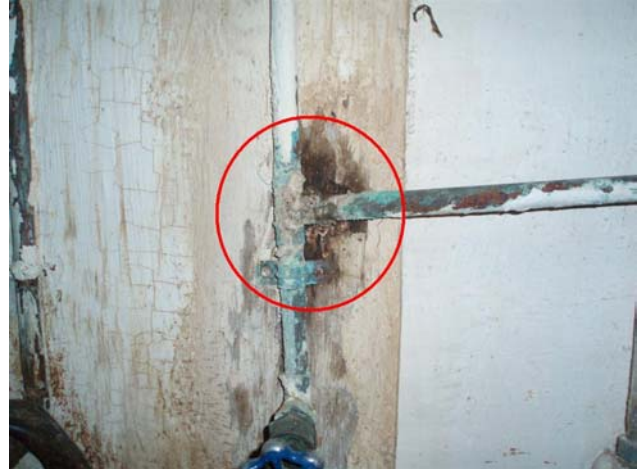
- **Repair:** The faucet to the bathtub is leaking.
- **Repair:** The bathroom sink drain plug is inoperative or missing and needs repair. **Repaired (replaced vanity and fixtures)**
- **Improve:** Cracked, deteriorated and/or missing bathtub enclosure caulk should be replaced.
- **Repair:** The bathtub drain plug is inoperative or missing and needs repair.
- **Repair:** The hose bib is leaky at the shutoff handle in the garage. The pipe is also leaky near the washer shutoff connection.
