**Star
Home
Inspection Services**

Home Inspection Report

133 E Woodbridge Ln, Kansas City, MO 64145

Inspection Date: 05/08/2009

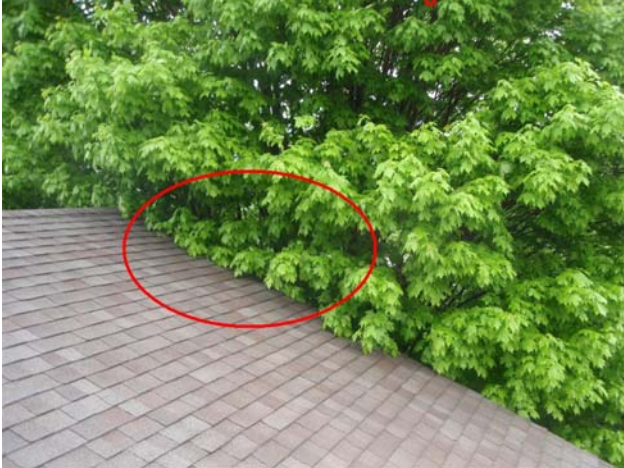
Exterior Eaves

- **Repair:** Tree branches should be trimmed away from the house to avoid damage to the building.

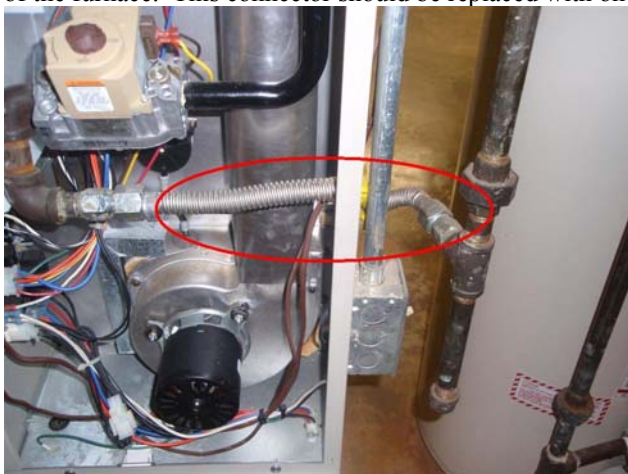
Gas Piping

- **Repair:** Flexible gas appliance connections should not pass through walls, floors or the appliance housing as is the case of the furnace. This connector should be replaced with one of suitable solid gas piping.

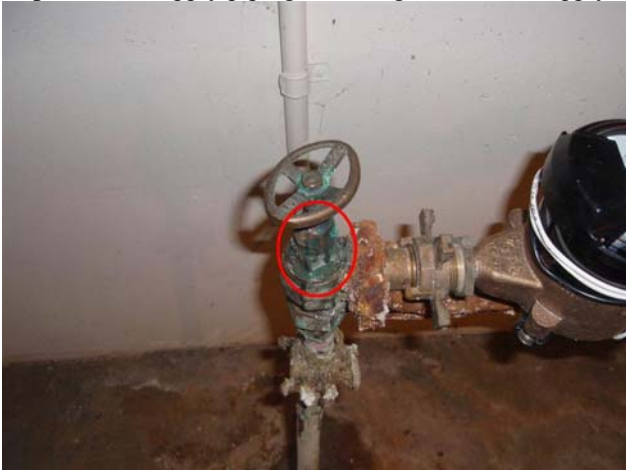
Supply Plumbing

- **Repair:** The supply piping is leaking at the main supply handle.

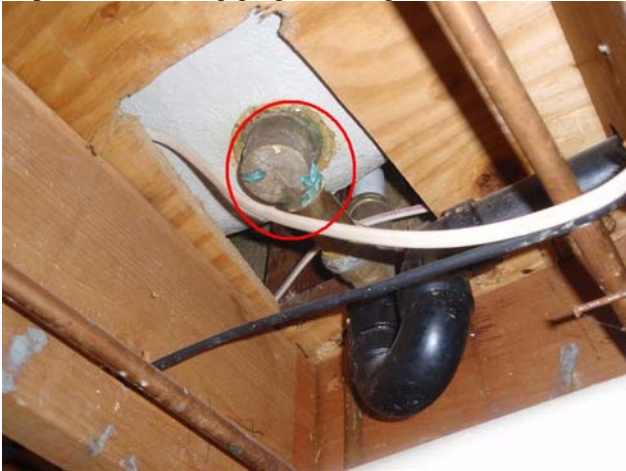
Waste / Vent

- **Repair:** The waste piping is leaking below the master bathtub.

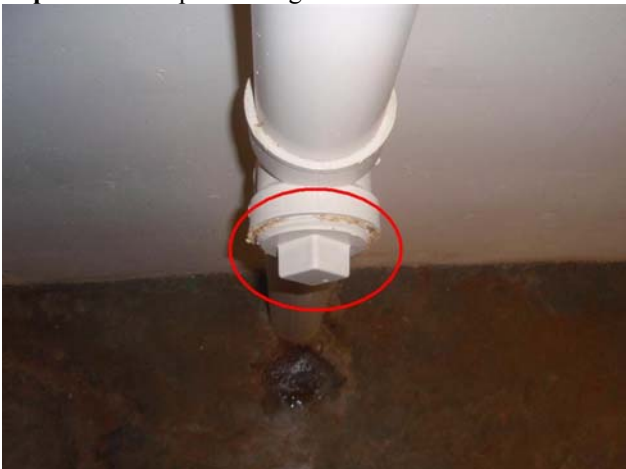
- **Repair:** The trap is leaking.
