Star Home Inspection Services

Home Inspection Report

133 E Woodbridge Ln, Kansas City, MO 64145

Report Number: 05082009-1A

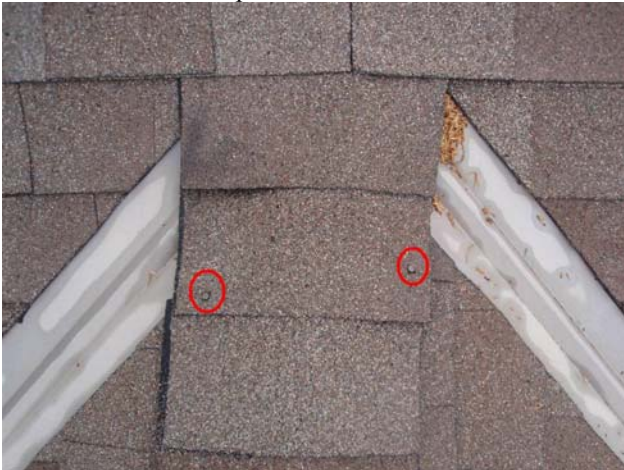
Sloped Roofing

- **Repair:** Exposed nail heads were observed in the roofing shingles and/or ridge caps. All exposed nail heads should be caulked to reduce the potential of leaks.

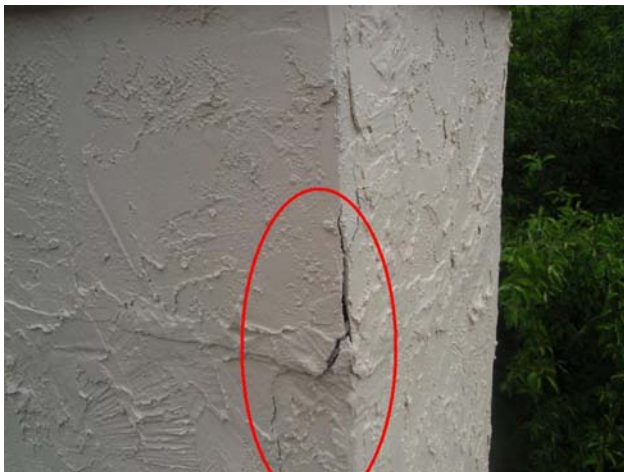
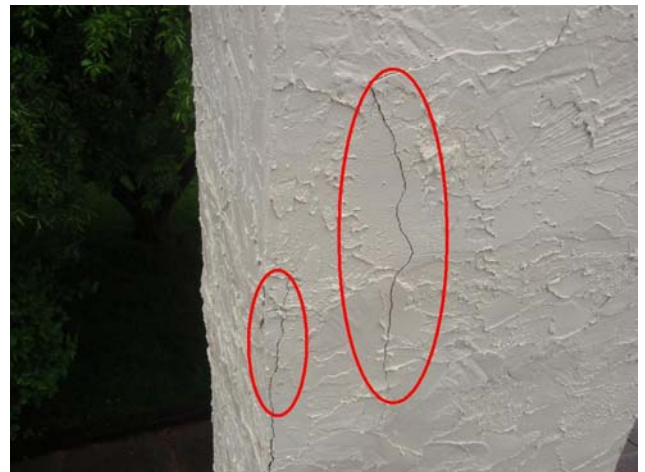
Exterior Walls

- **Repair:** Cracks were observed in the exterior stucco walls (example at the back side of the fireplace) these cracks should be repaired to prevent water from penetrating the wall and causing damage. There is extra risk of hidden damage in such areas.

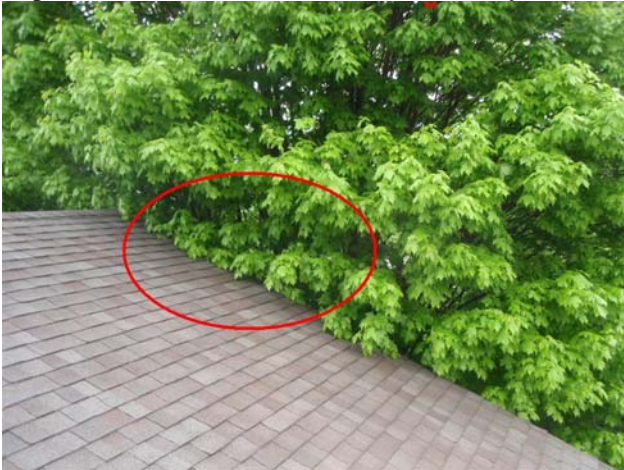
Exterior Eaves

- **Repair:** Tree branches should be trimmed away from the house to avoid damage to the building. **Repaired**

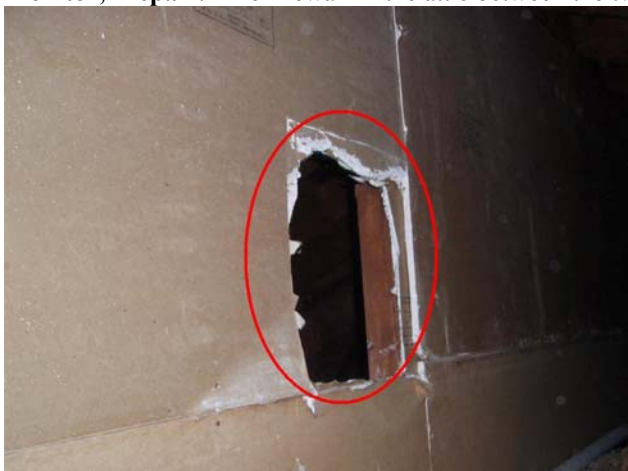
Attic / Roof

- **Monitor, Repair:** The firewall in the attic between the two homes is damaged.

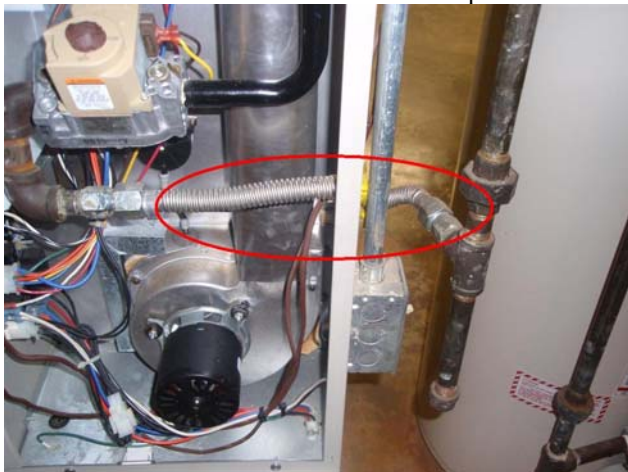
Gas Piping

- **Repair:** Flexible gas appliance connections should not pass through walls, floors or the appliance housing as is the case of the furnace. This connector should be replaced with one of suitable solid gas piping.

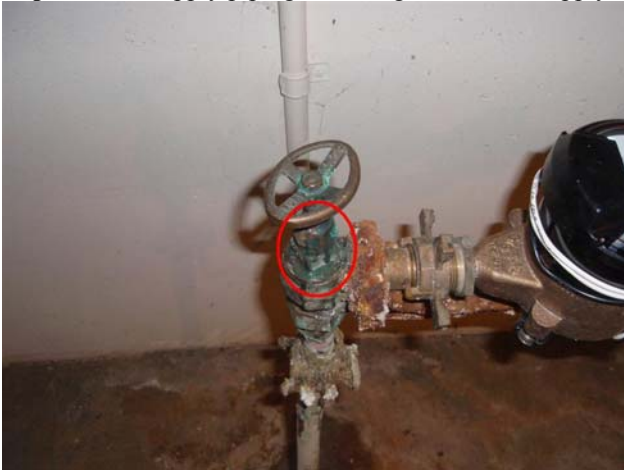
Supply Plumbing

- **Repair:** The supply piping is leaking at the main supply handle.

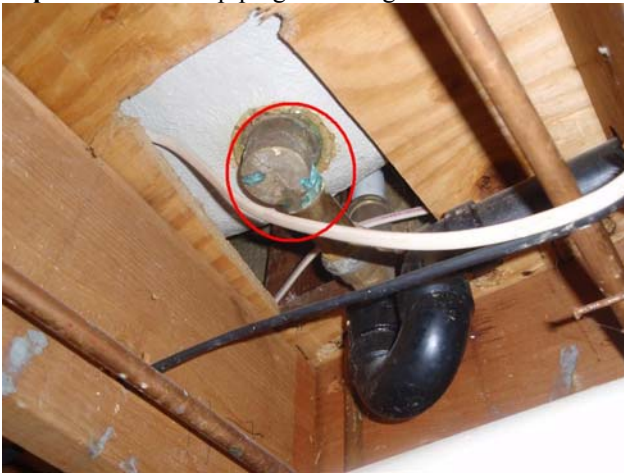
Waste / Vent

- **Repair:** The waste piping is leaking below the master bathtub. **Repaired**

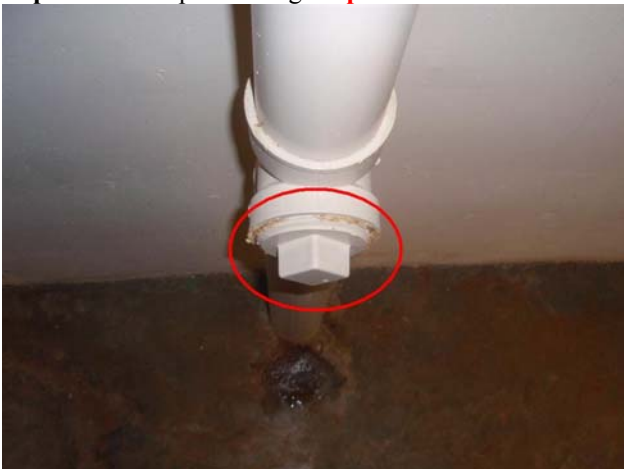
- **Repair:** The trap is leaking. **Repaired**
