# Star Home Inspection Services

## *Home Inspection Report*

**13304 W 111th Terr, Overland Park, KS 66210**

**Report Number: 05012009-1A**

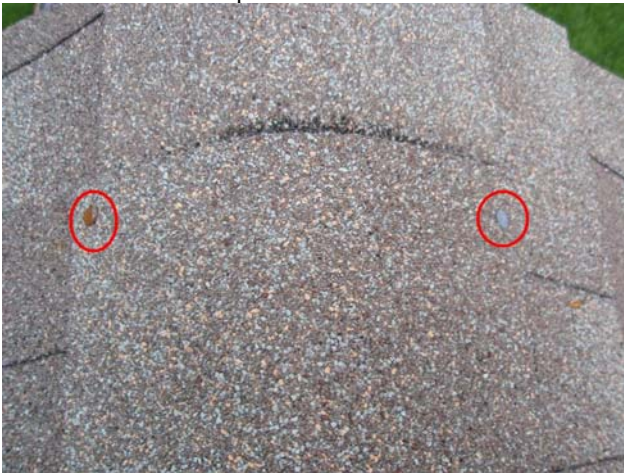
#### Sloped Roofing

- **Repair:** Exposed nail heads were observed in the roofing shingles and/or ridge caps. All exposed nail heads should be caulked to reduce the potential of leaks.

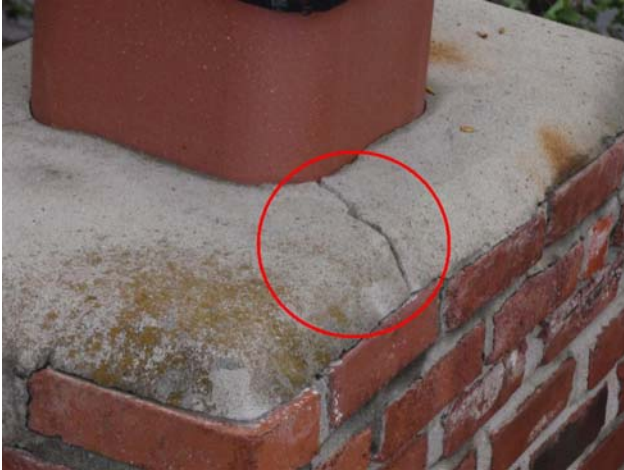
### Chimneys

- **Monitor, Repair:** The cap of the masonry chimney is cracked. These cracks should be sealed or caulked before winter to prevent damage from freezing water.

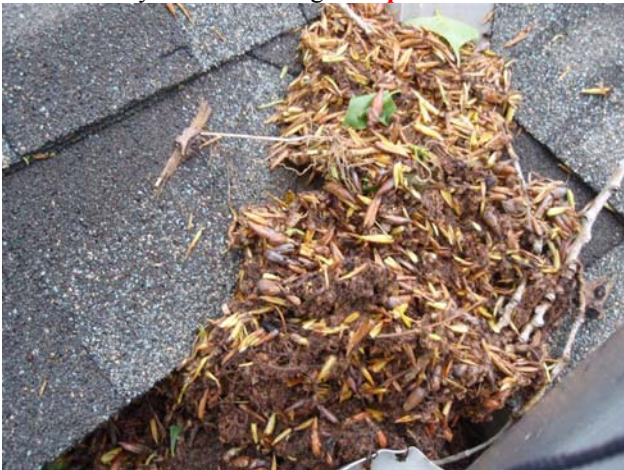
### Gutters & Downspouts

- **Repair:** The gutters/roof valleys require cleaning to avoid spilling roof runoff around the building – a potential source of water entry or water damage. **Repaired**

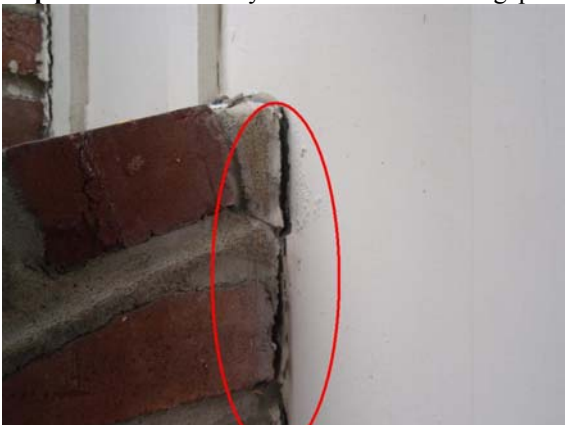
### Exterior Walls

- **Repair:** The exterior siding paint is peeling and/or worn thin in localized areas. These areas should be painted to prevent water damage or rot in the future (examples at bottom edge of siding).
- **Repair:** Localized rot was observed in the siding. Following repair of the damaged areas (which should be combined with exterior painting/maintenance) proper maintenance of the siding and control of water from roof or surface runoff can avoid further damage. **Repaired**
- **Repair:** Localized rot was observed in the trim around siding (example at west side). Following repair of the damaged areas (which should be combined with exterior painting/maintenance) proper maintenance of the siding and control of water from roof or surface runoff can avoid further damage. **Repaired**
- **Improve:** The chimney should be caulked at gaps where chimney meets siding.

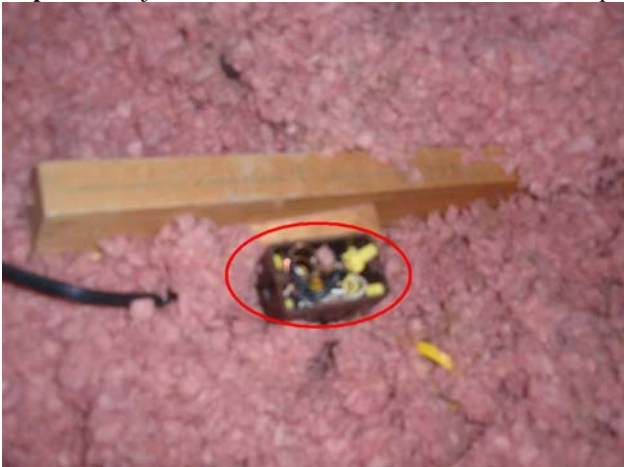
#### Distribution Wiring

- **Repair:** All junction boxes should be fitted with cover plates, in order to protect the wire connections (example in attic).
