Star Home Inspection Services

Home Inspection Report

1341 E 154th Terr, Olathe, KS 66062

Inspection Date: 11/24/2008

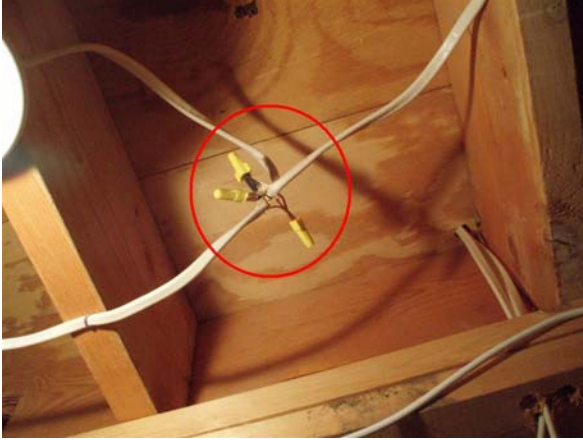
- **Repair:** Improper electrical connections should be repaired (example in sump pump room). All electrical connections should be made inside junction boxes fitted with cover plates. **Repaired**

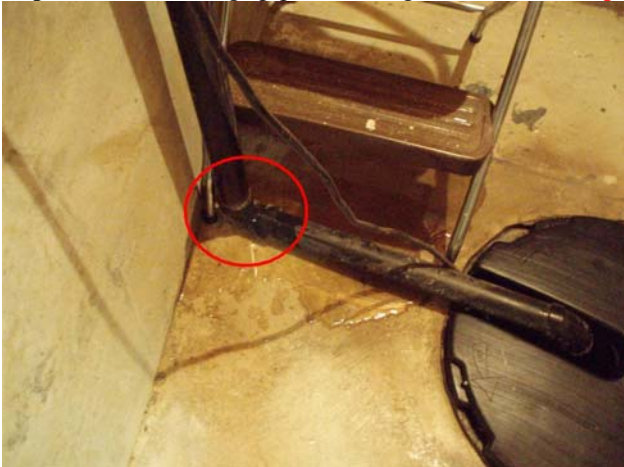
- **Repair:** The discharge pipe is leaking at the elbow. **Repaired**
