**Star
Home
Inspection Services**

Home Inspection Report

13603 S Sycamore St Olathe, KS 66061

Inspection Date: 02/18/2011

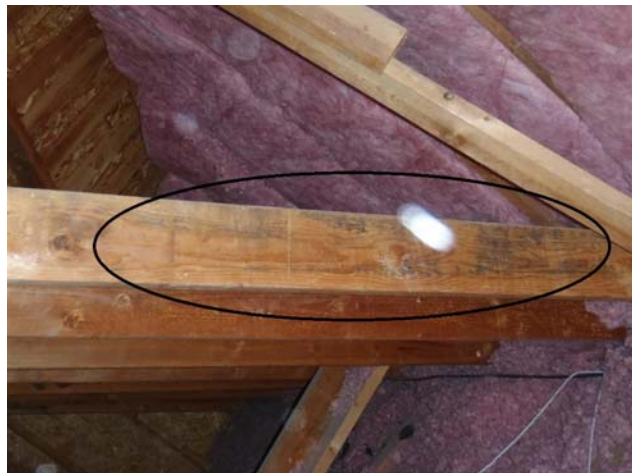
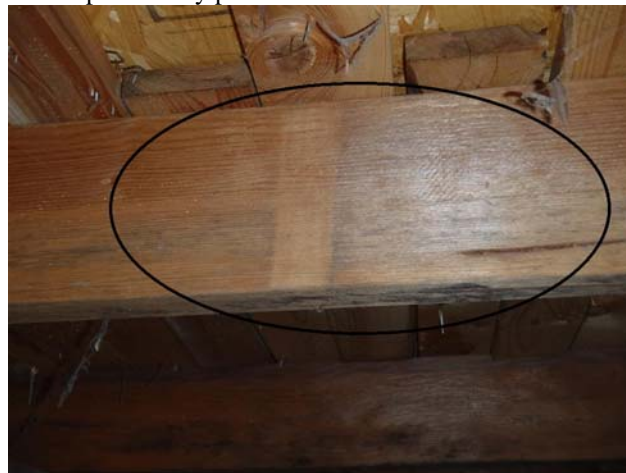
- **Monitor:** Construction mold was visible on some roof rafters. This is mold that grows on the lumber while lying in the weather during construction as evidenced by the strap marks. Most homes have some level of this mold and it goes dormant once removed from the elements and normally does not present any problems.

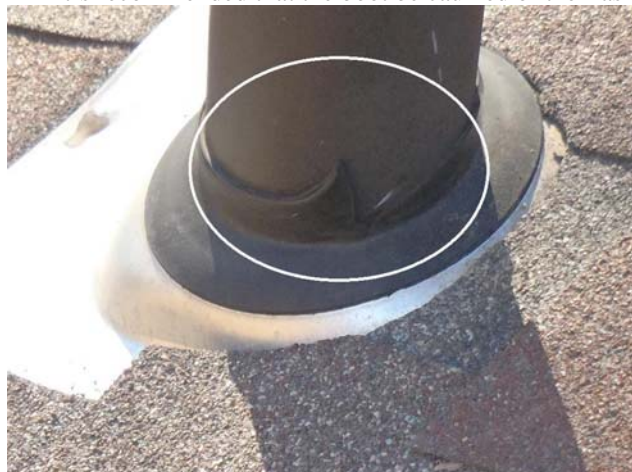
- **Monitor, Repair:** The plumbing vent flashing boot over the master bedroom bath is split making it vulnerable to leaks. It's recommended that the boot be caulked or the flashing replaced.

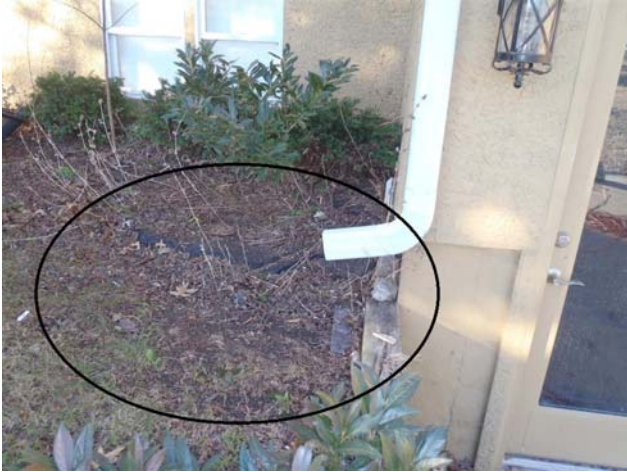
- **Repair:** The downspout(s) should discharge water at least five (5) feet from the house. Storm water should be encouraged to flow away from the building at the point of discharge.

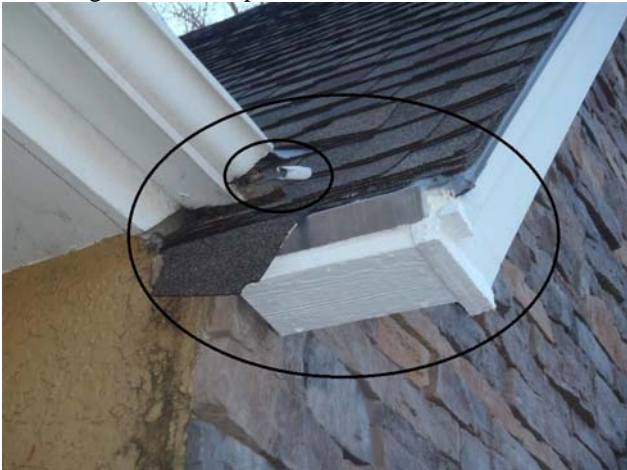
- **Repair:** Damaged gutter on the front of the house over the front porch should be repaired or replaced as necessary to avoid spilling roof runoff and causing damage. It appears that some damage has already occurred and been repaired but the gutter is not repaired.

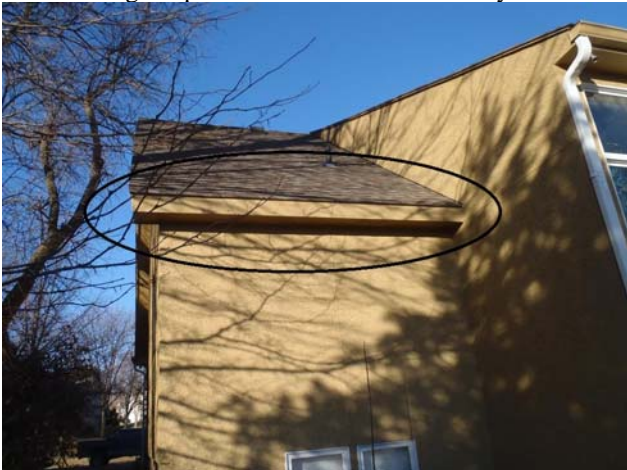
- **Repair:** It is recommended that missing gutters and downspouts be installed to avoid spilling roof runoff around the building – a potential source of water entry or water damage.

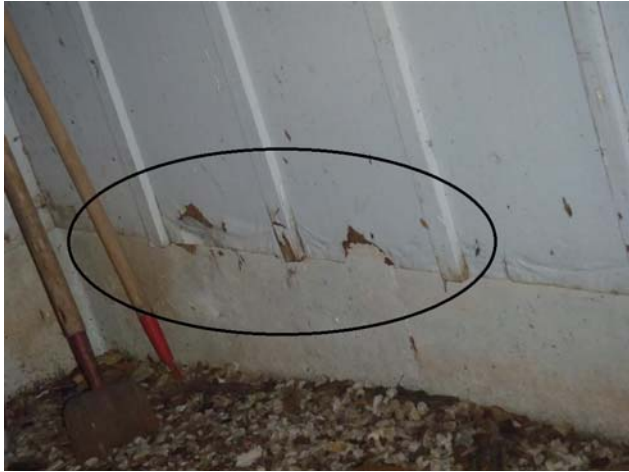
- **Repair:** Localized rot was observed in the old board and bat siding under the deck. Repair is discretionary due to the location.

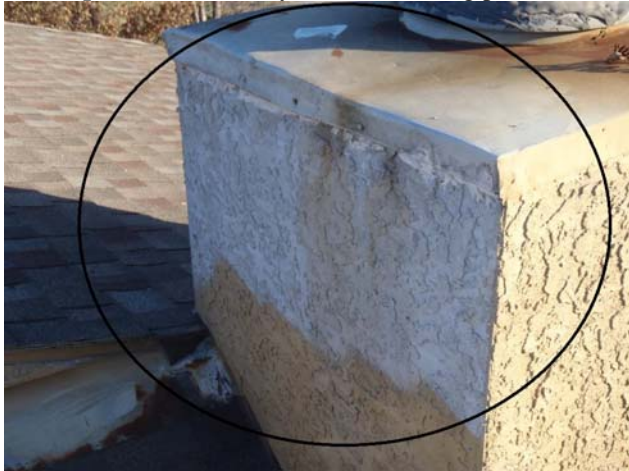
- **Repair:** The chimney stucco is lacking paint. This area should be painted.

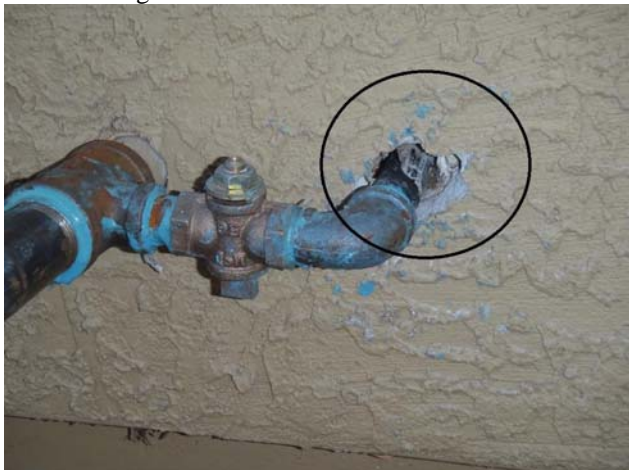
- **Repair:** Any openings in the exterior siding should be sealed. An example is where the gas pipe enters the house. Caulking is needed.

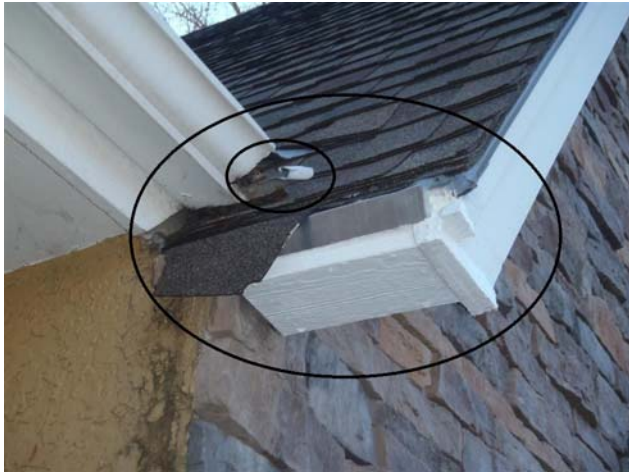
- **Repair:** Localized and repaired water damage and/or rot was observed in the eaves/fascia over the front porch. See gutter notes in the Roofing Section.

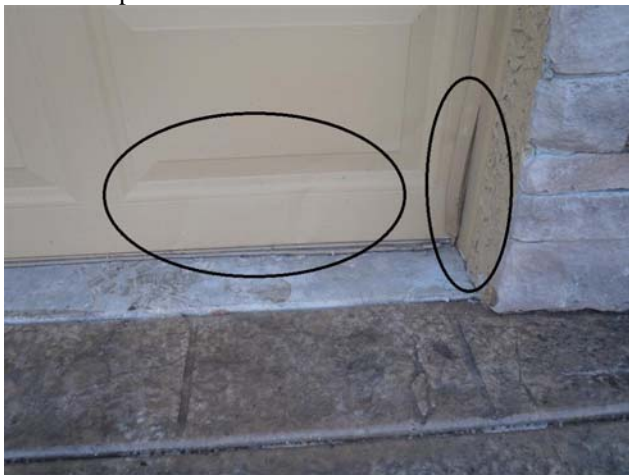
- **Repair:** The north overhead garage door weather strip is loose and needs repair. There is also very minor damage to lower panel next to this area.

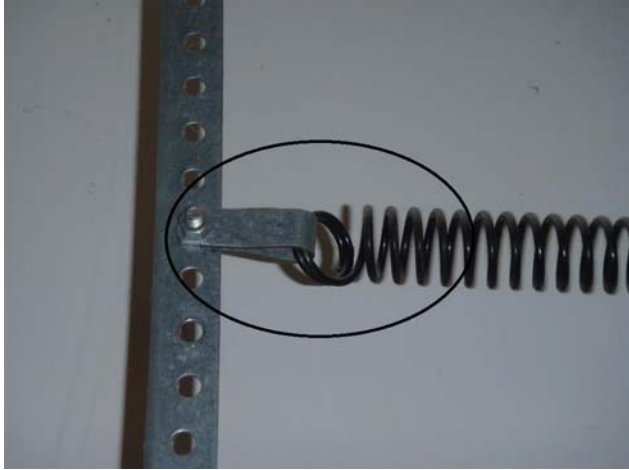
- **Repair, Safety Issue:** The garage door openers did not automatically reverse under resistance to closing. *There is a serious risk of injury, particularly to children, under this condition.* Adjustment or replacement is needed if the opener has this feature. Both doors did reverse with the floor sensors.
- **Repair, Safety Issue:** No safety springs/cables were noted on the garage door springs. The installation of the springs/cables would improve safety during operation.

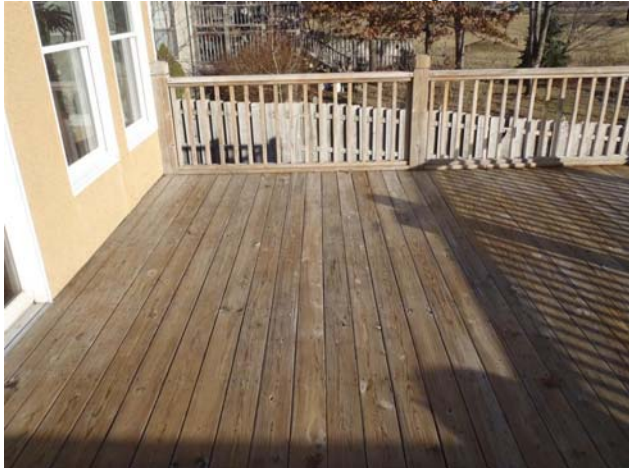
- **Recommend:** The deck should be painted or stained to improve durability.

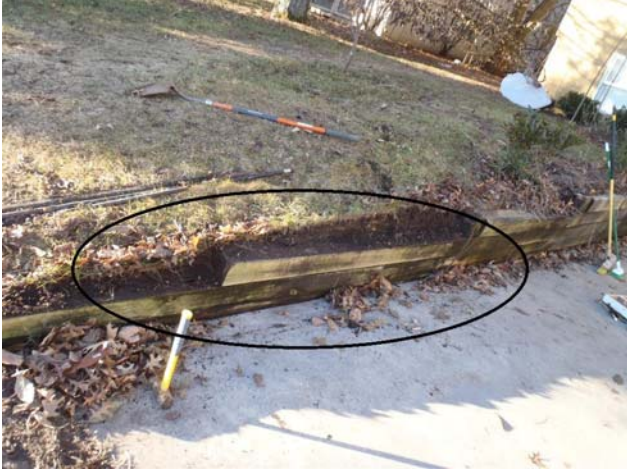
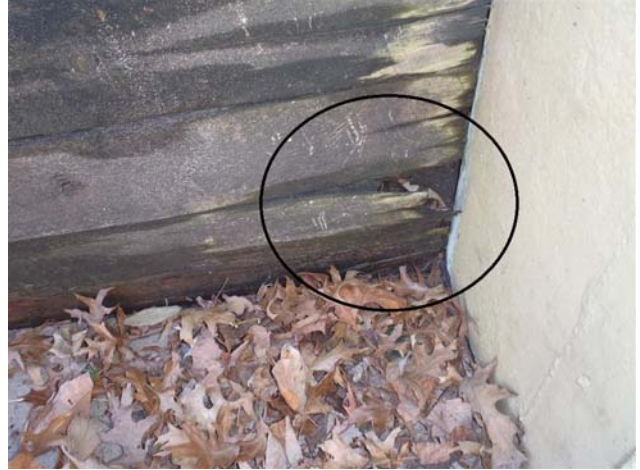
- **Repair:** The retaining wall shows evidence of movement, damage and rot. This condition should be repaired.

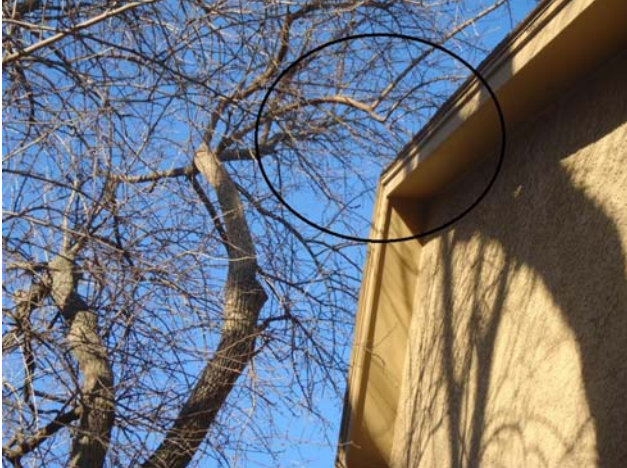
- **Repair:** Tree branches should be trimmed away from the house to avoid damage to the building.

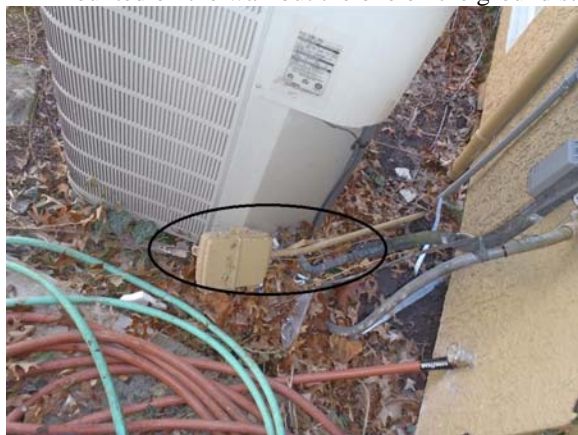
- **Repair:** The phone cable service box is lying on the ground. This box may have been replaced with a newer one that is mounted on the wall but the one on the ground still has wiring in it. This should be removed or repaired as necessary.

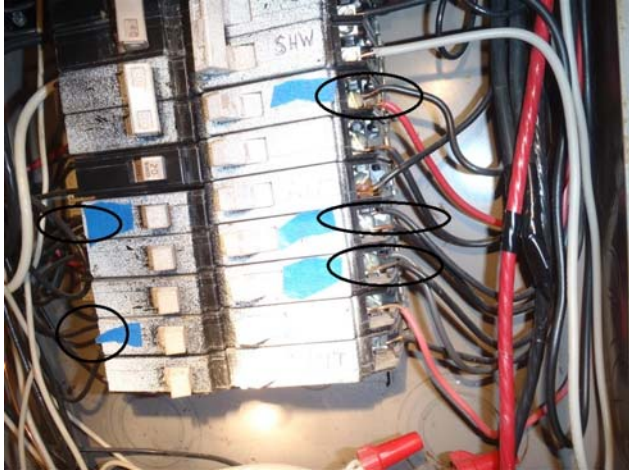
- **Repair:** Circuits within the main distribution panel that are doubled up (referred to as “double taps”) should be separated. Each circuit should be served by a separate fuse or breaker.

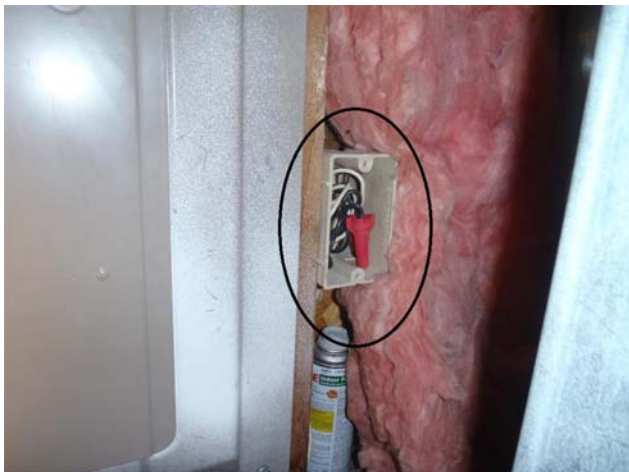
- **Repair:** The open outlet box on the side of the main panel should be covered or an outlet installed in order to protect the wire connections.

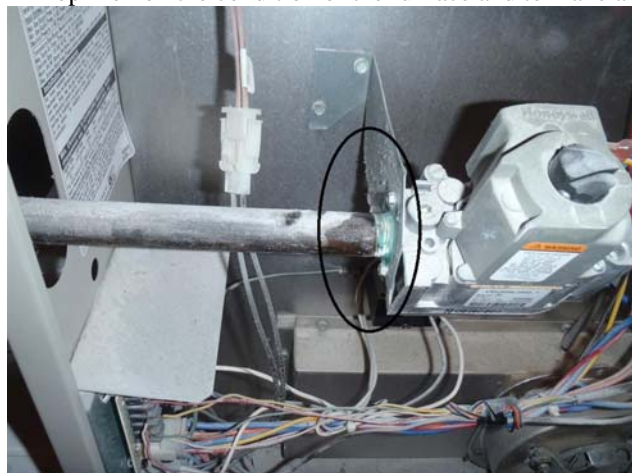
- **Repair, Safety Issue:** The furnace was tested for carbon monoxide spillage and gas leaks with a TUFF 8800 and positive readings were observed for gas in the threads on the left side of the control unit and confirmed with soapy water. *This condition is a safety risk.* Since home inspectors are not considered to be experts in these matters it is recommended that a qualified service technician or utility company representative should be engaged immediately to get a second opinion on the condition of the furnace and to make any repairs necessary.

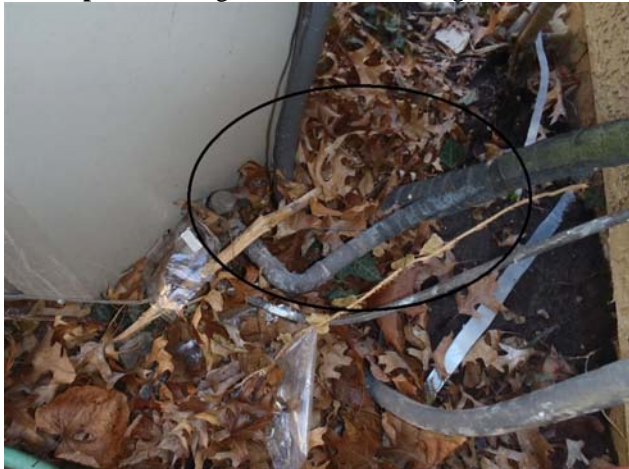
- **Repair:** Damaged insulation on refrigerant lines should be repaired.

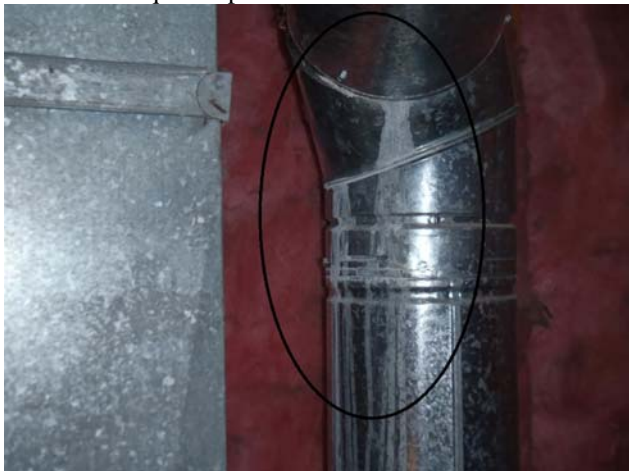
- **Monitor:** While in the attic water stains were observed on the lower sections of the furnace flue. This can be caused from several things. The most common is just condensation in the flue above the roof. Another would be the storm collar around the flue could be leaking. The wind can also blow just right that rain blows in under the rain cap and runs down the interior of the flue until it gets to the first joint where it then transferred to the outside surface and dripped off the elbow. This is a common condition in 80% of homes but very seldom is enough to penetrate completely through the insulation to the drywall below. Monitor for any additional wetness after rains. There were no signs above the roof that would require repairs.

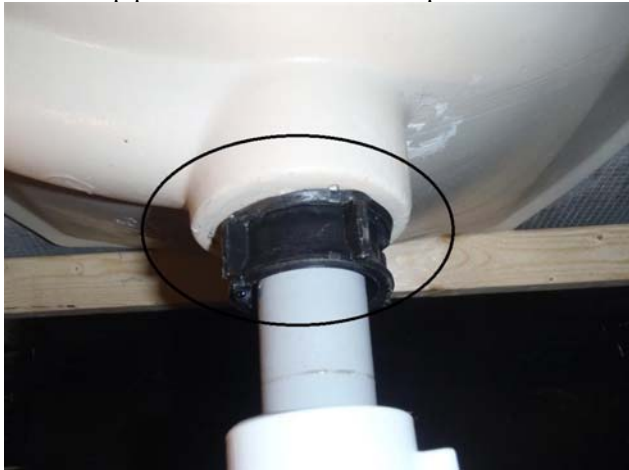
- **Repair:** The drain pipes on both master bedroom bath, basement bath and basement bar sinks are leaking where the drain pipe connects to the sink. Repairs are needed.

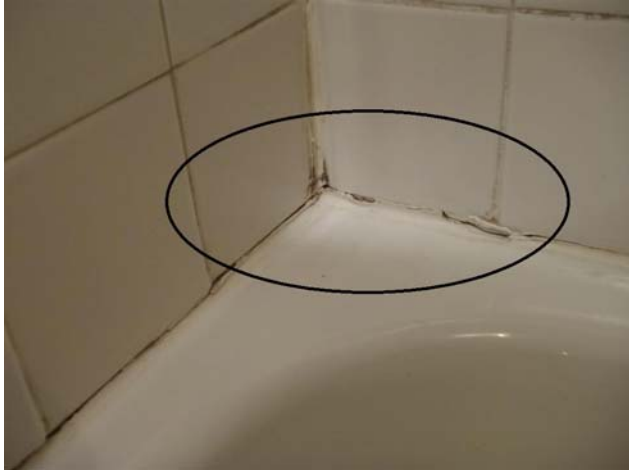
- **Improve:** Cracked, deteriorated and/or missing bathtub enclosure caulk in the upstairs hallway bathroom could be improved.

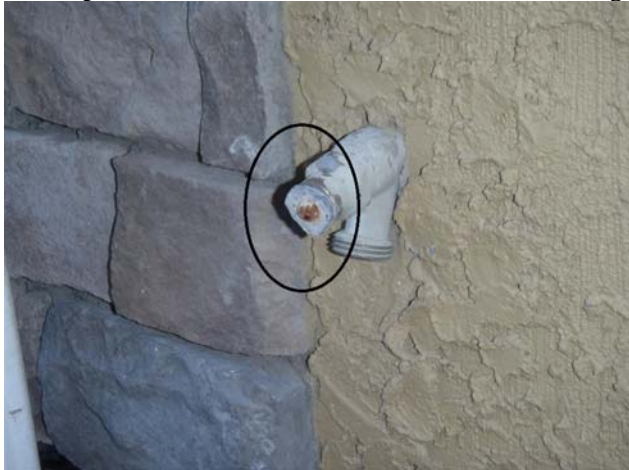
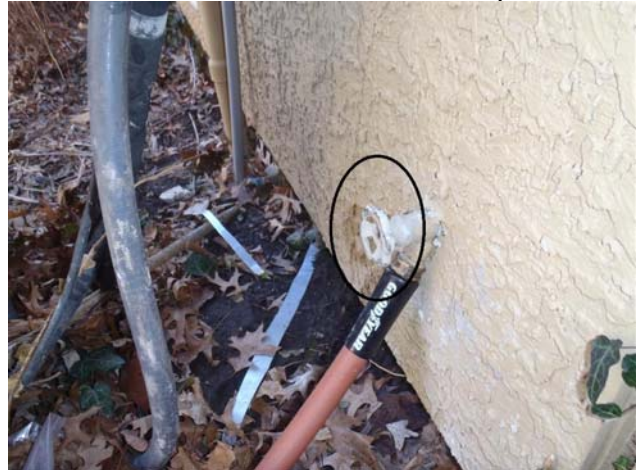
- **Repair:** The handle for the south hose bib is missing and the handle for the north hose bib is loose. Repairs are needed.

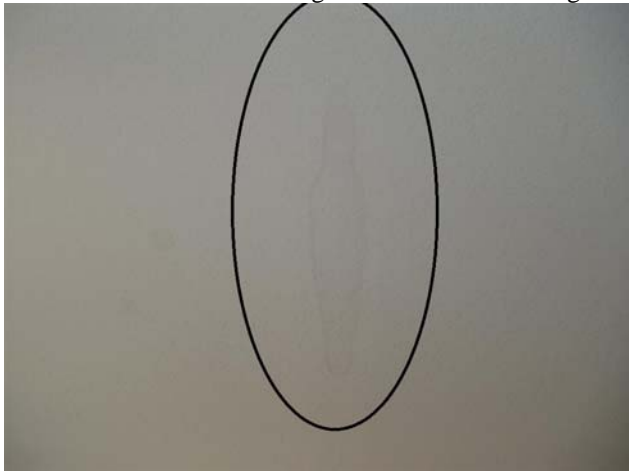
- **Monitor:** Water staining was noted on the living room ceiling.

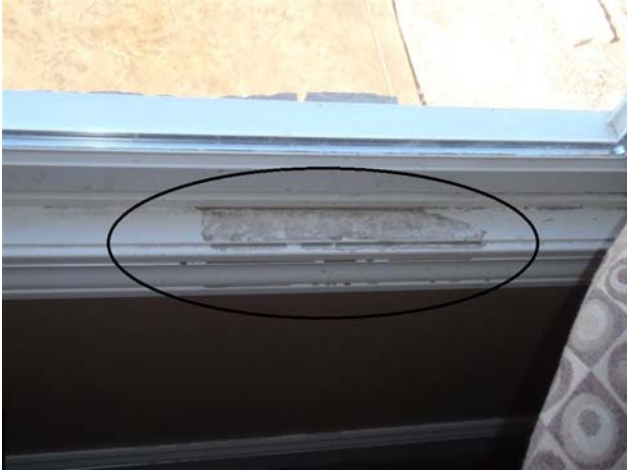
- **Monitor:** Water staining was observed on the interior window trim in the northwest bedroom.

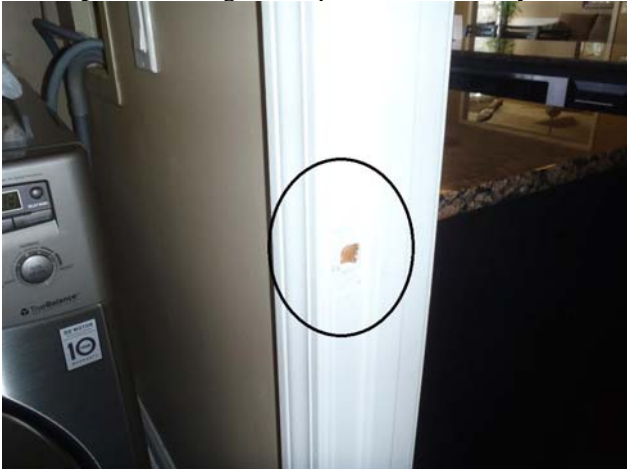
- **Repair:** Door to the southwest bedroom should be adjusted as necessary to latch properly.
- **Repair:** Doors to the furnace closet should be repaired to stay in the track when opening.
- **Repair:** Missing striker plate on the laundry room door should be installed
