**Star
Home
Inspection Services**

Home Inspection Report

13968 W 150th Terr Olathe, KS 66062

Inspection Date: 08/03/2010

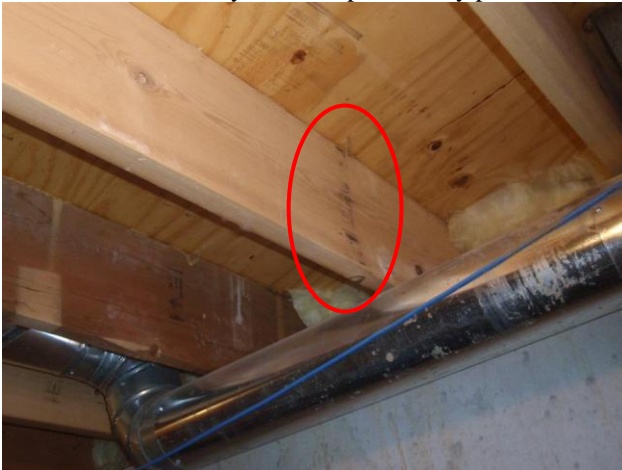
- **Monitor:** Construction mold was visible on some floor joists. This is mold that grows on the lumber while lying in the weather during construction. Most homes have some level of this mold and it goes dormant once removed from the elements and normally does not present any problems.

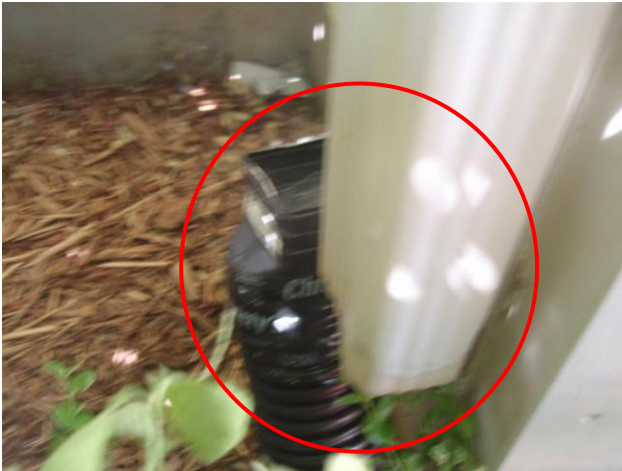
- **Repair:** The downspout is not inside the underground piping. This should be repaired so the water flows away from the foundation. **REPAIRED**

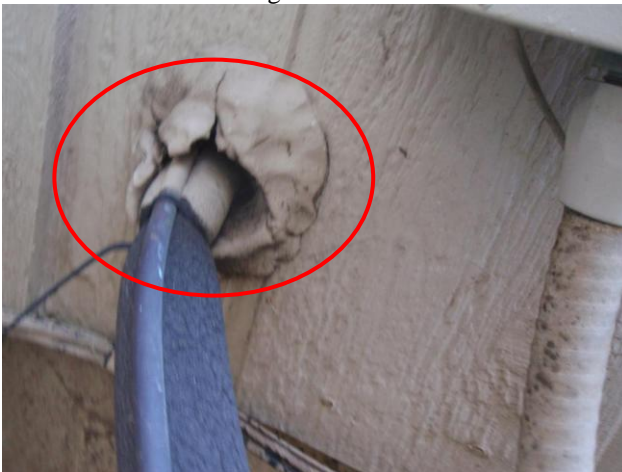
- **Repair:** Siding of this type requires considerable monitoring and maintenance. It has a tendency to pop out past nail heads creating a space where two panels join together. Re-securing and caulking the seams and nail holes is standard maintenance for this type of siding (i.e. west side seam needs caulking.) **REPAIRED**
- **Repair:** Any openings in the exterior siding should be sealed. An example is where the air conditioner refrigerant lines enter the house. Caulking is needed. **REPAIRED**

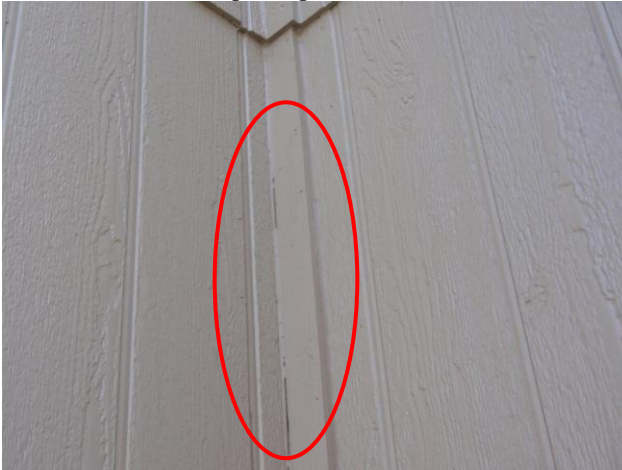
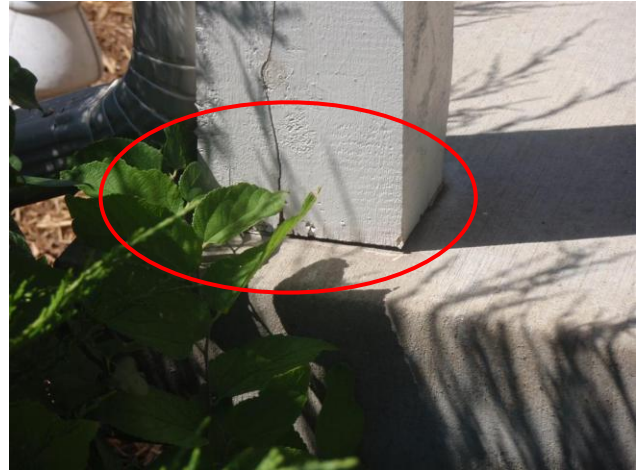
- **Repair:** The siding trim needs caulking improvements in localized areas to prevent water damage and rot (i.e. northeast corner and bottom of porch post trim.) **REPAIRED**

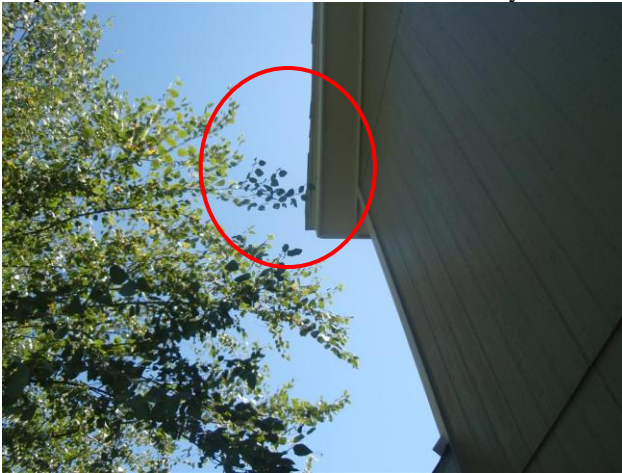
- **Repair:** Tree branches should be trimmed away from the house to avoid damage to the building. **REPAIRED**

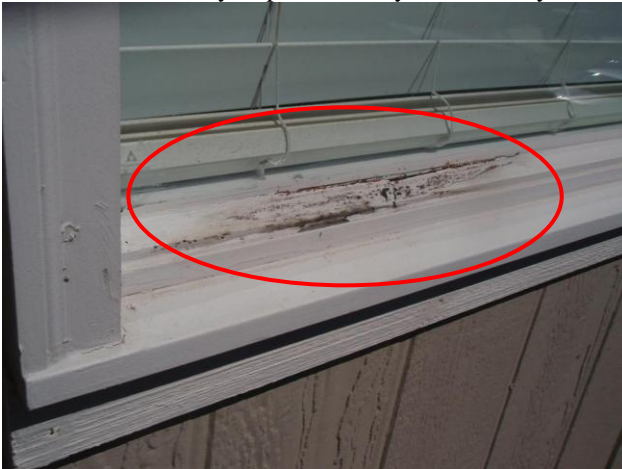
- **Repair:** Some of the window frames require painting and caulking.
- **Repair:** Localized evidence of rot was visible on window trim/frames (i.e. west side and 2nd story front.) Repair to the window frame can usually be accomplished by a skilled carpenter. It's recommended that a thorough "inventory" be taken by a competent window repair technician to ascertain exactly how many areas will need to be repaired or replaced. Further evaluation by a specialist may well identify additional areas that require servicing.

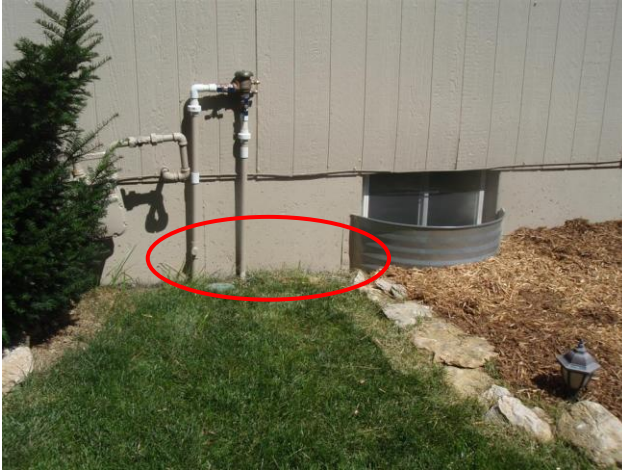
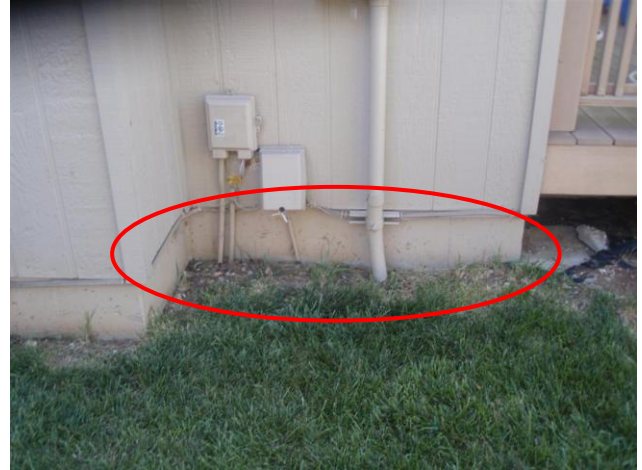
- **Repair:** The grading should be improved to promote the flow of storm water away from the house. This can often be accomplished by the addition of top soil. The ground should slope away from the house at a rate of one inch per foot for at least the first five feet. At least eight (8) inches of clearance should be maintained between soil level and the bottom of exterior wall siding. *It should be understood that it is impossible to predict whether moisture penetration will pose a problem in the future.*

- **Recommend:** Covers should be provided for the basement window wells to keep storm water out of the well.

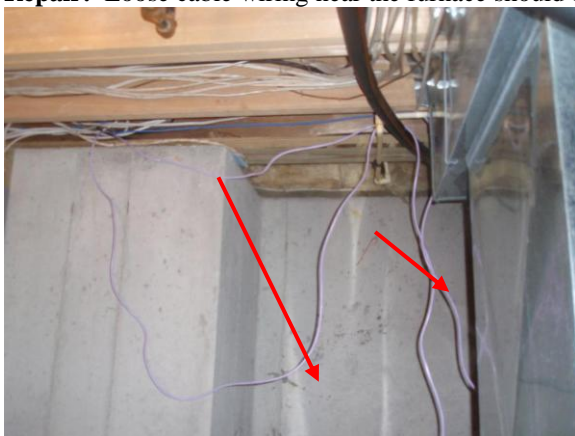
- **Repair:** Loose cable wiring near the furnace should be secured or removed.

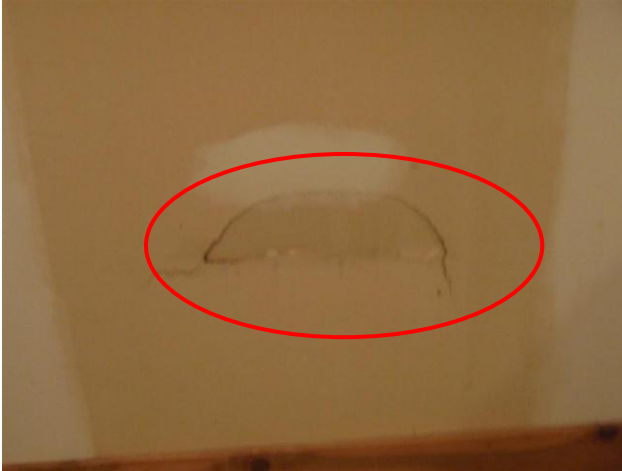
- **Monitor, Repair:** Damage to the garage drywall was observed.
