Star Home Inspection Services

Home Inspection Report

1440 N Hunter Dr, Olathe, KS 66061

Report Number: 10182008-1A

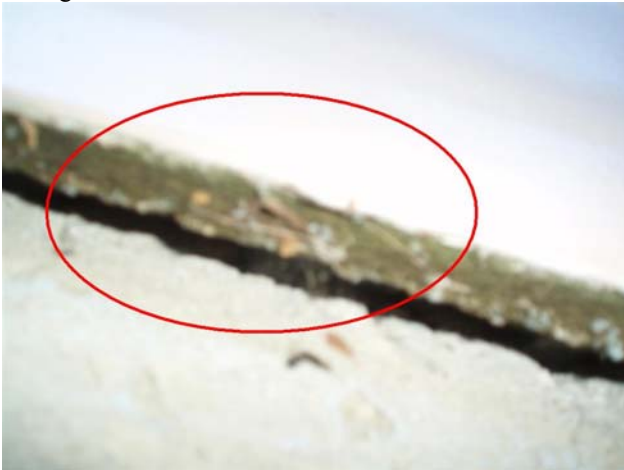
- **Repair:** The exterior siding paint is unpainted at bottom edge of siding . These areas should be painted to prevent water damage or rot in the future.

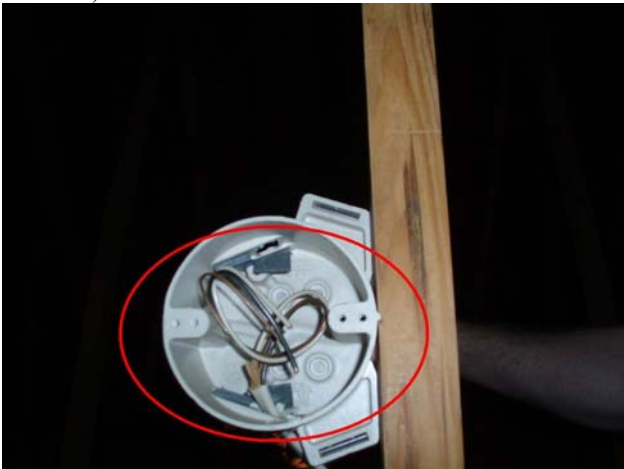
- **Repair:** All junction boxes should be fitted with cover plates, in order to protect the wire connections (example in attic entrance).

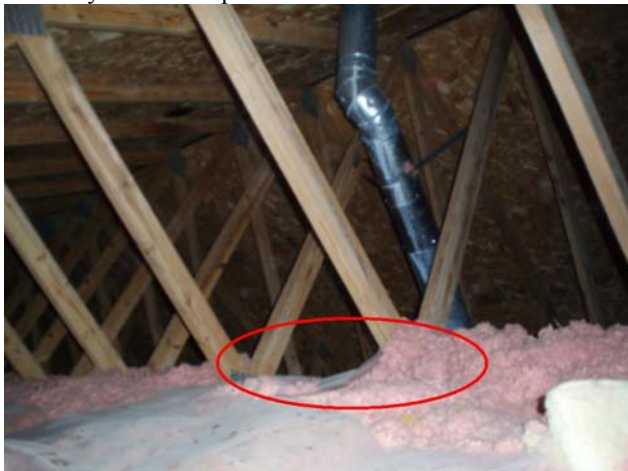
- **Monitor:** Plastic was noted in attic below furnace vent piping. This area should be monitored as this suggest a previous leak may have been present.
