**Star  
Home  
Inspection Services**

*Home Inspection Report*

**14832 W 81st Terr, Lenexa, KS 66215**

**Inspection Date: 06/29/2009**

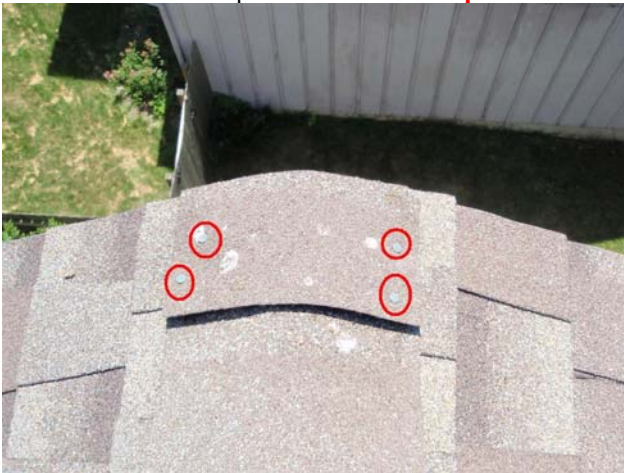
- **Repair:** Exposed nail heads were observed in the roofing shingles and/or ridge caps. All exposed nail heads should be caulked to reduce the potential of leaks. **Repaired**

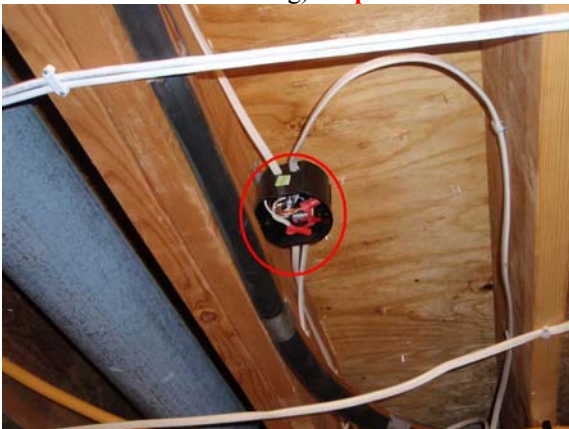
- **Repair:** Loose cable wiring at the unfinished basement ceiling should be secured. **Repaired**
- **Repair:** All junction boxes should be fitted with cover plates, in order to protect the wire connections (example at unfinished basement ceiling). **Repaired**
