**Star
Home
Inspection Services**

Home Inspection Report

15003 W 147th St, Olathe, KS 66062

Inspection Date: 05/29/2009

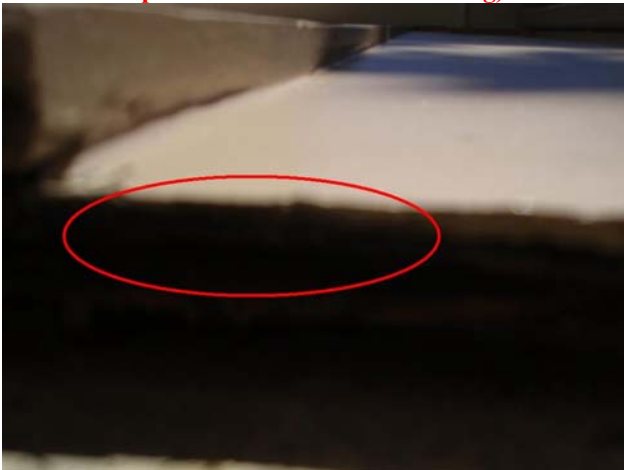
- **Repair:** The exterior siding paint is peeling and/or worn thin in localized areas (minor area at bottom edge of siding near front porch). These areas should be painted to prevent water damage or rot in the future. **Repaired (Painted the under-edge of siding and trim along the front of house near porch to prevent future wood rot. Used clear silicon seal around porch where it meets the siding)**

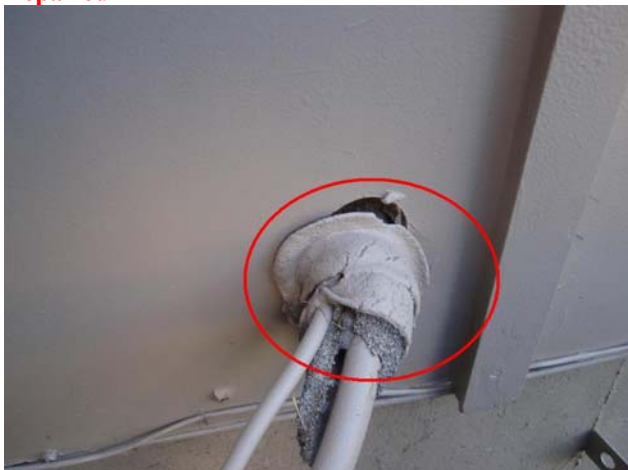
- **Repair:** Openings at siding should be sealed (example at air conditioner where refrigerant lines enter the siding).
Repaired

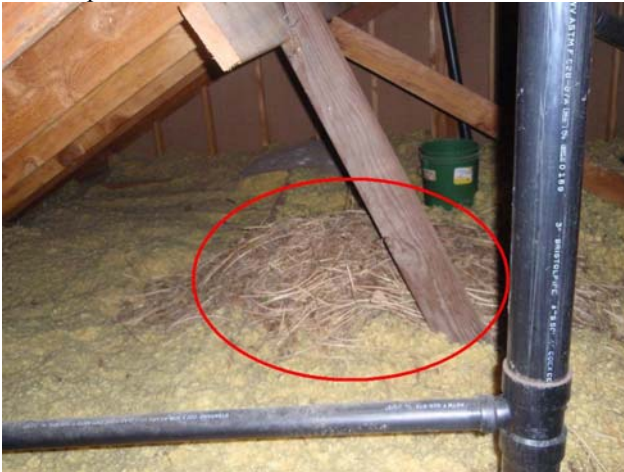
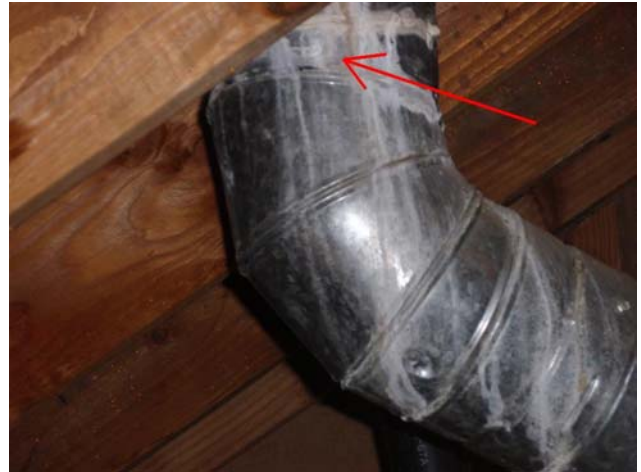
- **Recommend:** There is a large bird nest in the attic. It's recommended this be removed. **Repaired (removed nest)**
- **Monitor:** Evidence of previous leak at the furnace exhaust vent pipe in the attic was observed. This is a common condition normally caused by weather with strong wind and heavy rains where water entering the exhaust vent at the roof seeps out at the first elbow.
