**Star  
Home  
Inspection Services**

*Home Inspection Report*

**15401 Antioch, Overland Park, KS 66221**

**Inspection Date: 9/26/2008**

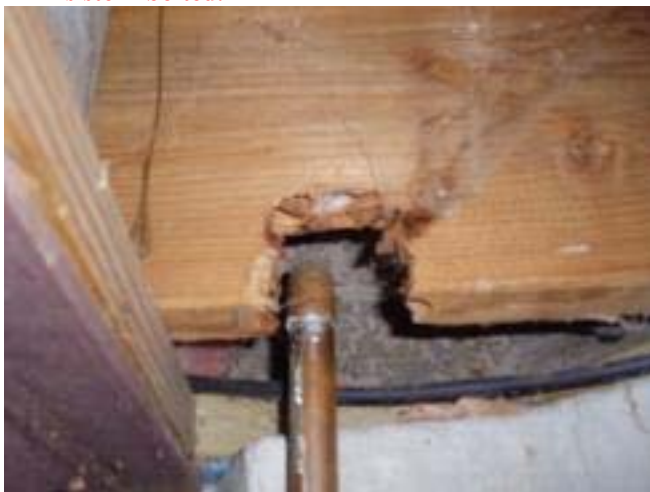
- **Monitor/Repair:** A floor joist is notched and or cut above the water main entry (cut by a plumber during construction). This weakens the joist and risks structural damage; repairs or additional support may be needed. **Repaired – 2x6 “sister” bolted.**

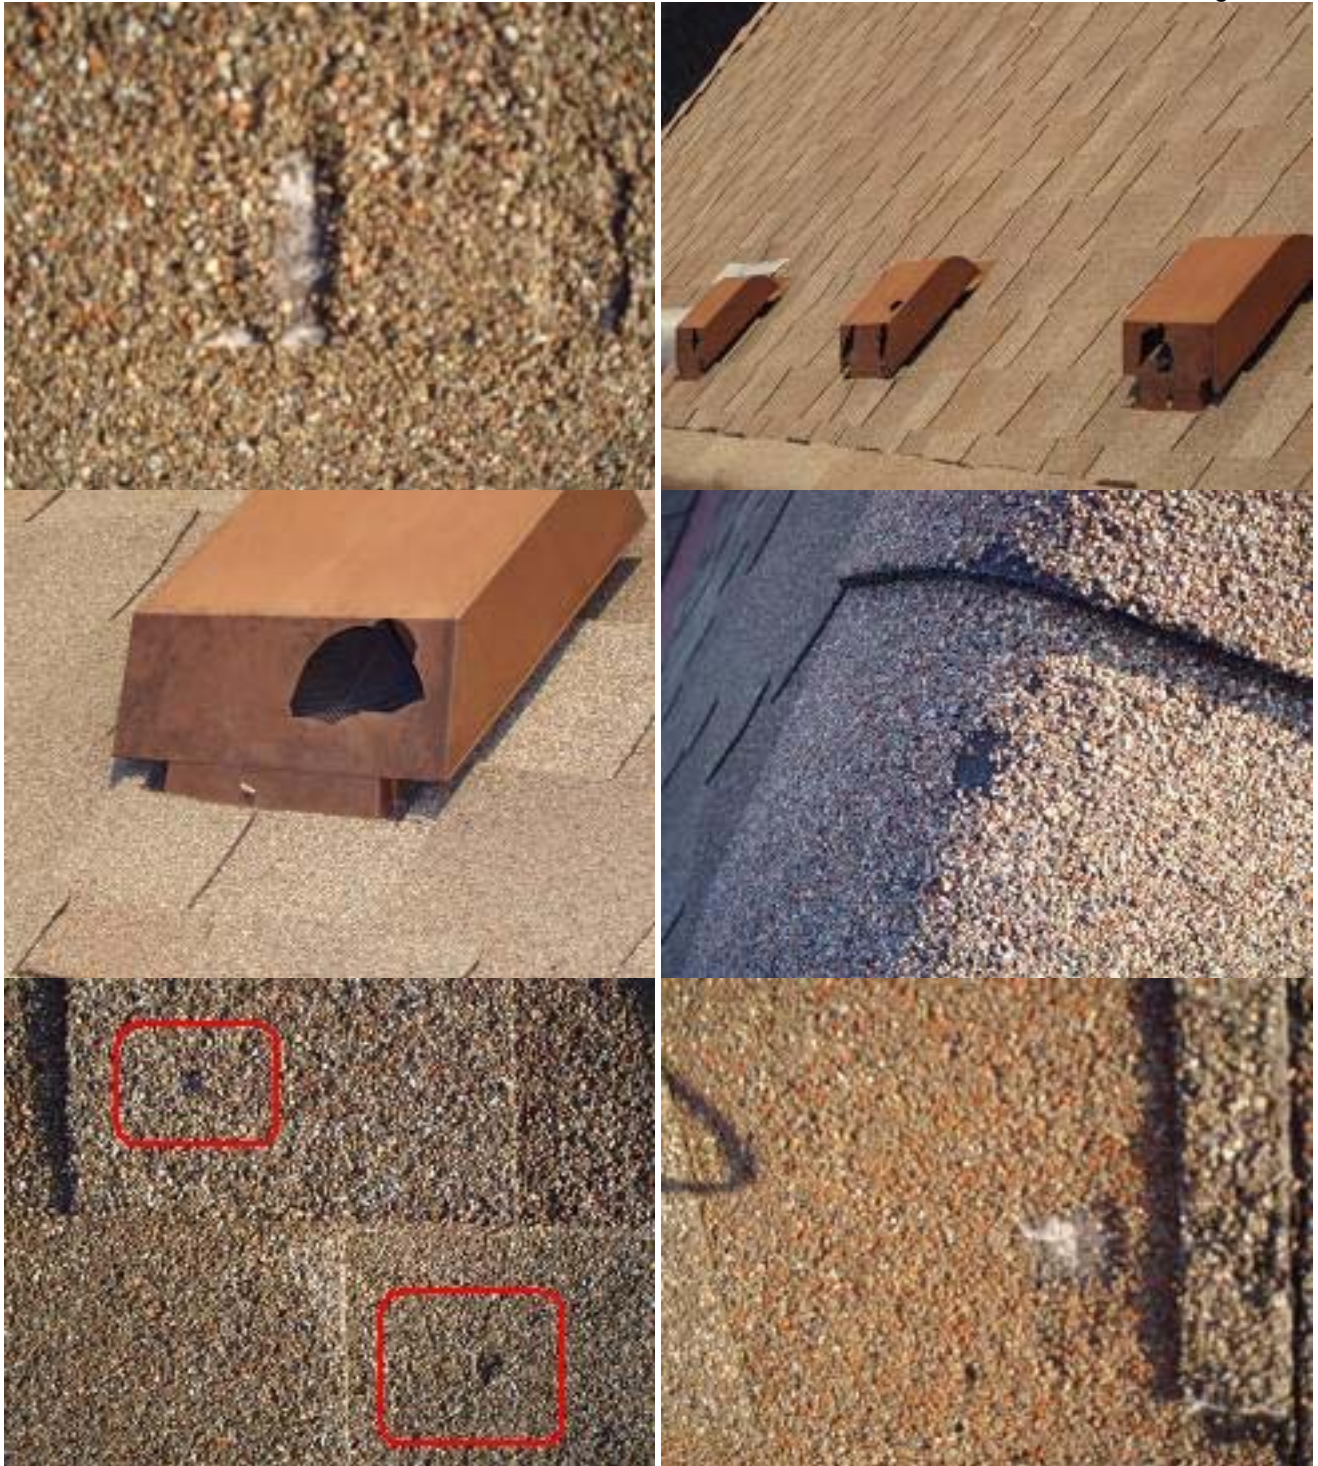
- **Repair:** Repairs to the roofing are needed (suspected storm damage). Damaged or missing roofing material should be repaired. All roof penetrations should be examined and sealed as necessary. Pock marks typically associated with hail damage were noted as well as damage to all roof vents (see photos).

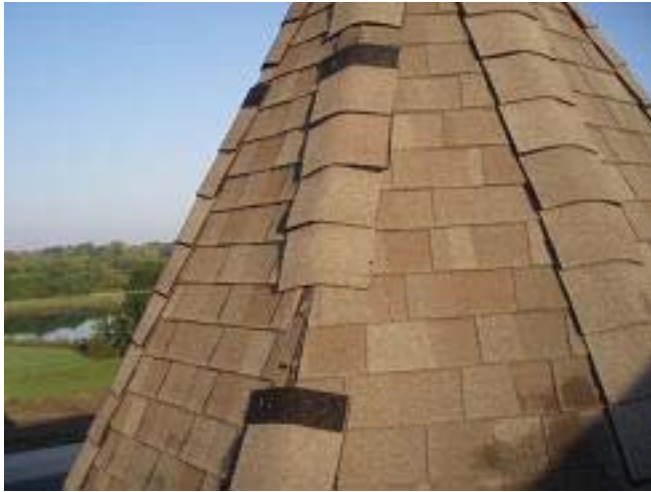
- **Repair:** There are missing tabs on shingles. Repairs are recommended at this time these areas should be monitored especially after instances of high wind.

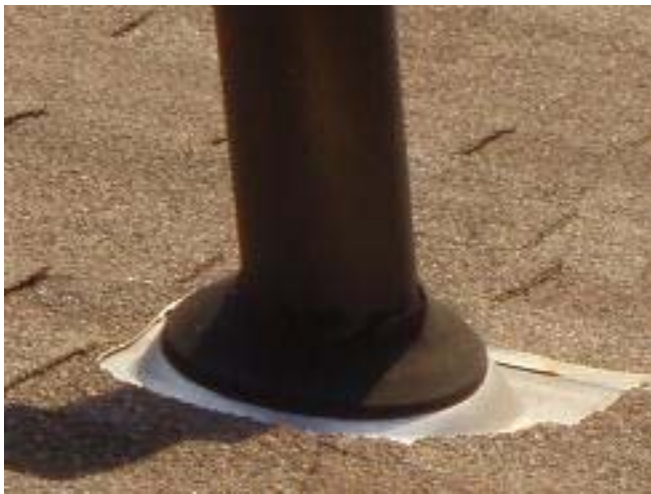
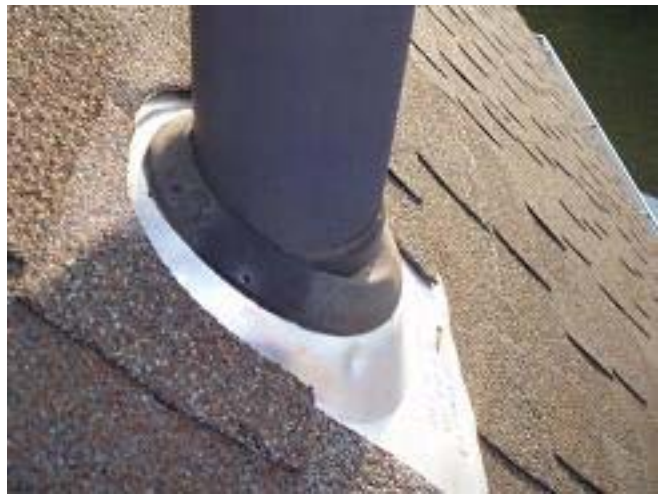
- **Monitor/Repair:** The rubber boot flashing on the plumbing vents is older and vulnerable and should be carefully monitored for leaks or replaced.

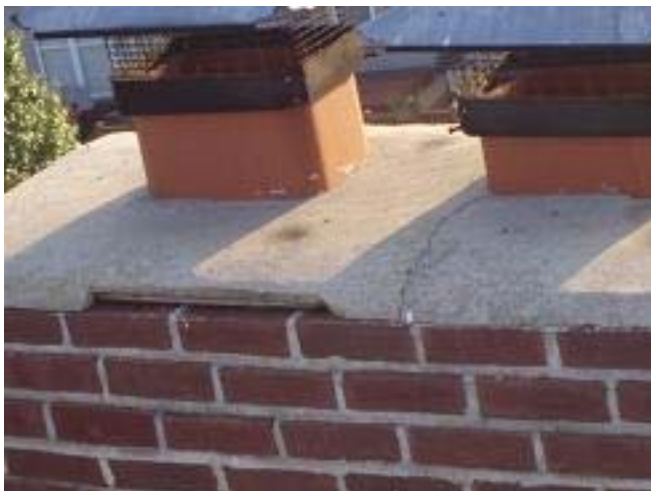
- **Repair:** The cap of the masonry chimney is cracked. These cracks should be sealed or caulked before winter to prevent damage from freezing water.

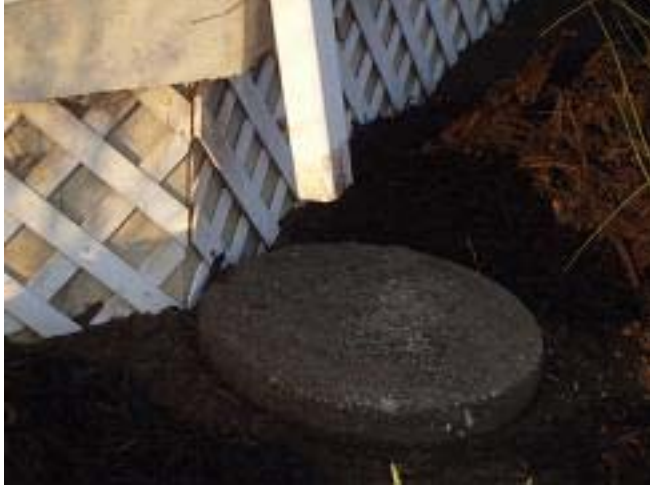
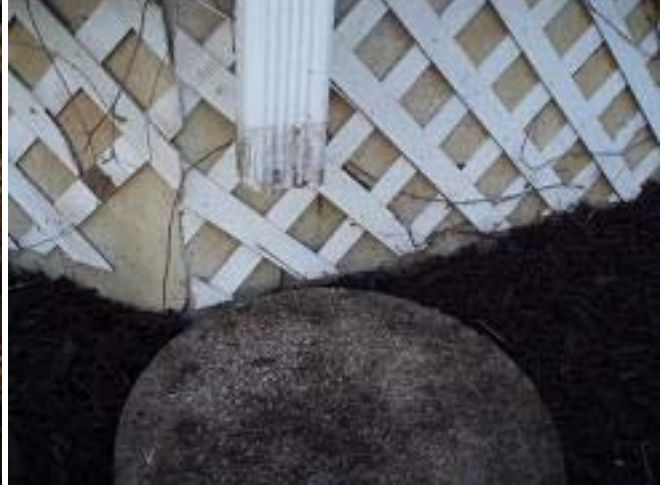
- **Repair:** The downspout(s) should discharge water at least five (5) feet from the house. Storm water should be encouraged to flow away from the building at the point of discharge.

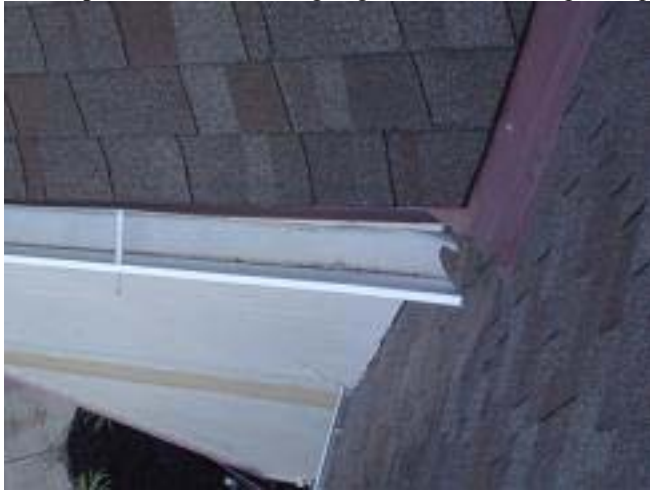
- **Repair:** Loose or damaged gutters should be repaired promptly.

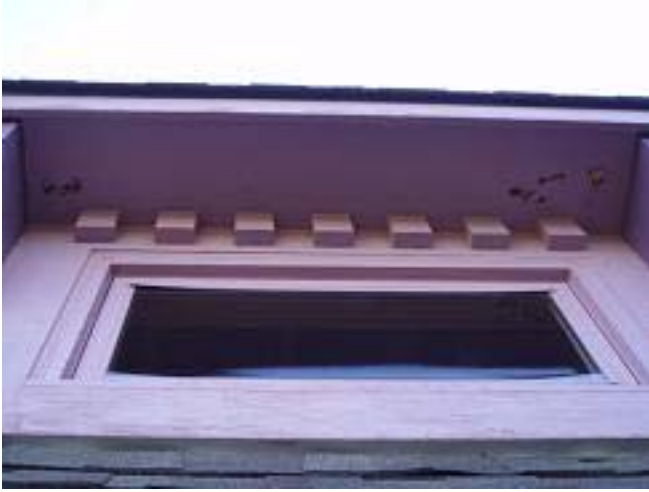
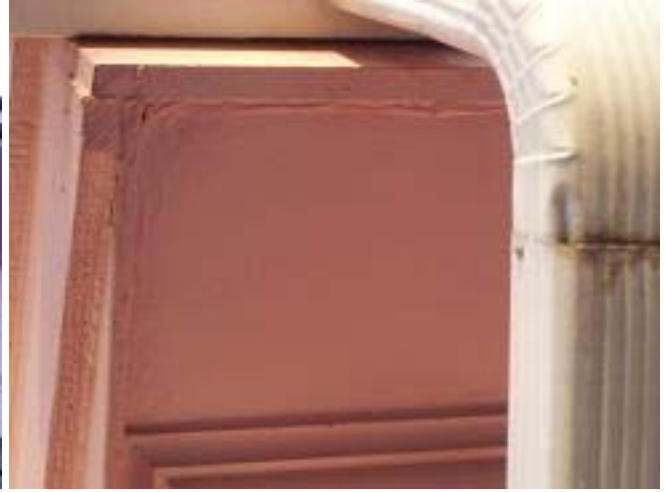
- **Monitor:** Localized rot & damage was observed in the soffit. Improvement is not necessary at present, although this condition should be repaired when exterior painting or maintenance are planned.

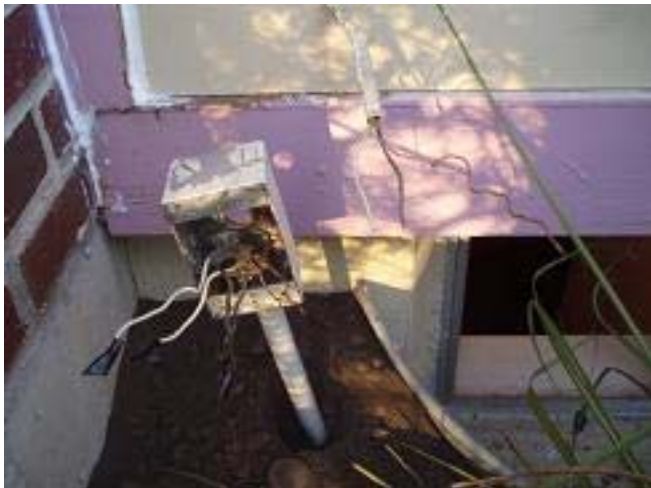
- **Repair:** Improper electrical connections should be repaired (exterior wiring – appears to be in process of repairs). All electrical connections should be made inside junction boxes fitted with cover plates. **Repaired – Junction box in back of he pond has been covered with a place with all wires inside**

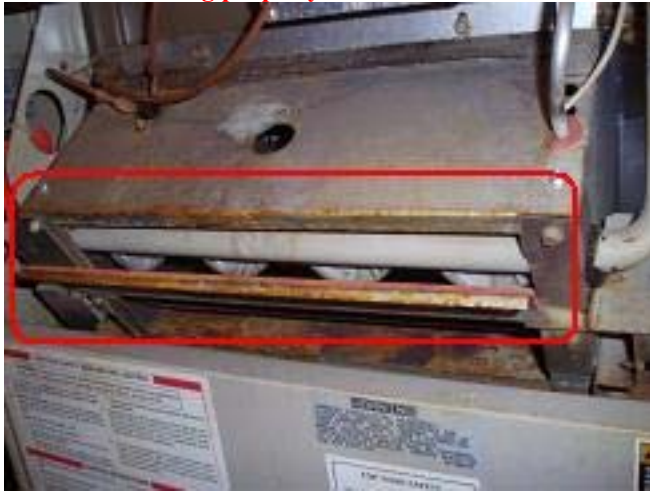
- **Repair:** The heating system requires service – the door on the right hand unit (5892G16973) won't fully close off the heat exchanger unit as designed). This should be a regular maintenance item to assure safe, reliable heat. **Repaired – door is closing properly**

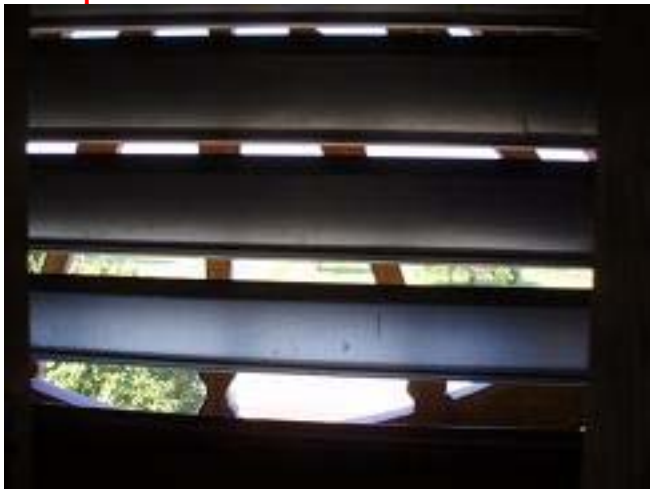
- **Repair:** The gable roof vents above the front of the home should be screened to prevent insect and vermin entry.  
**Repaired – screen installed**

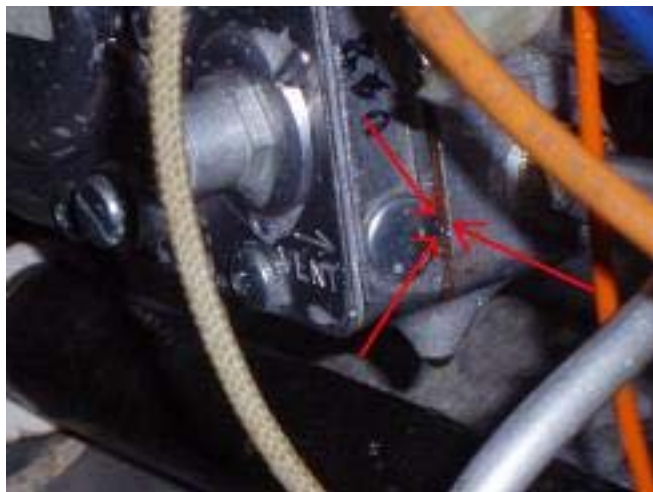
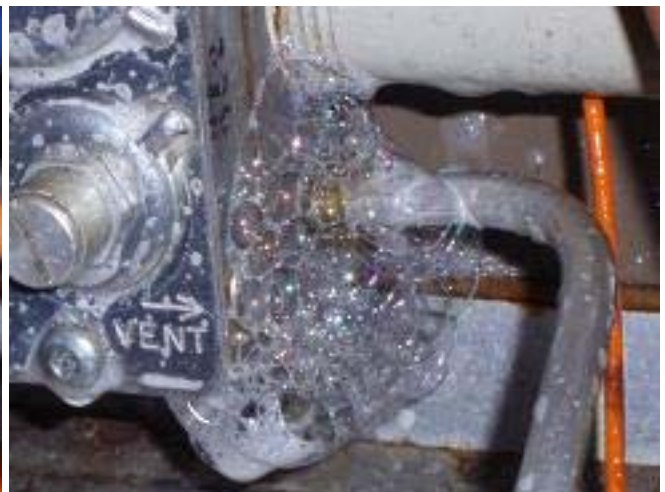
- **Repair, Safety Issue:** *Two gas leaks were detected using a TUFF 8800 multi gas detector and soapy water – both of the leaks are within the walls of the two furnaces. The left hand unit (5892G16879) is leaking at the control box and the right hand unit (5892G16973) is leaking at the supply to the pilot. This is a serious safety concern. It is recommended that a plumber or an HVAC Technician be engaged immediately. The current occupants of the home should be notified. **Repaired – both gas leaks resolved***

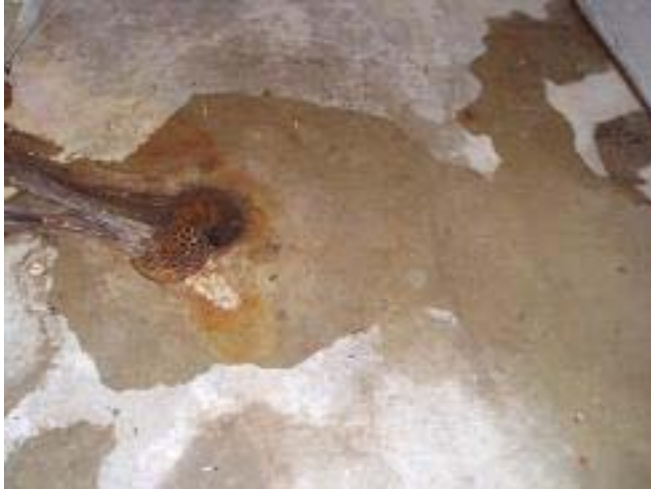
- **Repair:** It is suspected that the waste piping is obstructed at the basement floor drain in front of the furnaces. Further investigation is needed. **Repaired – cleaned and now unobstructed**

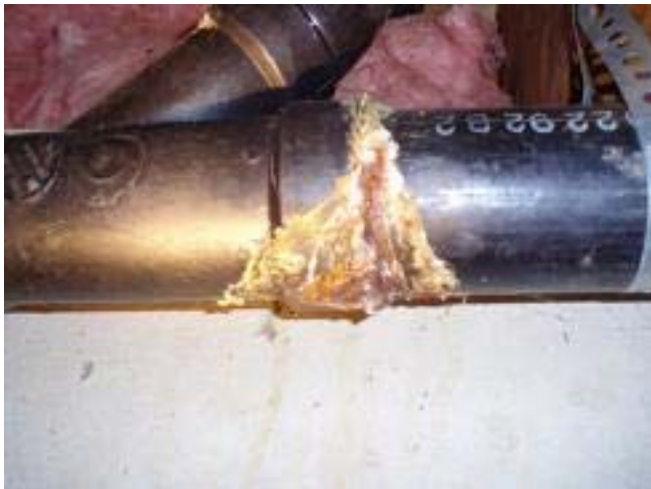
- **Repair:** The trap is leaking in the north unfinished area of the basement.

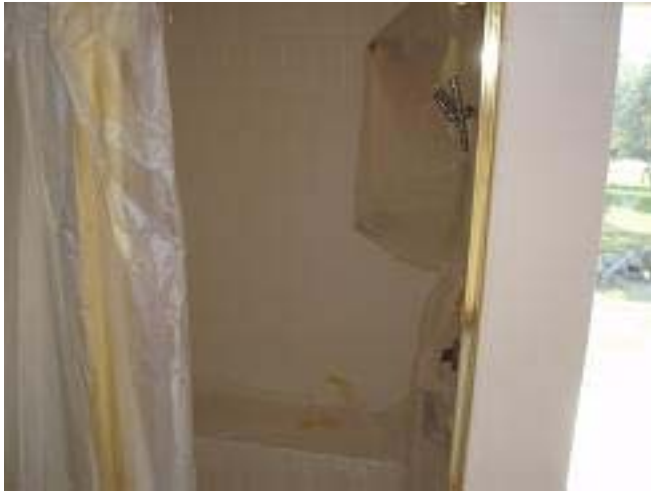
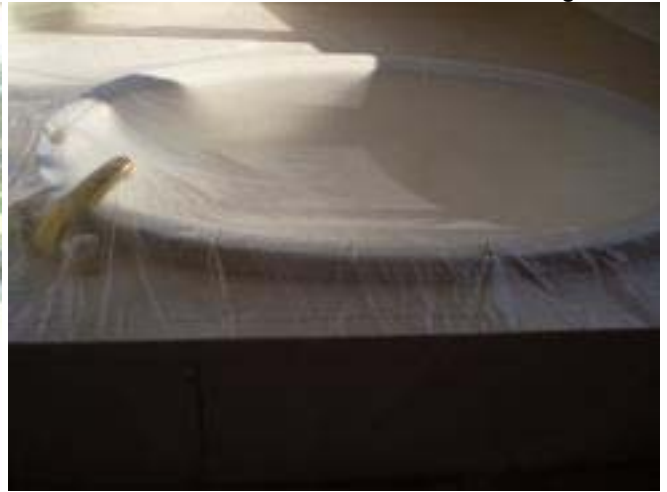
- **Repair:** The faucet(s) are leaking at the bidet.
- **Repair:** The sink drain plug is inoperative or damaged and needs repair in the upstairs bathroom – right side of dual sink.
- **Improve:** Cracked, deteriorated and/or missing shower stall grout and caulk could be improved.
- **Repair:** The bidet was drain plug is missing.
- **Note:** Painting was in process in the master bathroom, rendering the tub and shower inaccessible for testing.

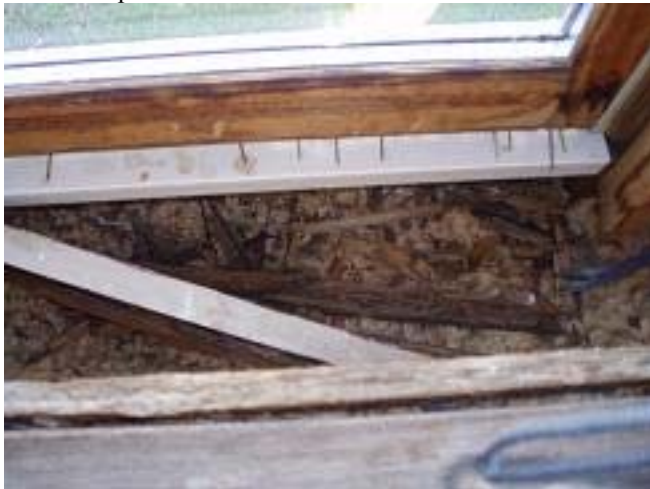
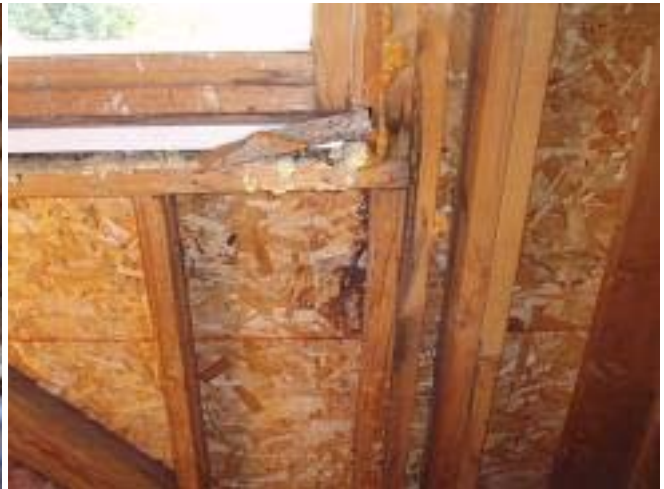
- **Monitor/Repair:** Water damage was observed below the window sills of the attic windows. This would suggest chronic leakage. Caulking can be improved as a first step –and some repairs have already been undertaken. If leakage persists, replacement of the window and repair to any concealed damage may be necessary. Refer also to the Exterior section of this report.

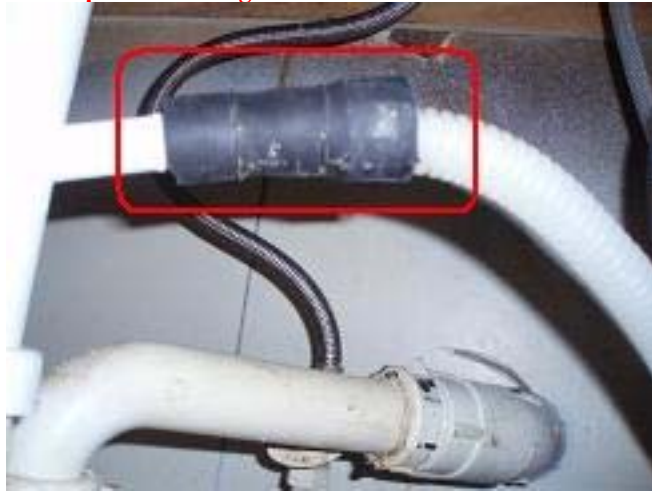
- **Monitor/Repair:** The dishwasher drain connection at the waste piping is marginal – a hose clamp should be installed.  
**Repaired – new grout installed**
