**Star  
Home  
Inspection Services**

*Home Inspection Report*

**15609 W 127th Terr Olathe, KS 66062**

**Inspection Date: 03/17/2010**

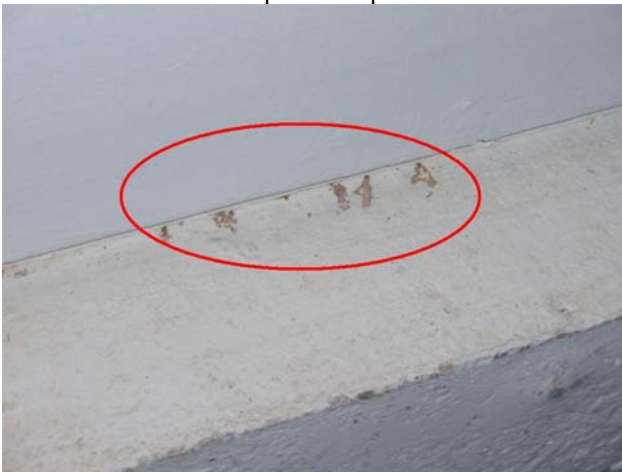
- **Repair:** Evidence of termite staining and exit shelter tubes was observed at the west garage wall and there is risk of additional hidden damage since termites can do a substantial amount of damage. If the property has not already been treated, a licensed pest control specialist should be engaged to eliminate further termite activity within the home. Damaged wood should be repaired or replaced. Any wood soil contact should be eliminated. See Pest Management Professionals termite inspection report for additional details.

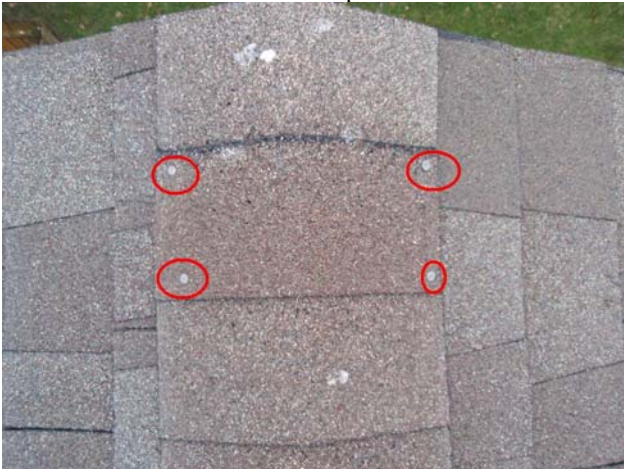
- **Recommend:** Exposed nail heads were observed in the roofing shingles and/or ridge caps. All exposed nail heads should be caulked to reduce the potential of leaks.

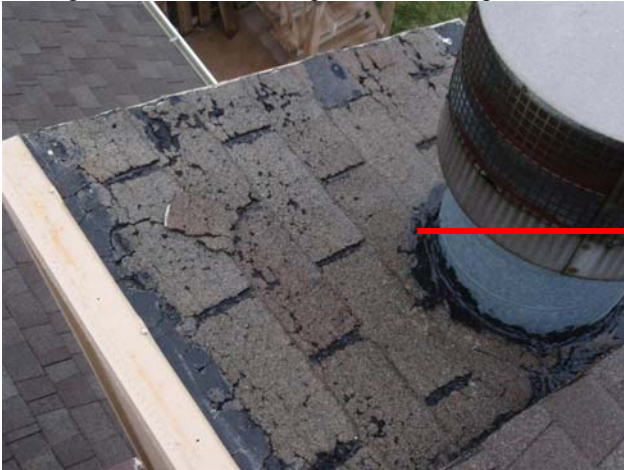
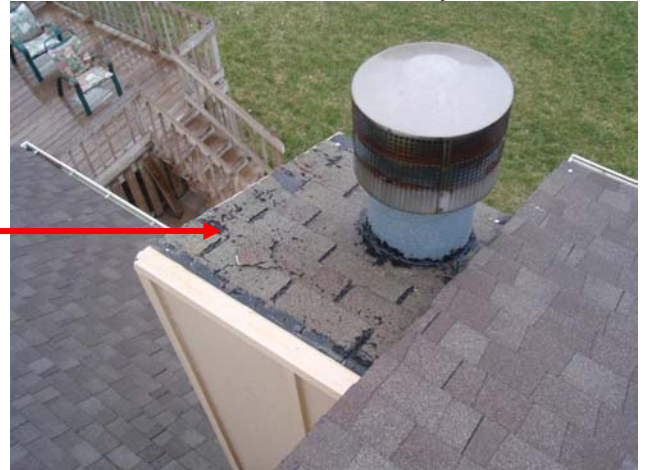
- **Repair:** Repairs to the roofing are needed at the small section of roofing over the chimney area. Damaged or missing roofing material should be repaired. All roof penetrations should be examined and sealed as necessary.

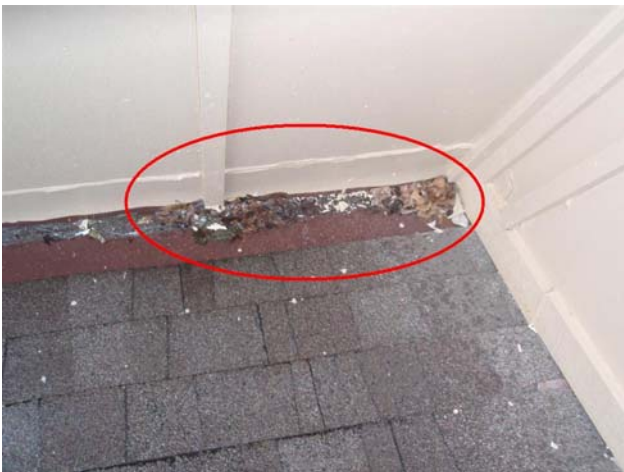
- **Monitor:** The skylight flashing should be carefully monitored. Skylight flashings are extremely vulnerable to leakage.
- **Improve:** Debris should be removed from the roofing near the chimney siding flashing to reduce risk of leaks and early roof wear.

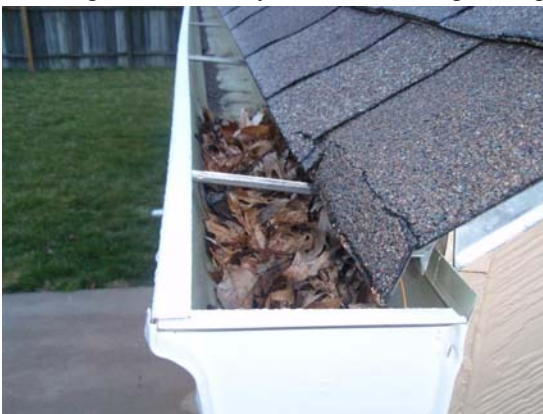
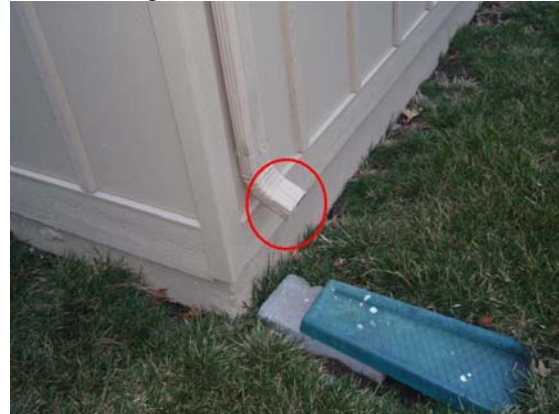
- **Repair:** The gutters require cleaning to avoid spilling roof runoff around the building – a potential source of water entry or water damage.
- **Repair:** The downspout(s) should discharge water at least five (5) feet from the house. Storm water should be encouraged to flow away from the building at the point of discharge.

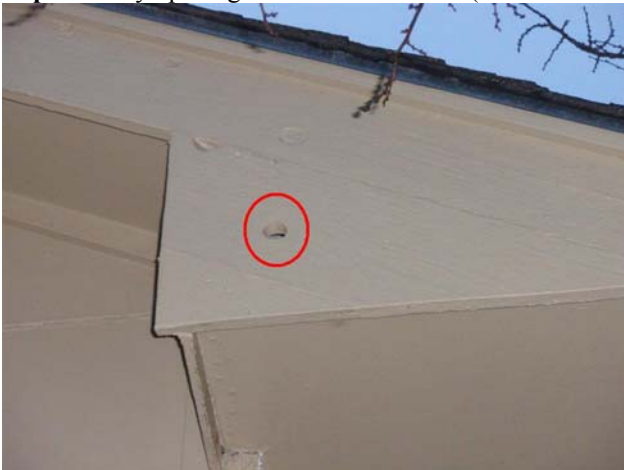
- **Repair:** Any openings in the exterior eave (i.e. hole at northeast corner) should be sealed. Caulking is needed.

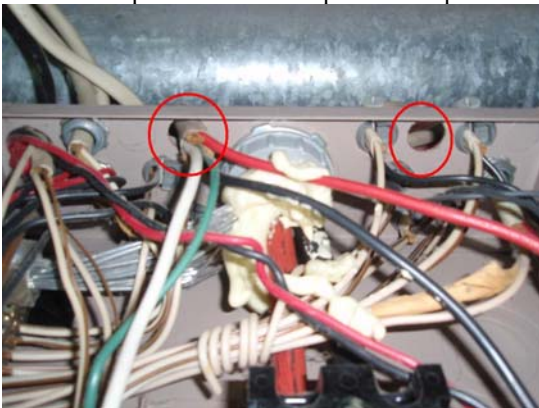
- **Repair:** Any openings in the main panel should be covered.
- **Repair:** Cable clamps (sometimes referred to as bushings or grommets) are required where wiring passes into the main distribution panel. Cable clamps serve to protect the wiring from the metal edges of the panel openings.

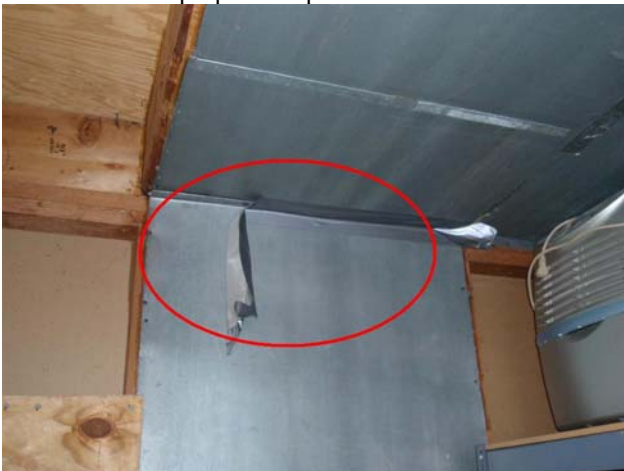
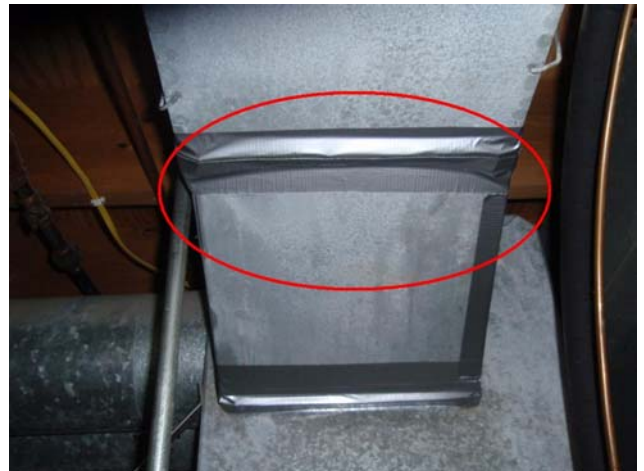
- **Monitor:** Supply air flow is less than ideal in the master bedroom. Rebalancing the ductwork, blower cleaning or repairs, filter replacement, or additional duct work may be needed to obtain good air flow. This may also be the result of ductwork below grade and insufficient time during the length of the inspection for ductwork to heat properly.
- **Repair:** Loose fitting joints and/or openings in the ductwork should be improved. Duct tape is not the appropriate material for this purpose despite its name.
