Star Home Inspection Services

Home Inspection Report

15705 Mohawk Cr, Overland Park, KS 66224

Inspection Date: 3/11/2009

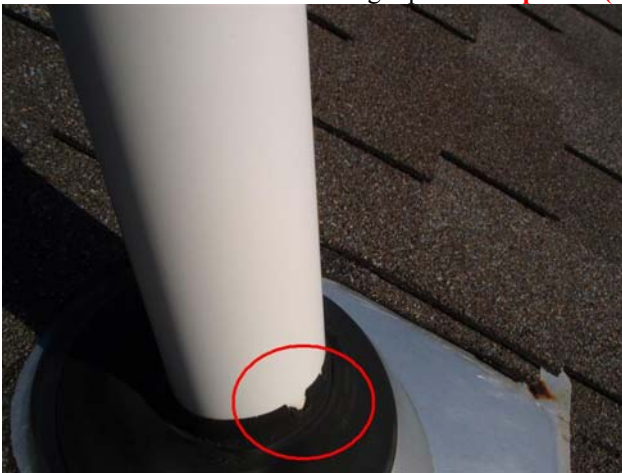
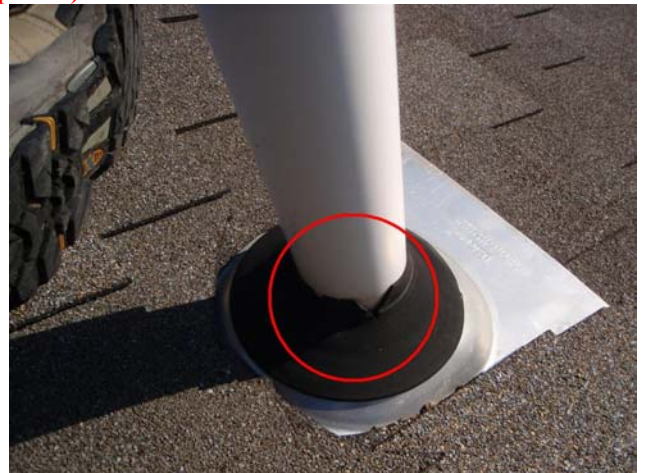
- **Monitor, Repair:** The plumbing vent flashing boots are split making them vulnerable to leaks. It's recommended that the boots be caulked or the flashing replaced. **Repaired (replaced)**
