**Star
Home
Inspection Services**

Home Inspection Report

15729 Ash St Overland Park, KS 66224

Inspection Date: 08/27/2010

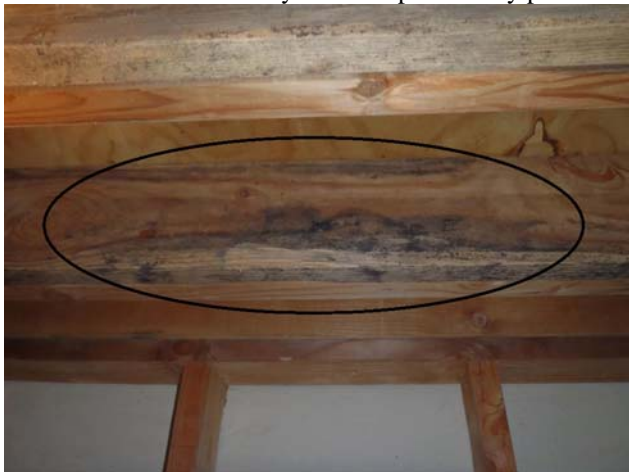
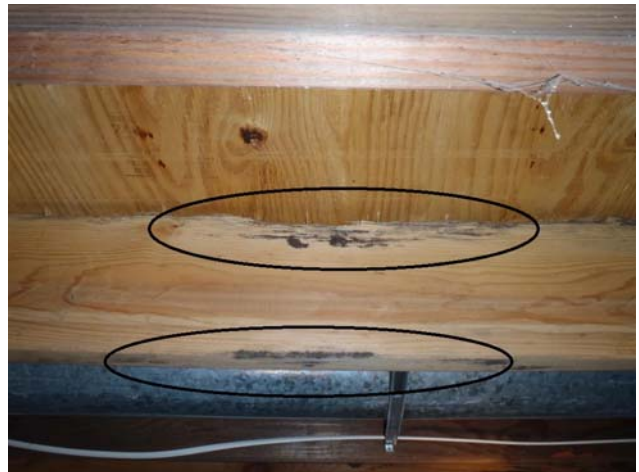
- **Monitor:** Construction mold was visible on some floor joists. This is mold that grows on the lumber while lying in the weather during construction. Most homes have some level of this mold and it goes dormant once removed from the elements and normally does not present any problems.

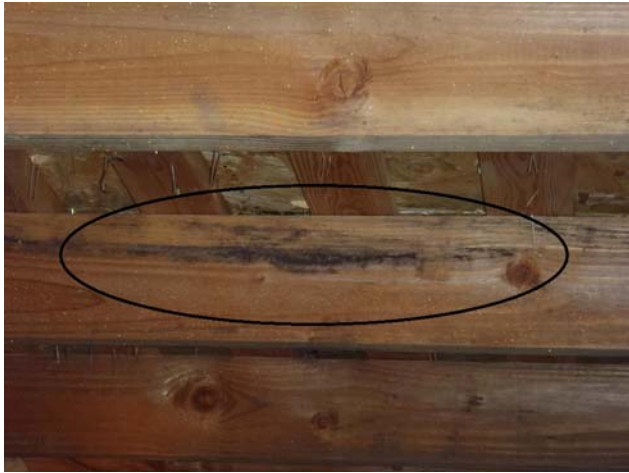
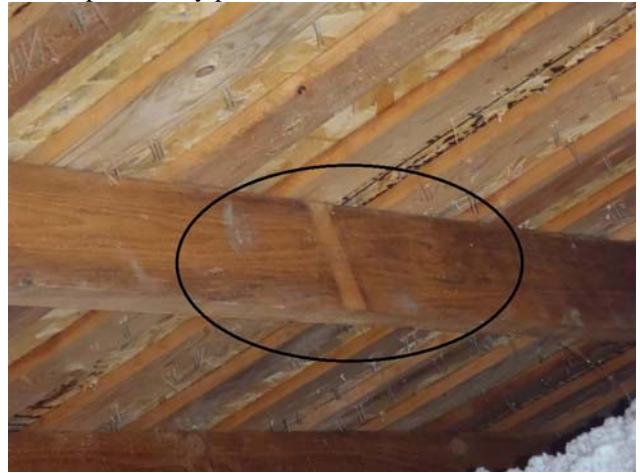
- **Monitor:** Construction mold was visible on some roof rafters. This is mold that grows on the lumber while lying in the weather during construction as evidenced by the strap marks. Most homes have some level of this mold and it goes dormant once removed from the elements and normally does not present any problems.

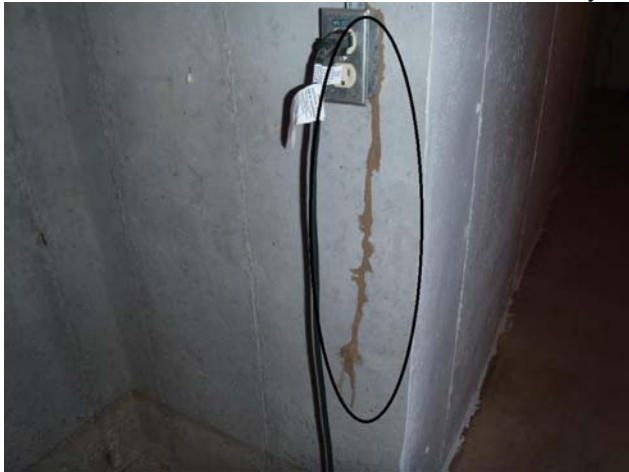
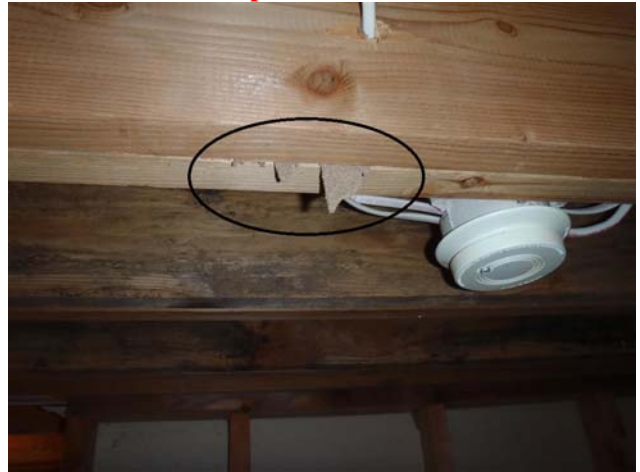
- **Repair:** Evidence of termite activity was observed and there is risk of additional hidden damage. If the property has not already been treated, a licensed pest control specialist should be engaged. Termites can do a substantial amount of damage to the wood structural components of a home. See termite report by Pest Management Professionals for additional information and recommendations if any. **Treated for termites completed**

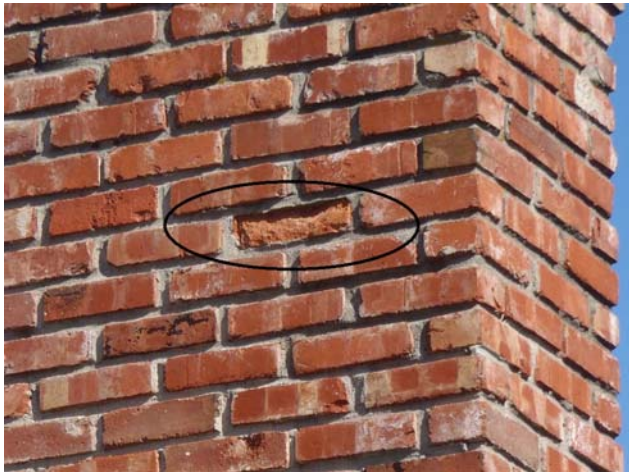
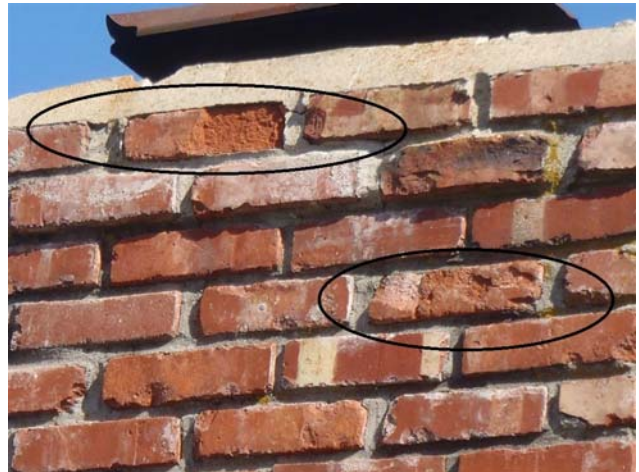
- **Monitor:** The masonry chimney shows evidence of spalling (surface deterioration of the masonry). Repair is not critical at this time but this condition should be monitored.

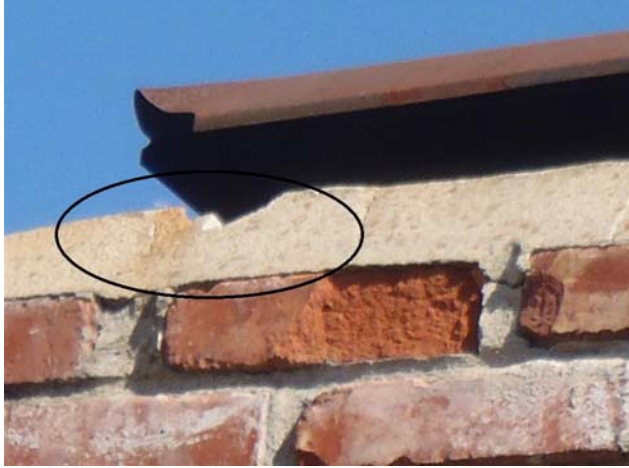
- **Monitor, Repair:** The cap of the masonry chimney appears to be cracked and/or damaged. Since the chimney was view with binoculars it's advisable to have it inspected by a chimney company that can view it from the top.

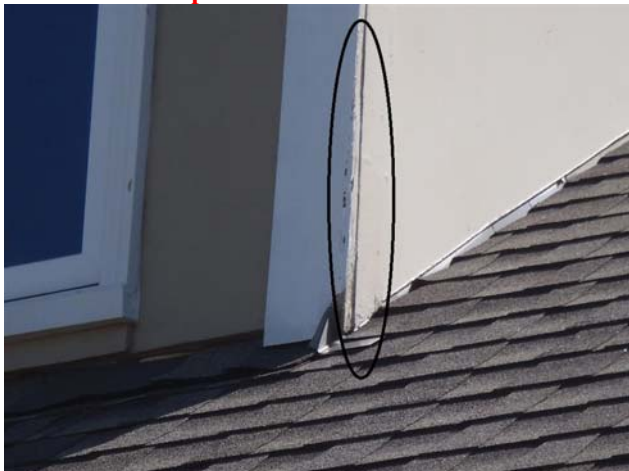
- **Repair:** The paint on the corner trim over the garage is peeling. These areas should be painted to prevent water damage and rot. **Repaired**

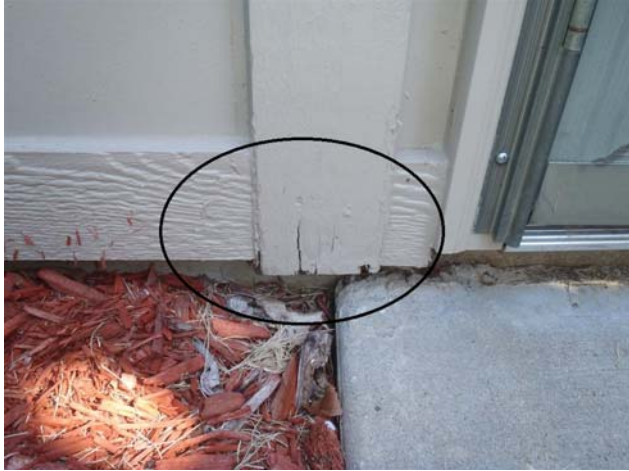
- **Repair:** Localized rot was observed in the trim by the garage walkout door. Following repair of the damaged areas (which should be combined with exterior painting/maintenance) proper maintenance of the siding and control of water from roof or surface runoff can avoid further damage. **Repaired**

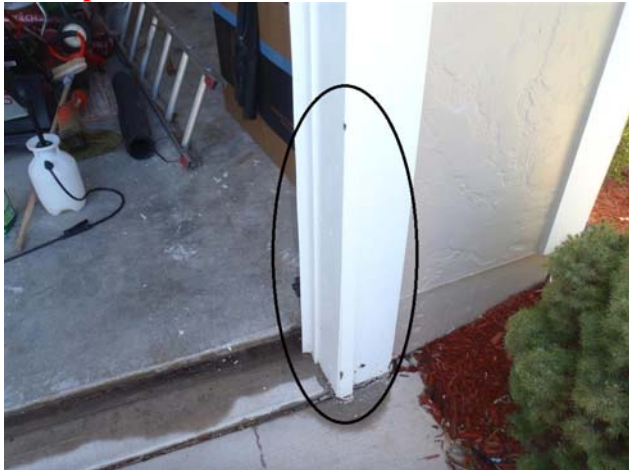
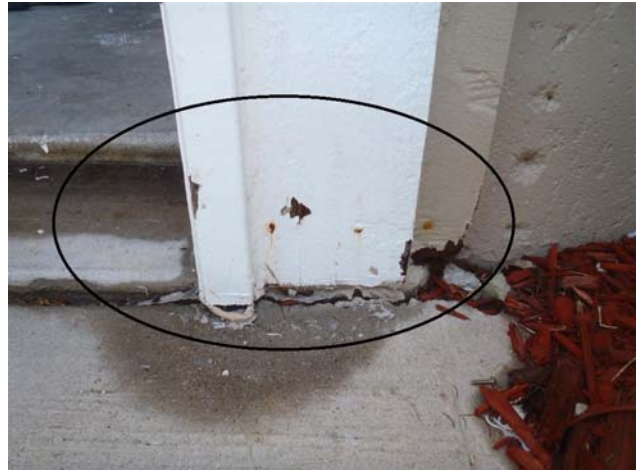
- **Repair:** The paint on the garage door frame/ trim is damaged and/or peeling and requires painting and caulking. **Repaired**

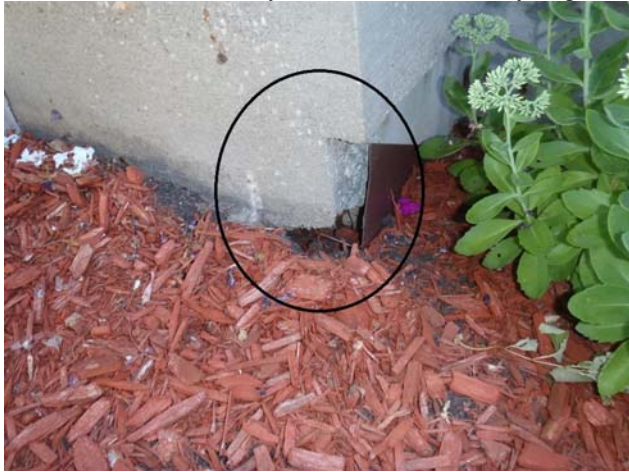
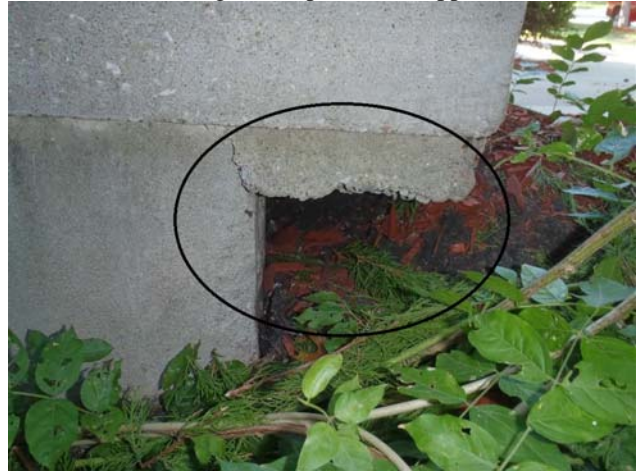
- **Monitor, Repair:** There is an absence of soil underneath the porch due to settlement and/or erosion or vermin activity. The size of the cavity is unknown but if very large it may need to be filled to give the porch the support needed.

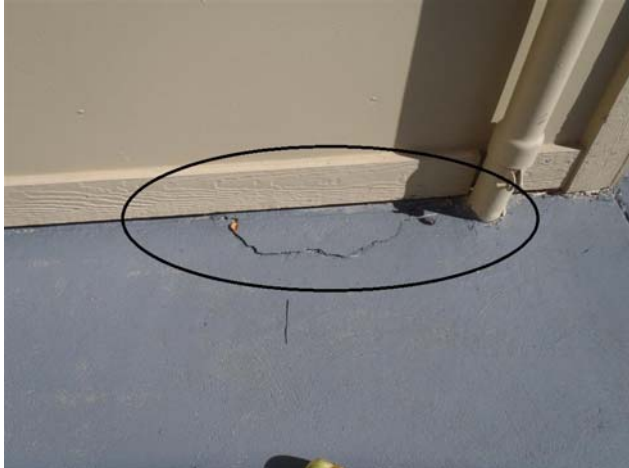
- **Monitor:** The patio has settled and cracked. Persisting movement may result in the need for repairs.

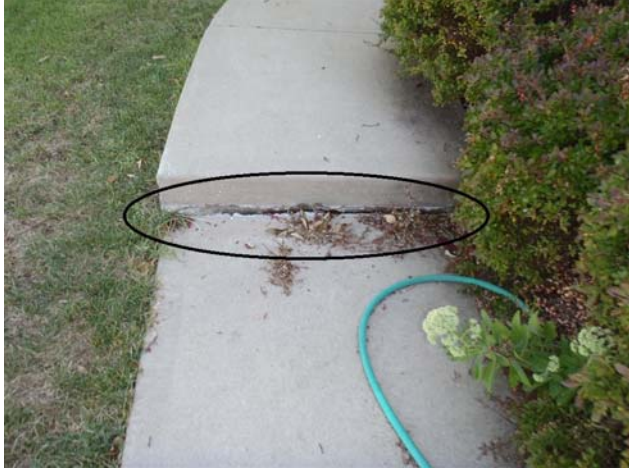
- **Monitor:** The walkway has settled and cracked. Persisting movement may result in the need for repairs. **Repaired**

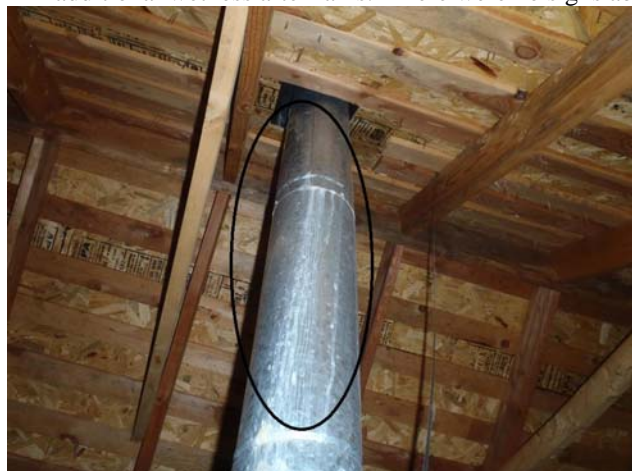
- **Monitor:** While in the attic water stains were observed on the lower sections of the furnace flue. The insulation below the elbow also showed signs of past moisture. This can be caused from several things. The most common is just condensation in the flue above the roof. Another would be the storm collar around the flue could be leaking. The wind can also blow just right that rain blows in under the rain cap and runs down the interior of the flue until it gets to the first joint where it then transferred to the outside surface and dripped off the elbow. This is a common condition in 80% of homes but very seldom is enough to penetrate completely through the insulation to the drywall below. Monitor for any additional wetness after rains. There were no signs above the roof that would require repairs.

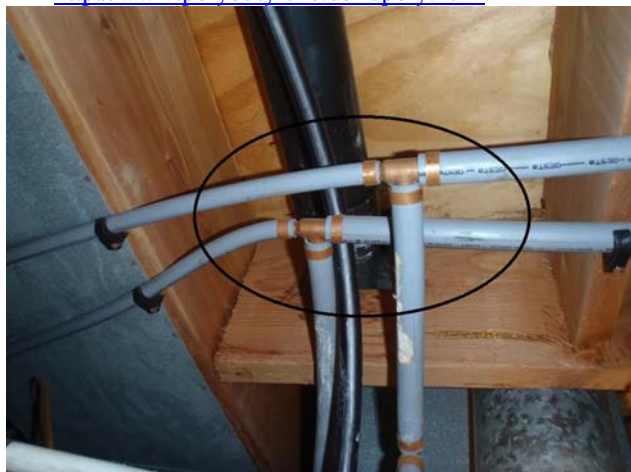
- **Note:** Polybutylene plumbing was noted in the house. While scientific evidence is scarce it is believed that oxidants in the public water supplies, such as chlorine, react with the polybutylene piping and acetal fittings causing them to scale and flake and become brittle. Micro-fractures result, and the basic structural integrity of the system is reduced. Thus, the system becomes weak and may fail without warning causing damage to the building structure and personal property. It is believed that other factors may also contribute to the failure of polybutylene systems, such as improper installation, but it is virtually impossible to detect installation problems throughout an entire system. Throughout the 1980's lawsuits were filed complaining of allegedly defective manufacturing and defective installation causing hundreds of millions of dollars in damages. Although the manufacturers have never admitted that poly is defective, they have agreed to fund the Class Action settlement with an initial and minimum amount of \$950 million. More detailed information can be found at <http://www.polybutylene.com/poly.html>.

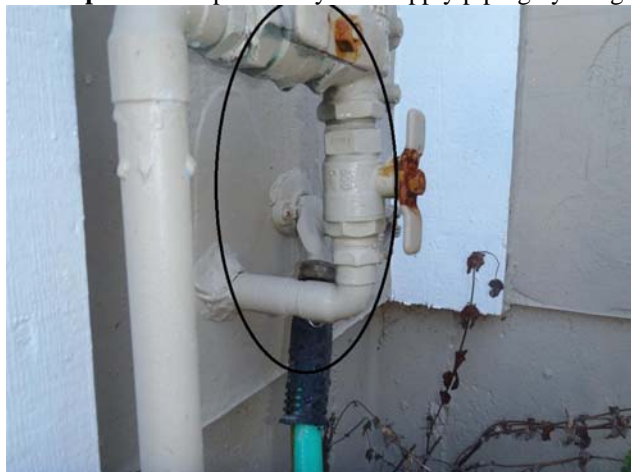
- **Repair:** The sprinkler system supply piping by the garage is leaking.

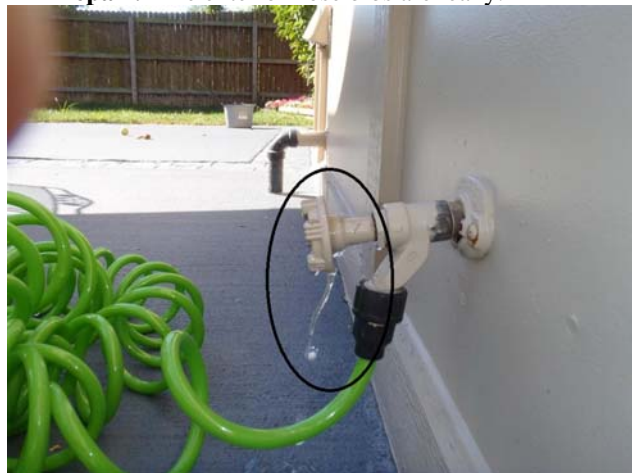
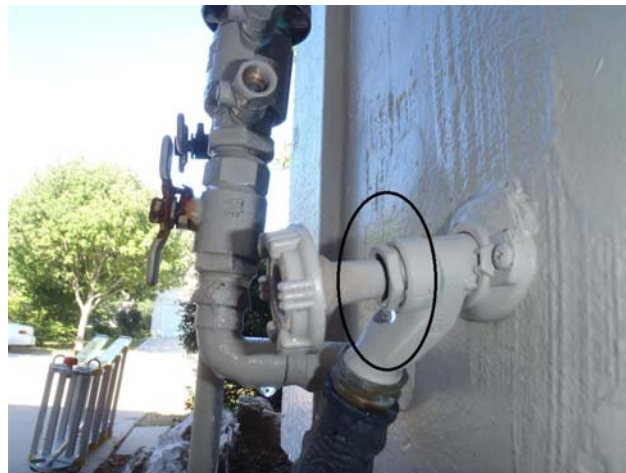
- **Repair:** The toilets are loose in the southwest bedroom and master bedroom bathrooms.
- **Repair:** The exterior hose bibs are leaky.

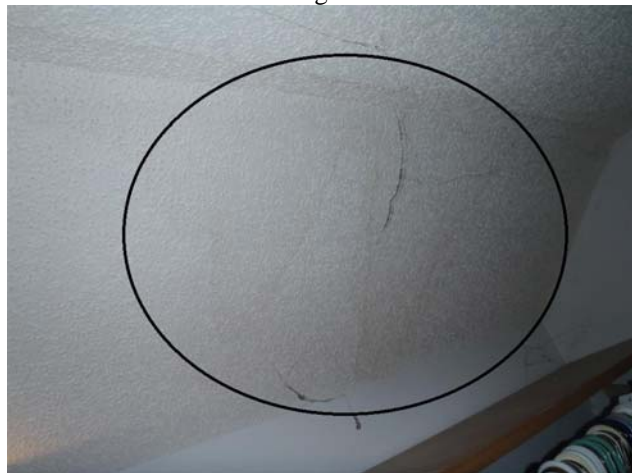
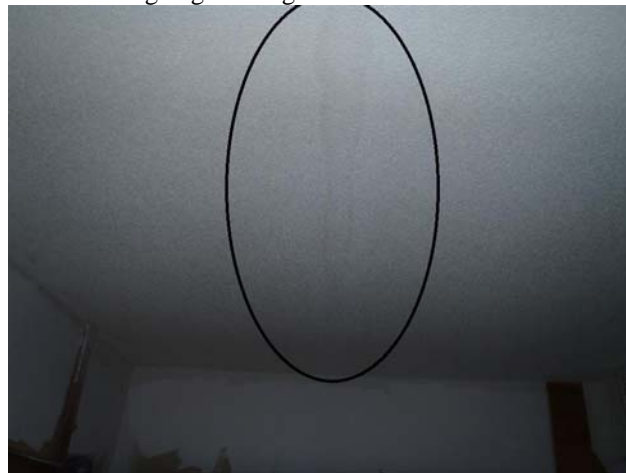
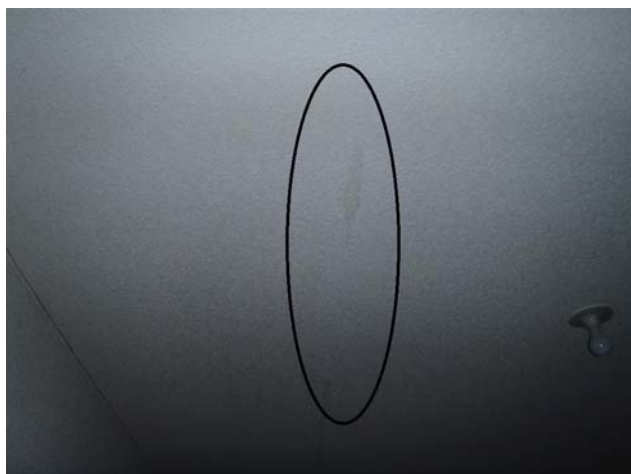
- **Monitor:** Water staining was noted on the south master bedroom and garage ceilings.

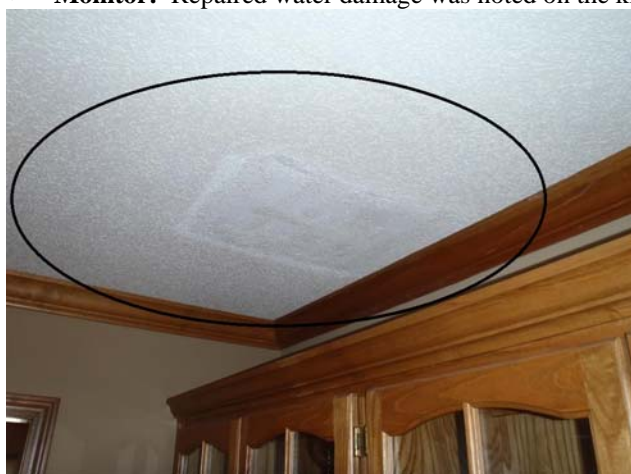
- **Monitor:** Repaired water damage was noted on the kitchen ceiling and over the dining room window.

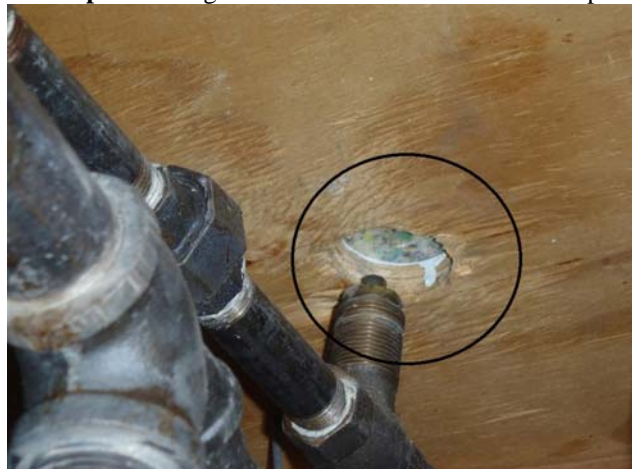
- **Repair:** The gas valve has been covered with carpet.
